# Glazing Investigation Report

One Wall Centre, 938 Nelson Street, Vancouver, BC

PROJECT # 2324.10

DATE October 2, 2009

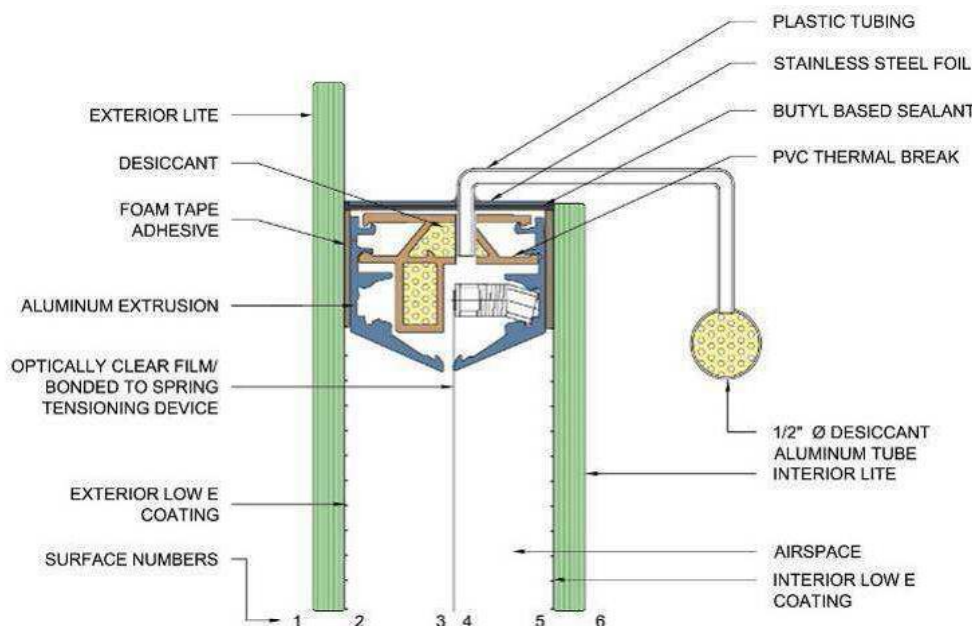
The Visionwall IGUs that were originally installed at One Wall Centre are shown in Fig. 2.5.2 and 2.4.2. The Visionwall IGUs have two unique design features that set them apart from conventional IGUs. Firstly, they contain an optically clear PET film that is suspended between the outer and inner lites of glass to increase the thermal insulating performance. The optically clear film is suspended on springs that are attached to the spacer bar. The spacer bar consists of a large desiccant filled PVC thermal break mechanically attached between two aluminum extrusions. The glass is fastened to the aluminum spacer bar extrusions with two sided foam tape. The hermetic seal around the perimeter of the IGU consists of a stainless steel foil or band set into a thin layer of a butyl based thermoplastic sealant. Thermoplastic refers to a class of sealants that soften when heated and return to their original properties when cooled to normal temperatures.

Fig. 2.5.2 Original Visionwall IGU as installed

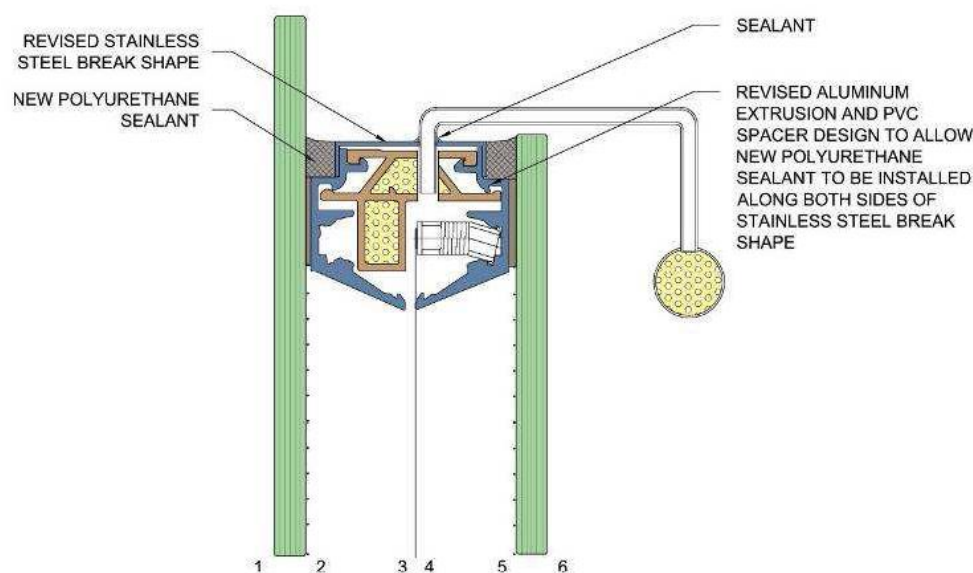
Fig. 2.5.3 New Visionwall IGU

Subsequent to the completion of One Wall Center, Visionwall changed their IGU edge seal design. New Visionwall IGUs delivered to site as replacement units in 2008 have a revised edge seal design. The new edge seal design shown in Fig. 2.5.3 incorporates a revised spacer bar assembly that has a 6mm reveal on both sides. The stainless steel foil strip has been revised into a break shape that fits into the reveal in the spacer and polyurethane caulking is installed to fill the 6mm reveal spanning between the

stainless steel break shape and the adjacent glass lites. The new edge seal design incorporates a better sealant profile which will allow more differential movement without causing damage, and incorporates a thermosetting sealant that will be less prone to ridging caused by temperature variations than the original edge seal design.

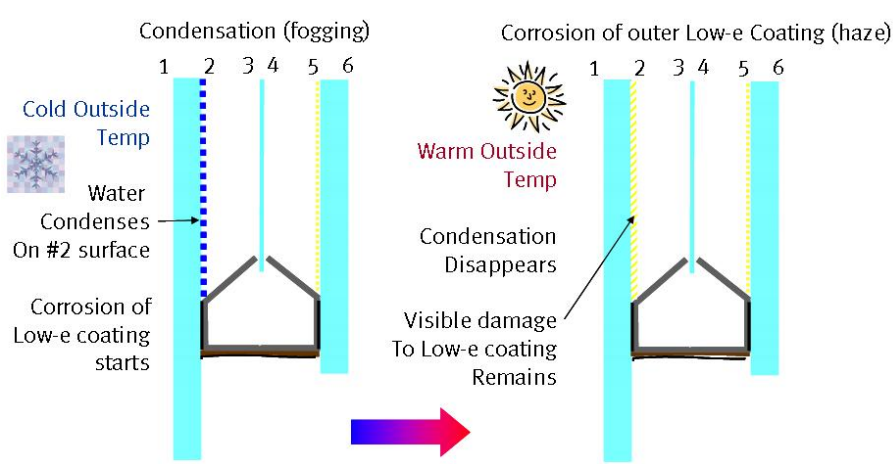
Fig. 2.6.2 Condensation (fogging) vs low-e Corrosion (Haze)

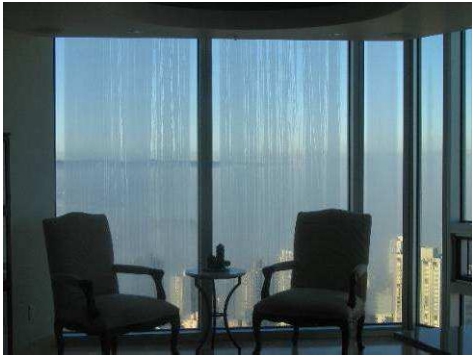
- a. Severe – Any visible condensation, large corrosion spots on low-e coating, large clusters of small spots, or permanent haze visible from 3m,

Visual condensation and corrosion visible from 3m

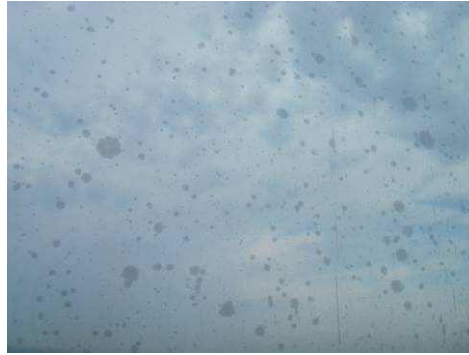
Large low-e corrosion spots visible from 3m

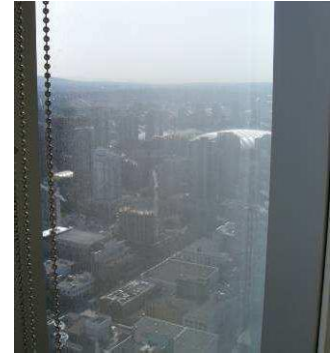
Permanent haze visible from 3m

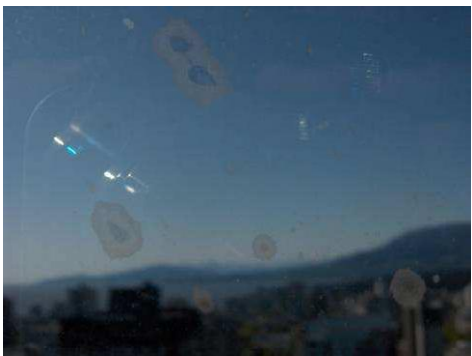
Large low-e corrosion spots visible from 3m

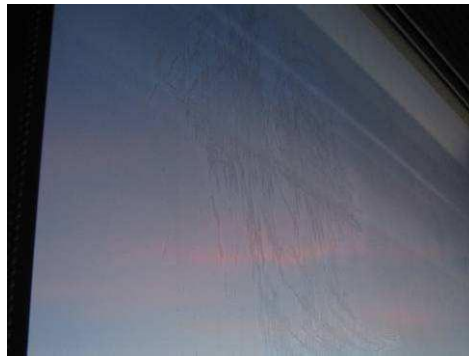
"Scratch" like patterns of frost/corrosion visible from 3m

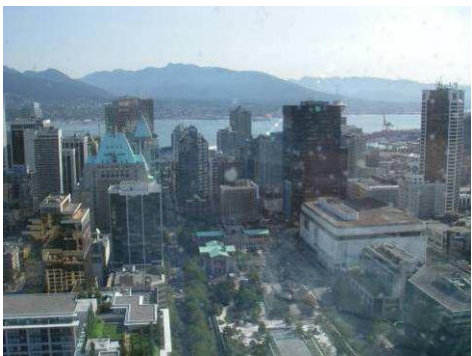
- b. Moderate – Any corrosion/oxidation of the low-e coating visible from 3m,

Moderate corrosion spots visible from 3m

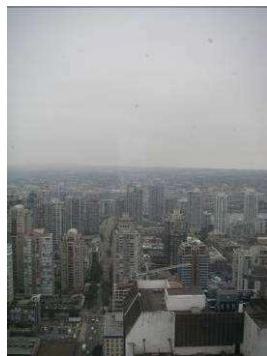
Moderate corrosion spots visible from 3m

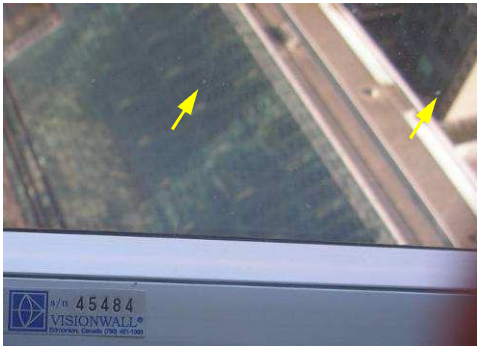
- c. Minor – Any visible corrosion/oxidation of low-e coating, but not visible from 3m,

Minor corrosion spots only visible from <3m away

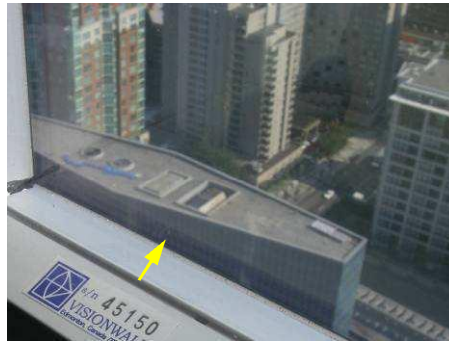
Minor corrosion spots only visible from <3m away

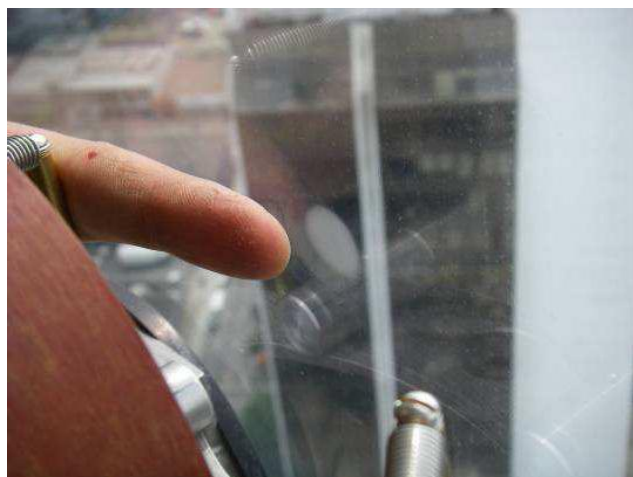
Fig. 3.2.3 Dewpoint Test Apparatus and Condensation on Surface #5 Indicating the IGU airspace Dewpoint Temperature

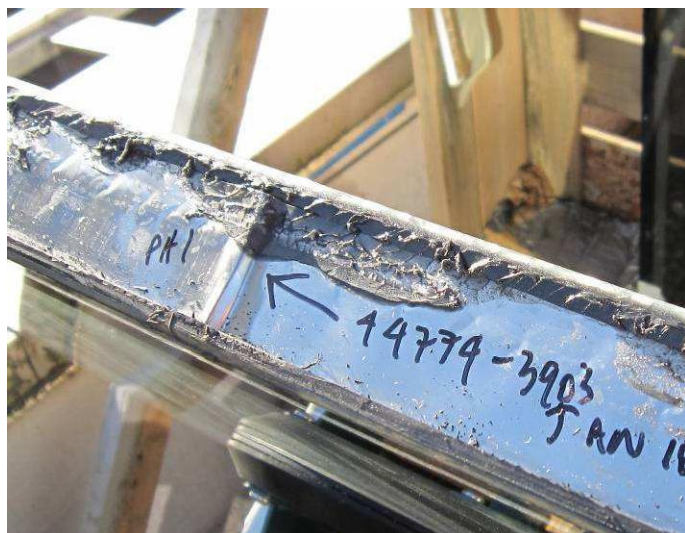
Fig. 3.7.1.1 Typical ripple or "fish mouth" in the stainless steel edge band. IGU 44774

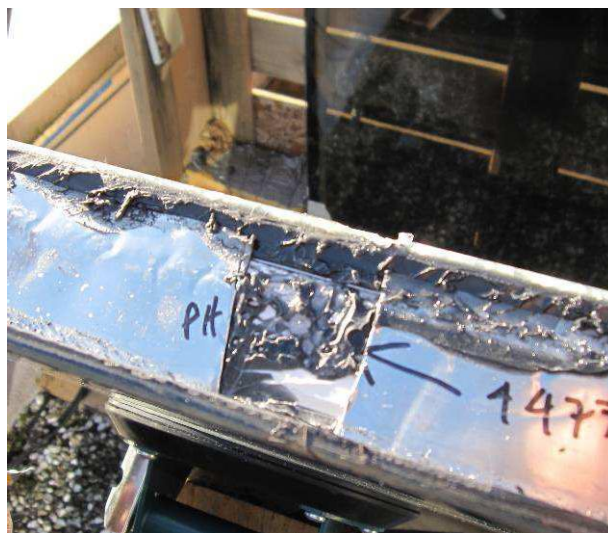
Fig. 3.7.1.2 Edge band removed at ripple revealing open joint between PVC and aluminum extrusion spacer bar components

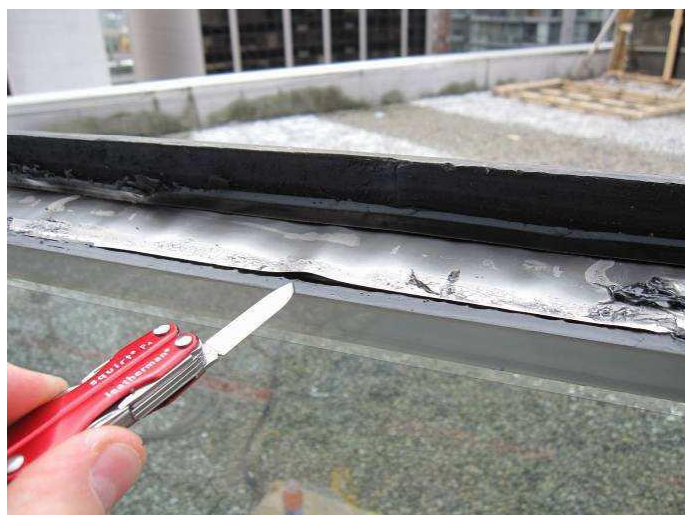
Fig. 3.7.1.3 Typical ripple or "fish mouth" in the stainless steel edge band of IGU 43161

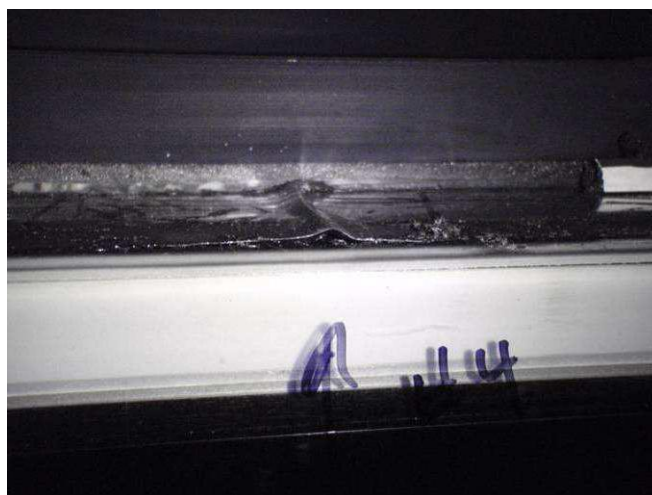
Fig. 3.7.1.4 Typical ripple or "fish mouth" in the stainless steel edge band of IGU 43882.

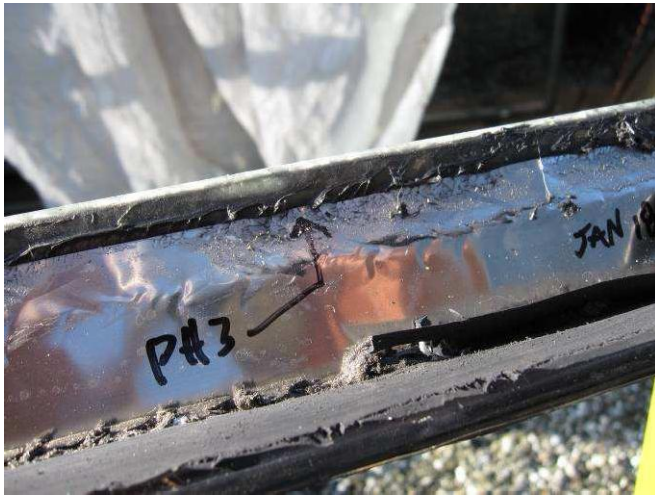
Fig. 3.7.1.5 Typical Buckling of stainless steel edge band of IGU 44774.

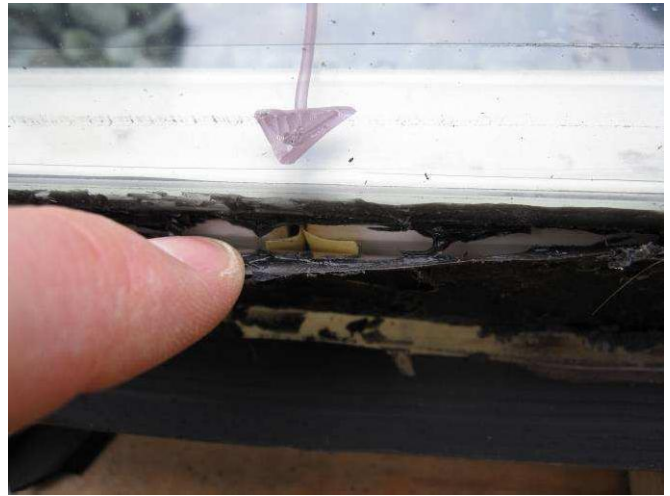
Fig. 3.7.1.6 Typical delamination of the stainless steel edge band at a large joint in the PVC spacer between the jamb and corner of IGU 43161.

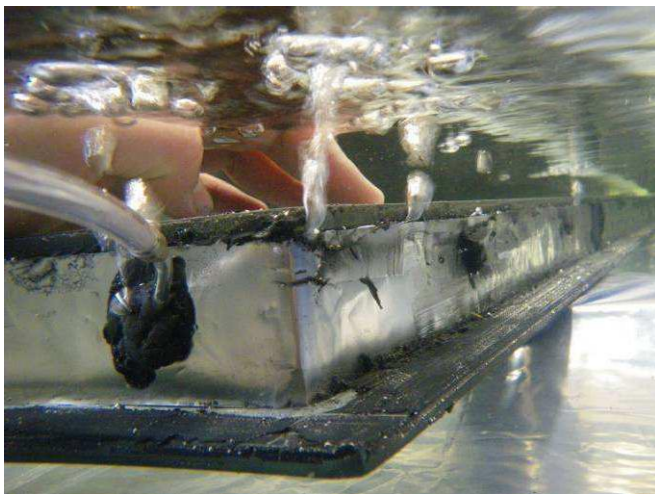
Fig. 3.7.2.1 Confirmed Air Leakage Paths #9, 11, 12, 13, 14, & 15 Moderate and Minor Category

method of preventing or repairing IGUs with high dew points unless all perimeter seal discontinuities can be sealed.

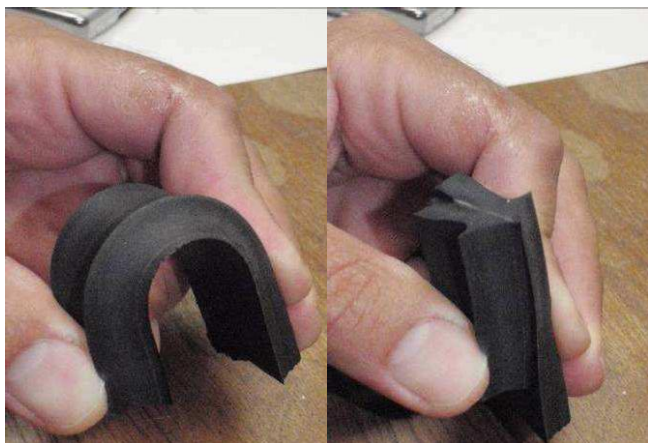
During the removal of IGU 43161 the structural sealant adhering the IGU to the curtain-wall frames was informally tested for strength and elastic modulus. It was found that the sealant was very brittle. In all cases when the sealant was flexed back

Fig. 3.7.3.1 Brittle Structural Sealant From IGU 43161 Breaking in Half After Being Bent 180 Degrees

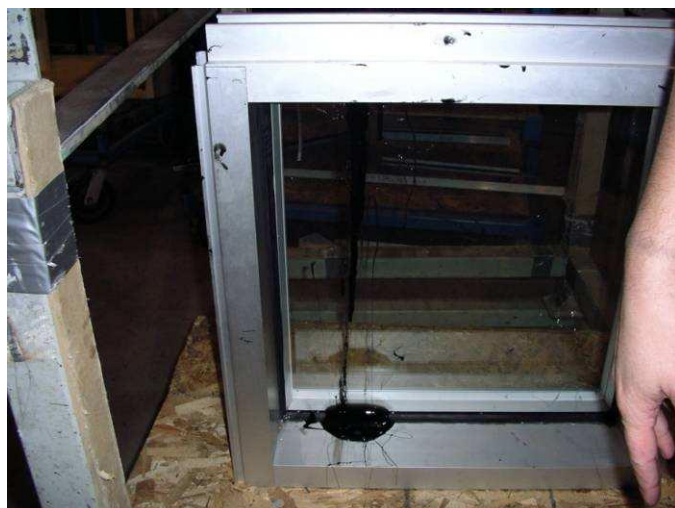
- The sealant was too viscous to completely fill the glazing rebate,
- Air locks were formed in the jambs and sills. After

Fig. 3.8.1 In-Situ Repair Mock-up After Sealant Injection

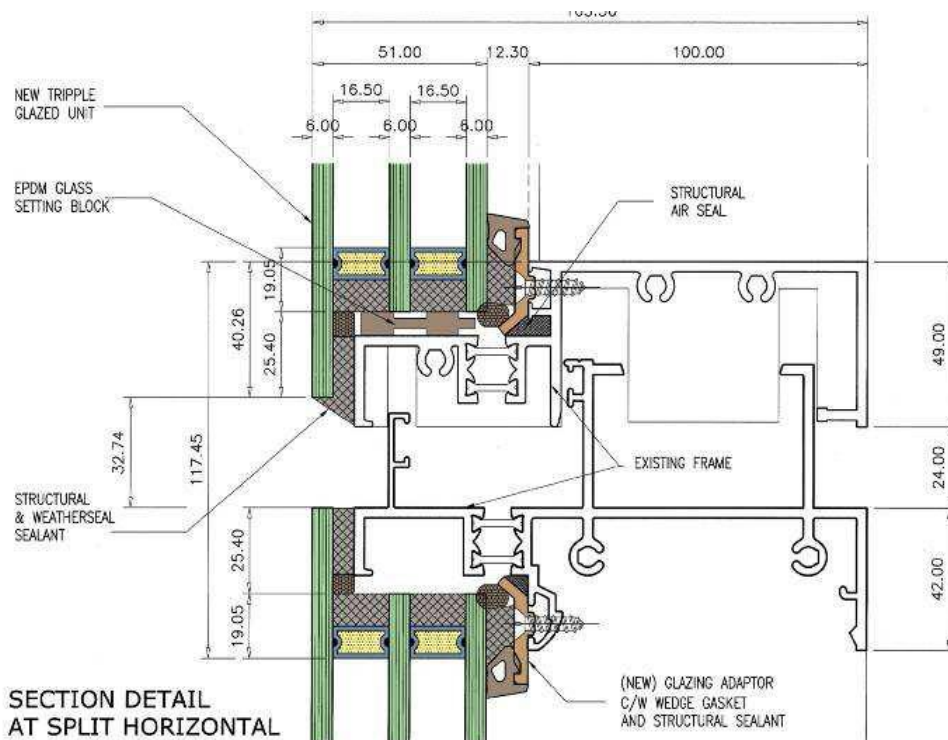
Fig. 4.1.1 Mechanically Attached Four Sided Structural Re-glazing Method – Stack Joint

Regardless of the type of IGU used, the design of the new replacement IGUs needs to address the overheating issues. Clear glass with a solar reflective low-e coating on surface 5 and 2 will help to reduce the heat gain in the suites. This same unit with tinted glass on the exterior to match the lower portion of the building will significantly reduce the overheating problems.

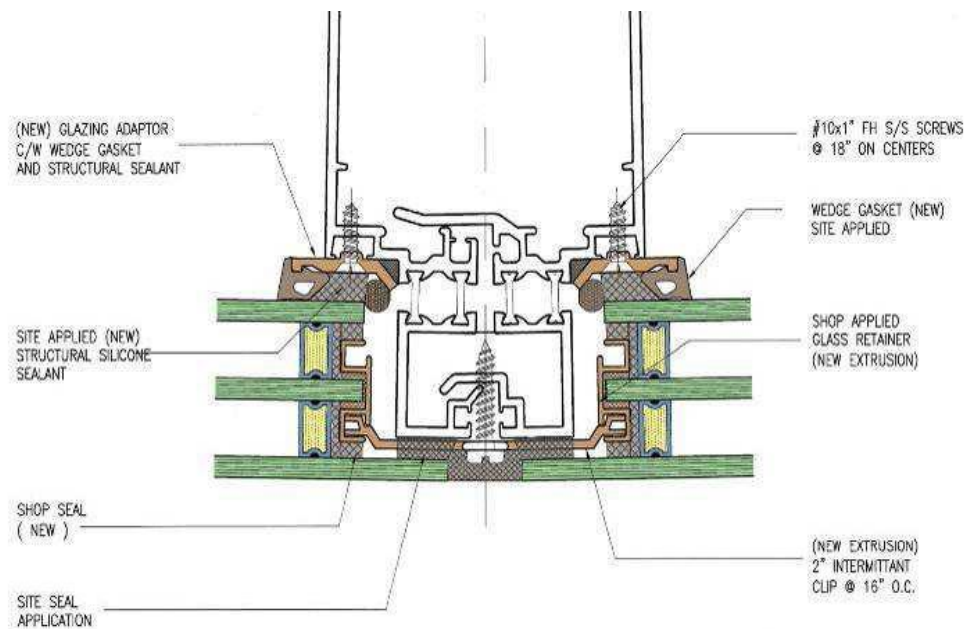
Fig. 4.1.2 Mechanically Attached Four Sided Structural Re-glazing Method – Vertical Mullion
