One Wall Centre Glazing Replacement SGM

December 17th, 2011

Background – Fogging and Overheating

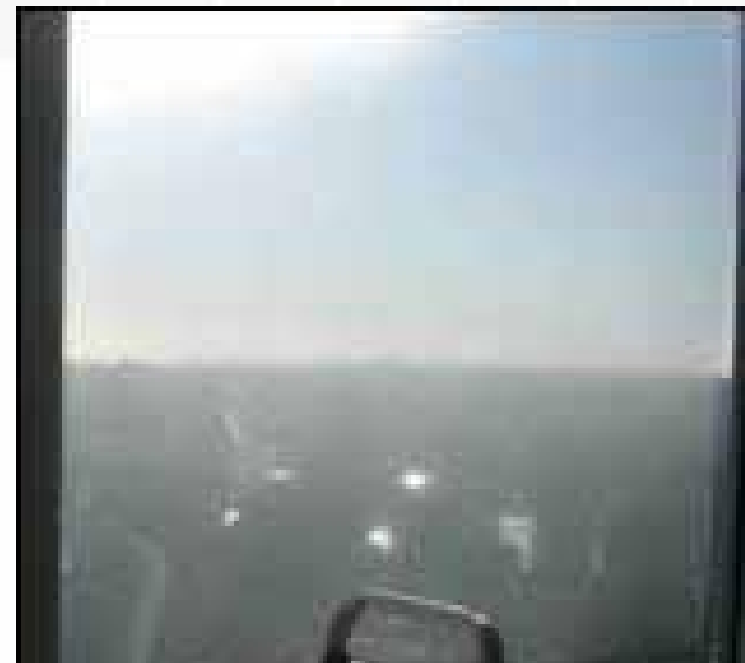
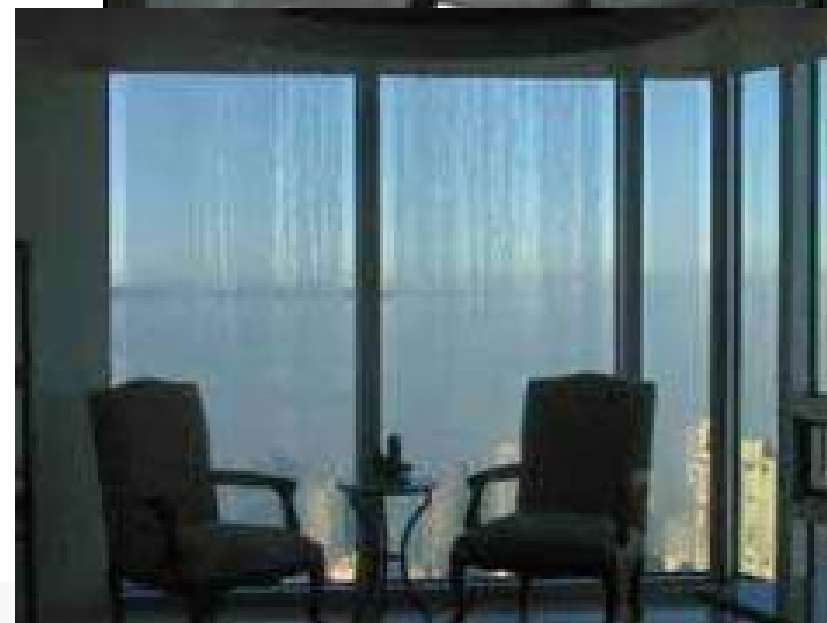
- *Fogged glazing unit and overheating problems since construction:*
- *Fogging problem is worse on some units and better on others*
 - *Severe – Any visible condensation, large corrosion spots, or permanent haze visible from 3m*
 - *Moderate – Any corrosion/oxidation of the low-e coating visible from 3m*
 - *Minor – visible corrosion visible only less than 3m away*
 - *Clear – No visible corrosion*

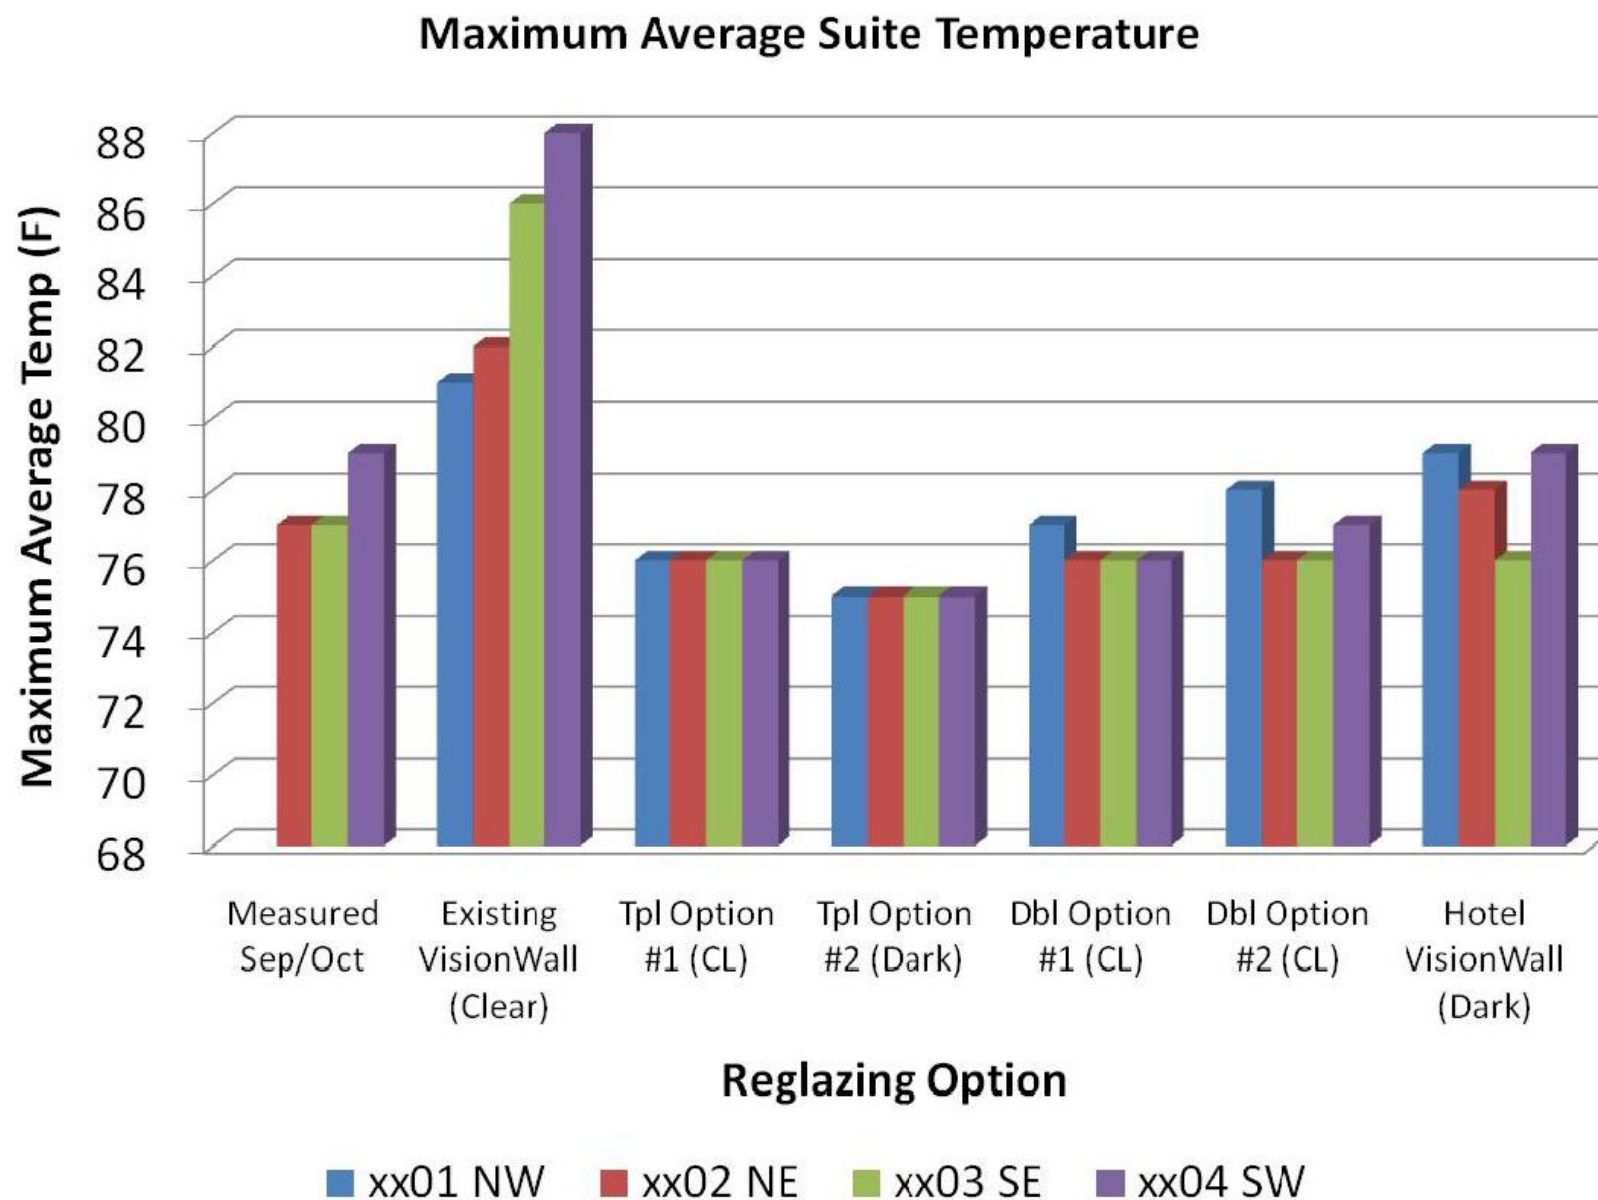
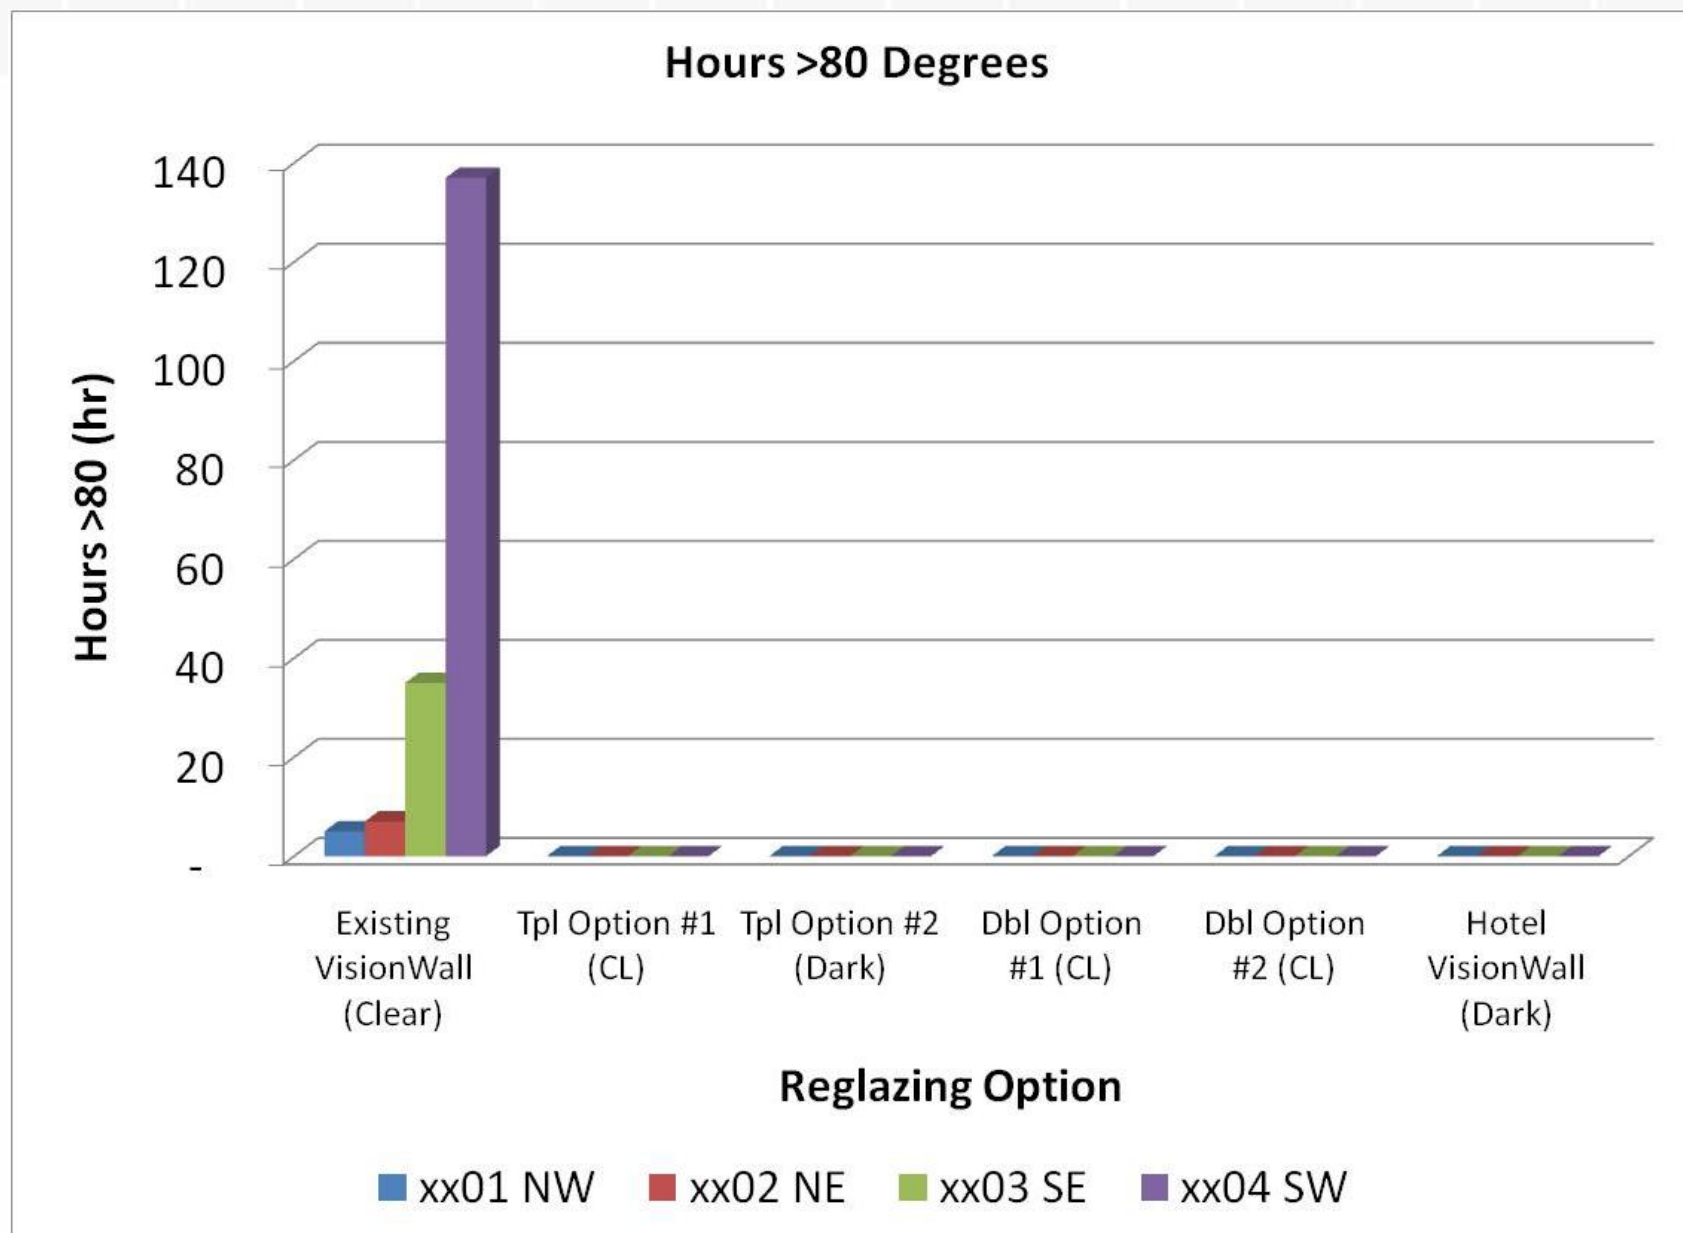
- Cooling units are generally undersized
- Ducting is significantly undersized (was not upgraded)
- New high performance clear glazing will provide similar or better performance to hotel dark glass.
- Mechanical under design can be resolved using high performance clear glazing in most suites
- Energy savings from glass replacement will be possible with triple glazed

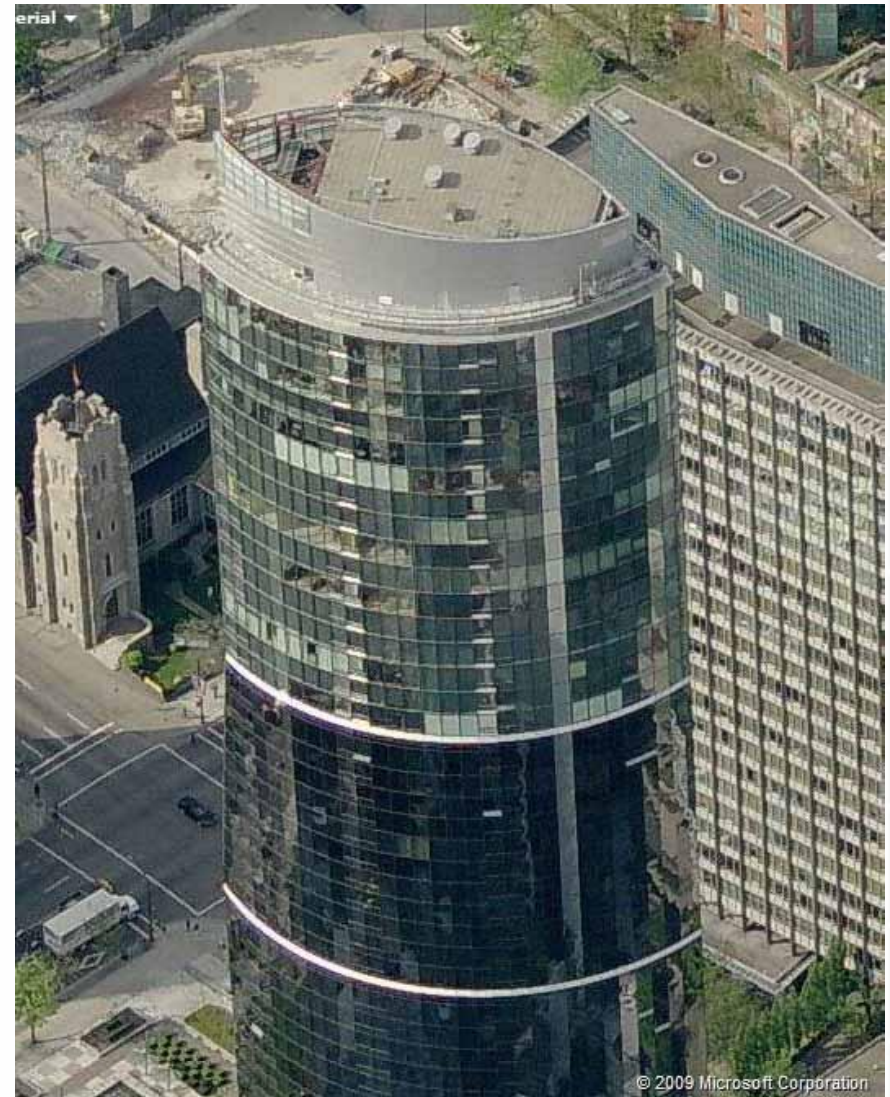
- The existing glazing for the hotel portion of the building is only available from one NA source
- The type of low E coating used for the hotel portion is not as readily available and will become more difficult to obtain in the future
- Matching the hotel glazing is difficult and more expensive
- The residential portion of the building a relatively clear glass with a slight green tint and is not a problem to match

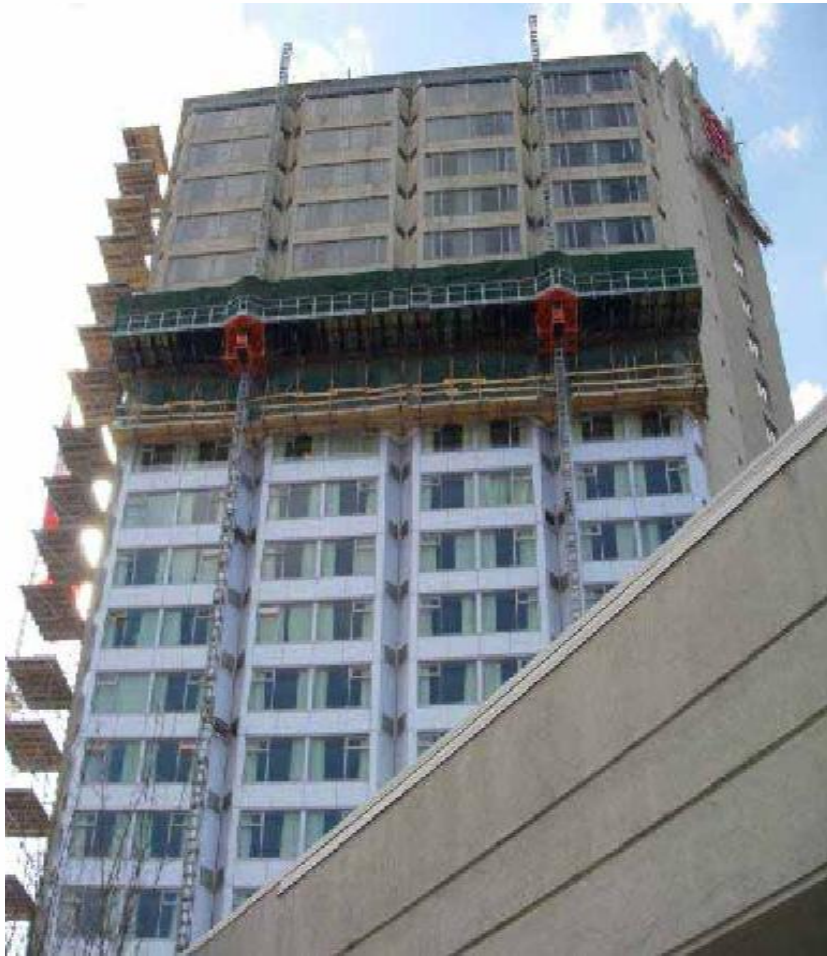
- RDH managed a cladding replacement program on the Sheraton Guildford Hotel while it carried on business as normal.
- RDH developed a rehabilitation strategy based on utilizing mast-climbers during the off-season to minimize disruption to hotel activities.

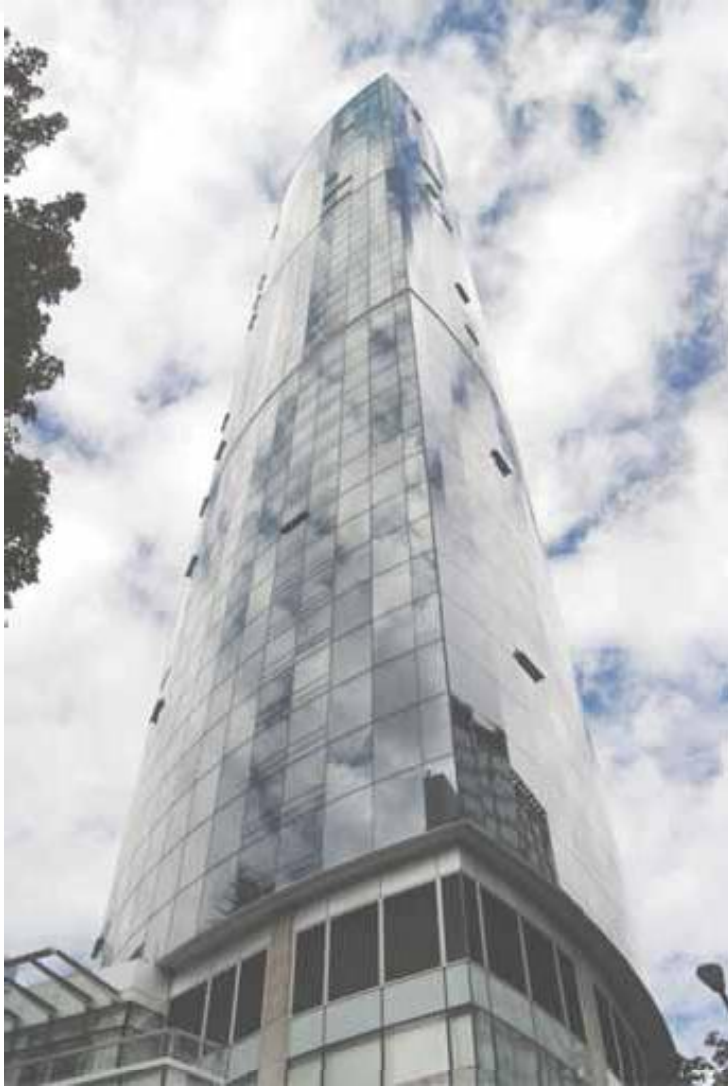
Accessing the work area is not straight forward

The height, exposure, and tight location makes this project especially challenging

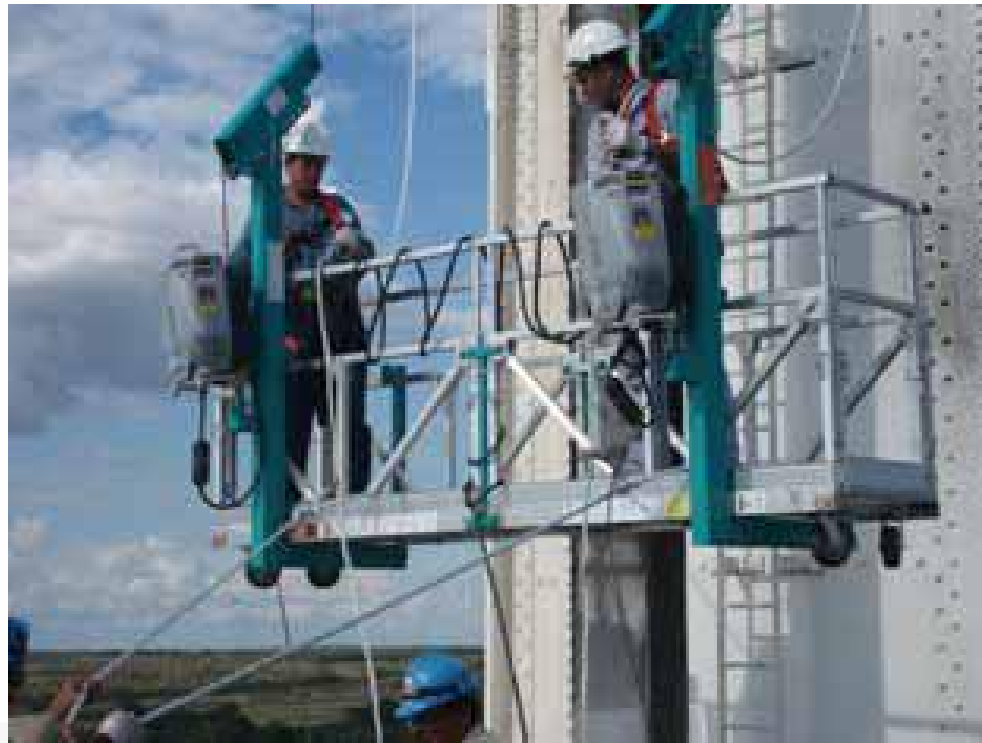
Swing stages are the conventional method for maintenance work however they aren't suitable for an extended construction project of this nature.

Swing stages have significant limitations with respect to efficiency, weight capacity, inclement weather, and wind.

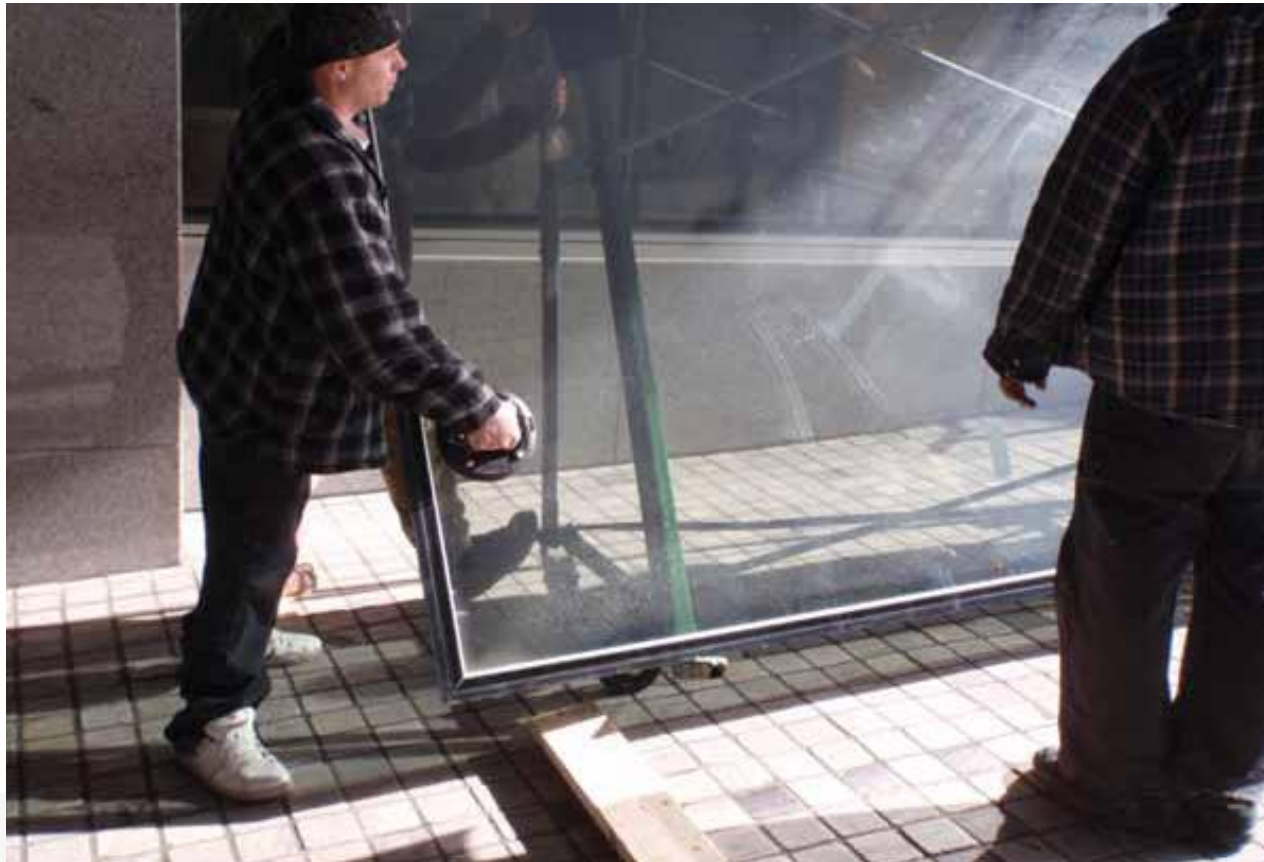
The sealed glazing units are very large, heavy, and difficult to handle.

Special methods will be required to remove, install, and transport these components.

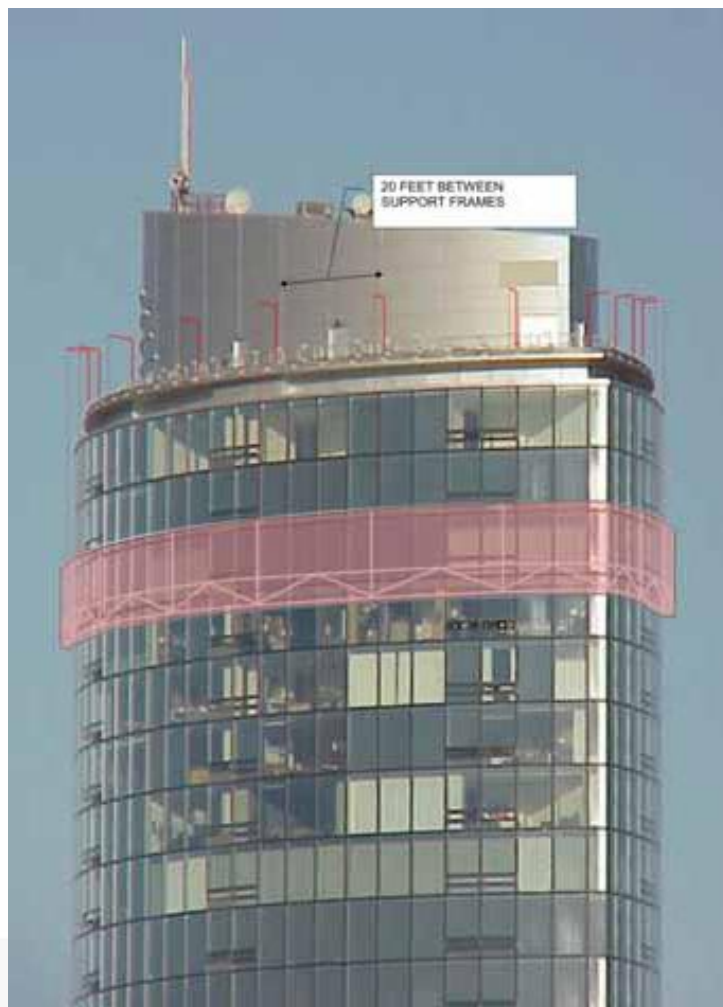
Logistical considerations – Access Concept

We needed to explore custom solutions to save time and money and to reduce the risk.
