One Wall Centre

Glazing Replacement Information Meeting

November 19th, 2011

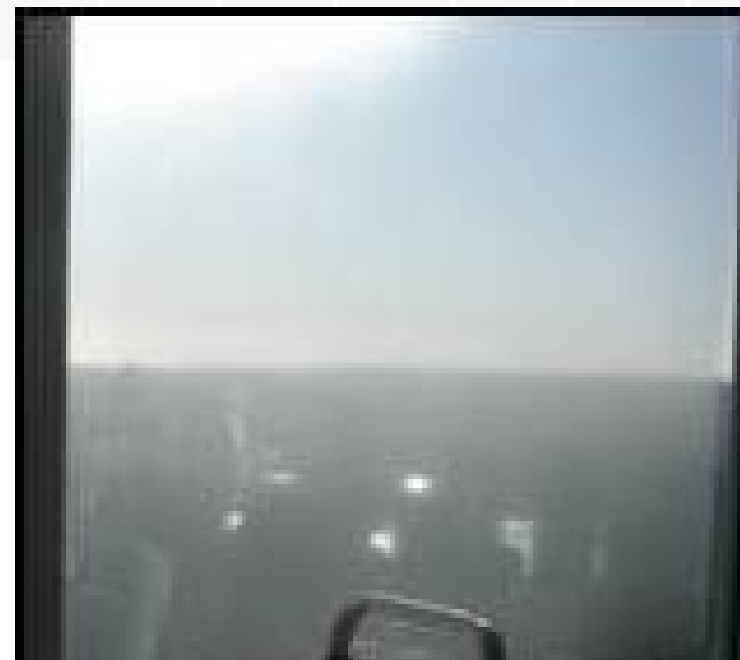
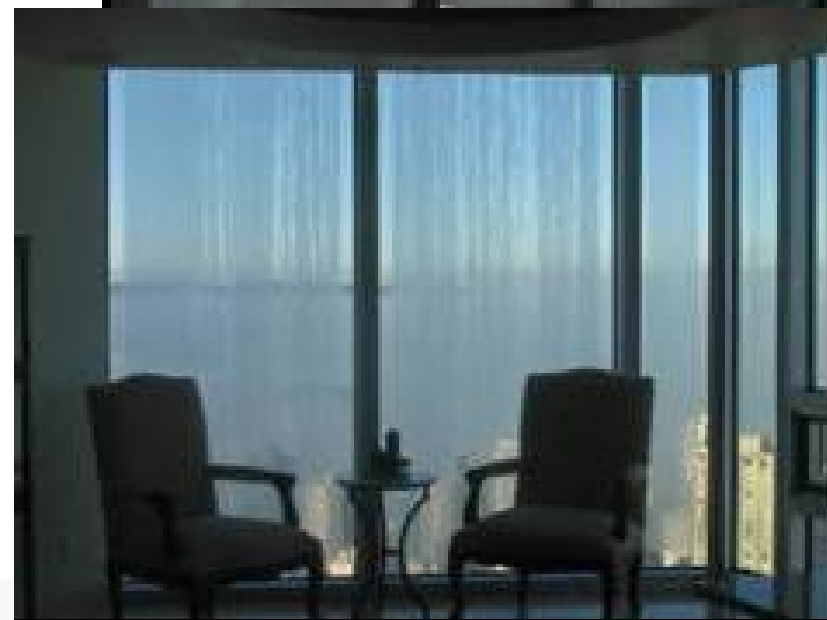
Background – Fogging and Overheating

- *Fogged glazing unit and overheating problems since construction:*
- *Fogging problem is worse on some units and better on others*
 - *Severe – Any visible condensation, large corrosion spots, or permanent haze visible from 3m*
 - *Moderate – Any corrosion/oxidation of the low-e coating visible from 3m*
 - *Minor – visible corrosion visible only less than 3m away*
 - *Clear – No visible corrosion*

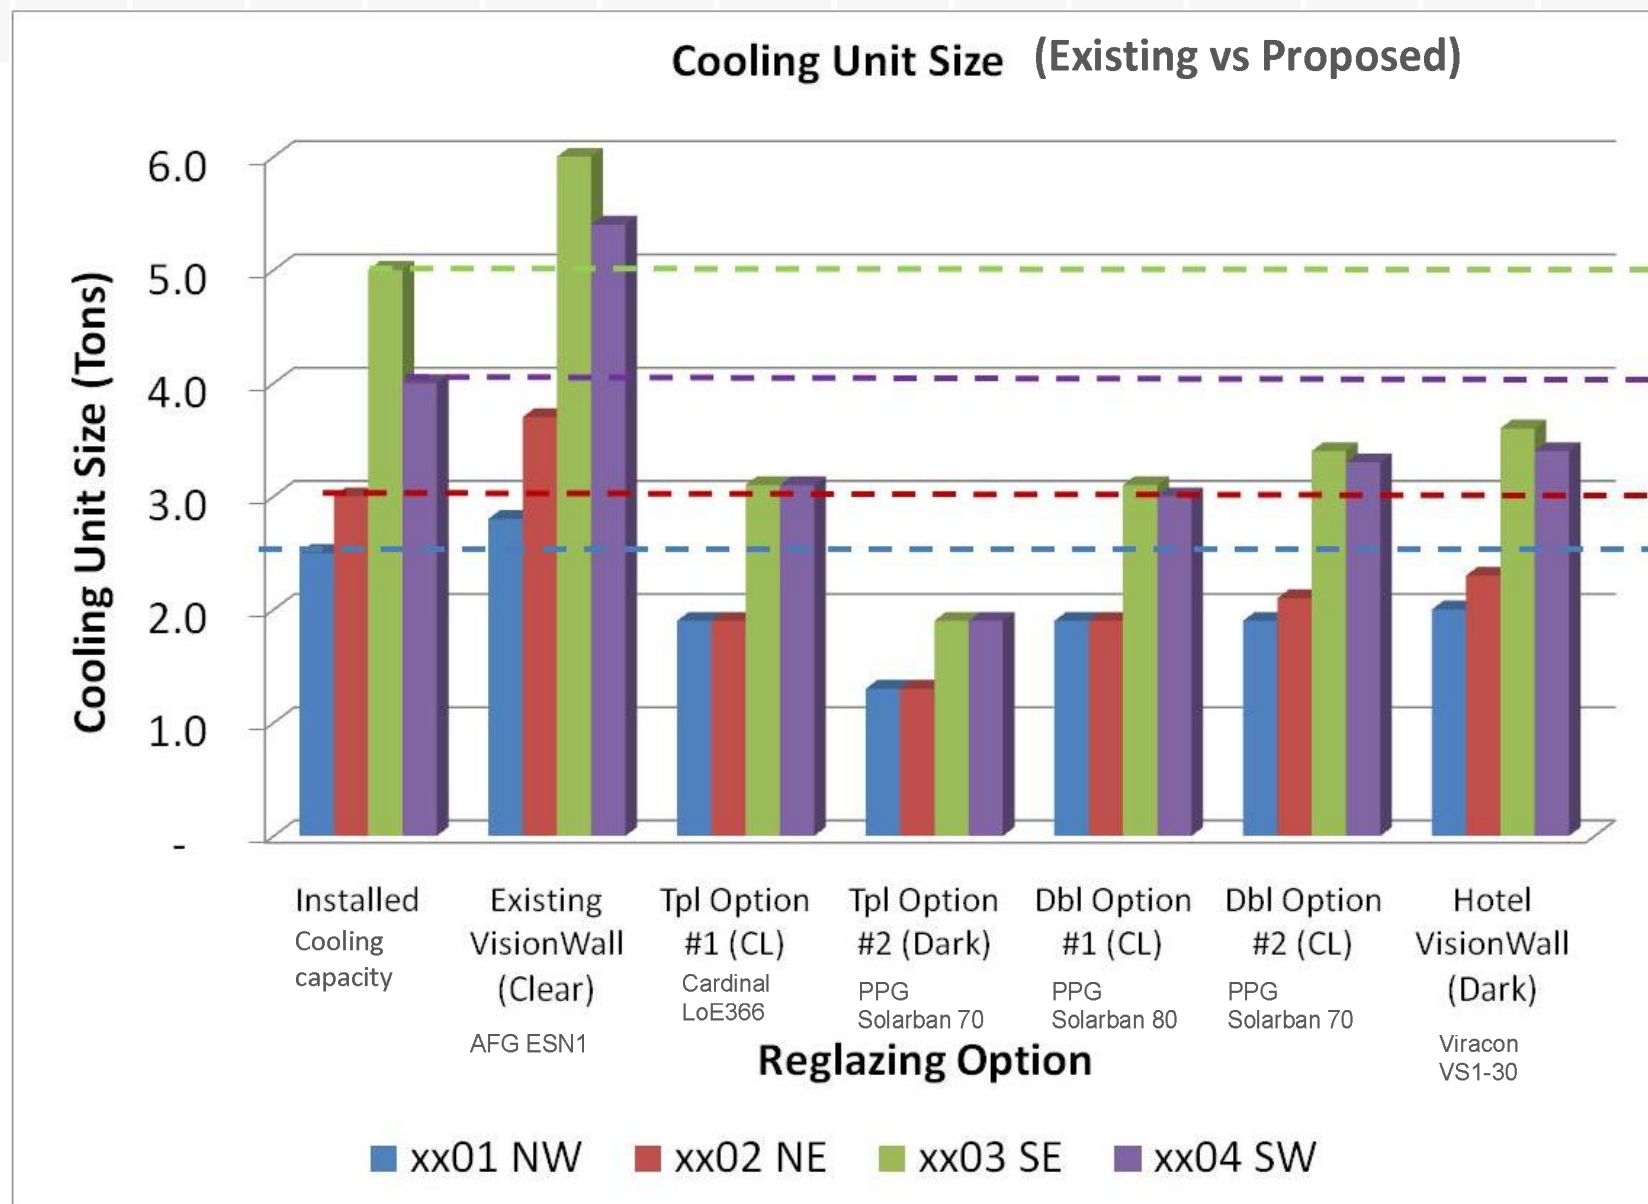
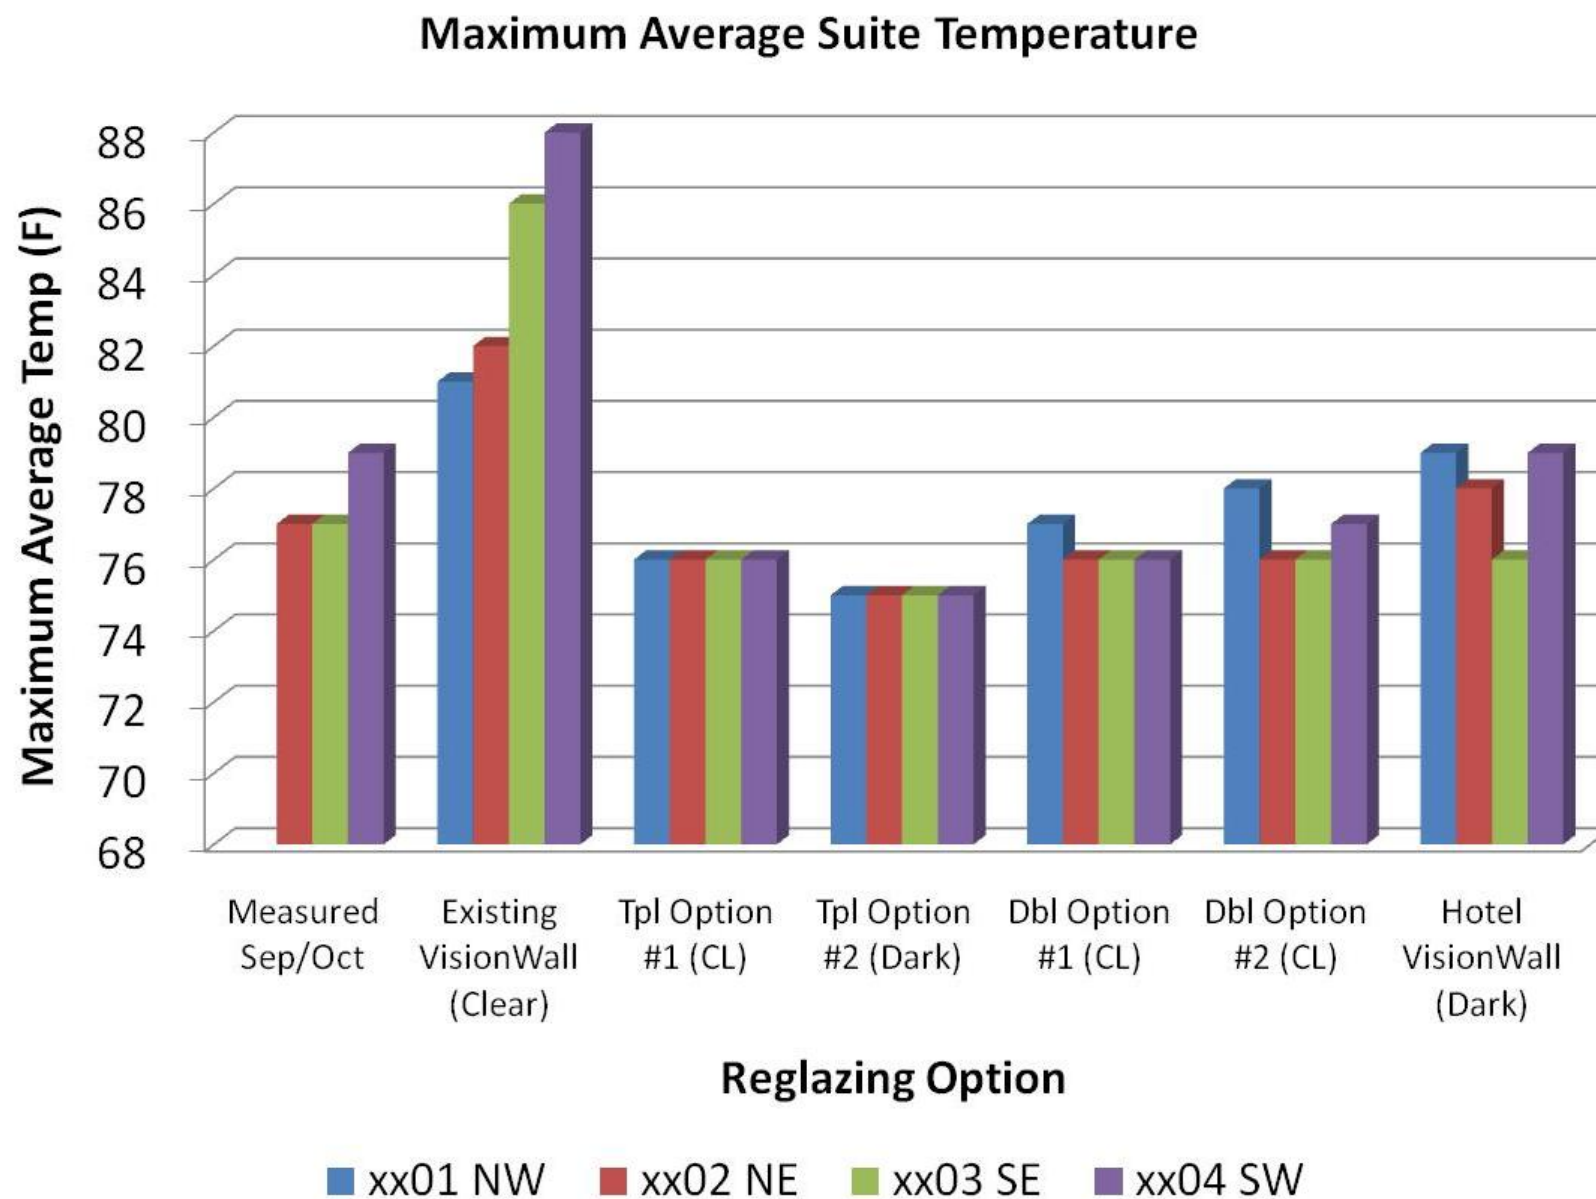
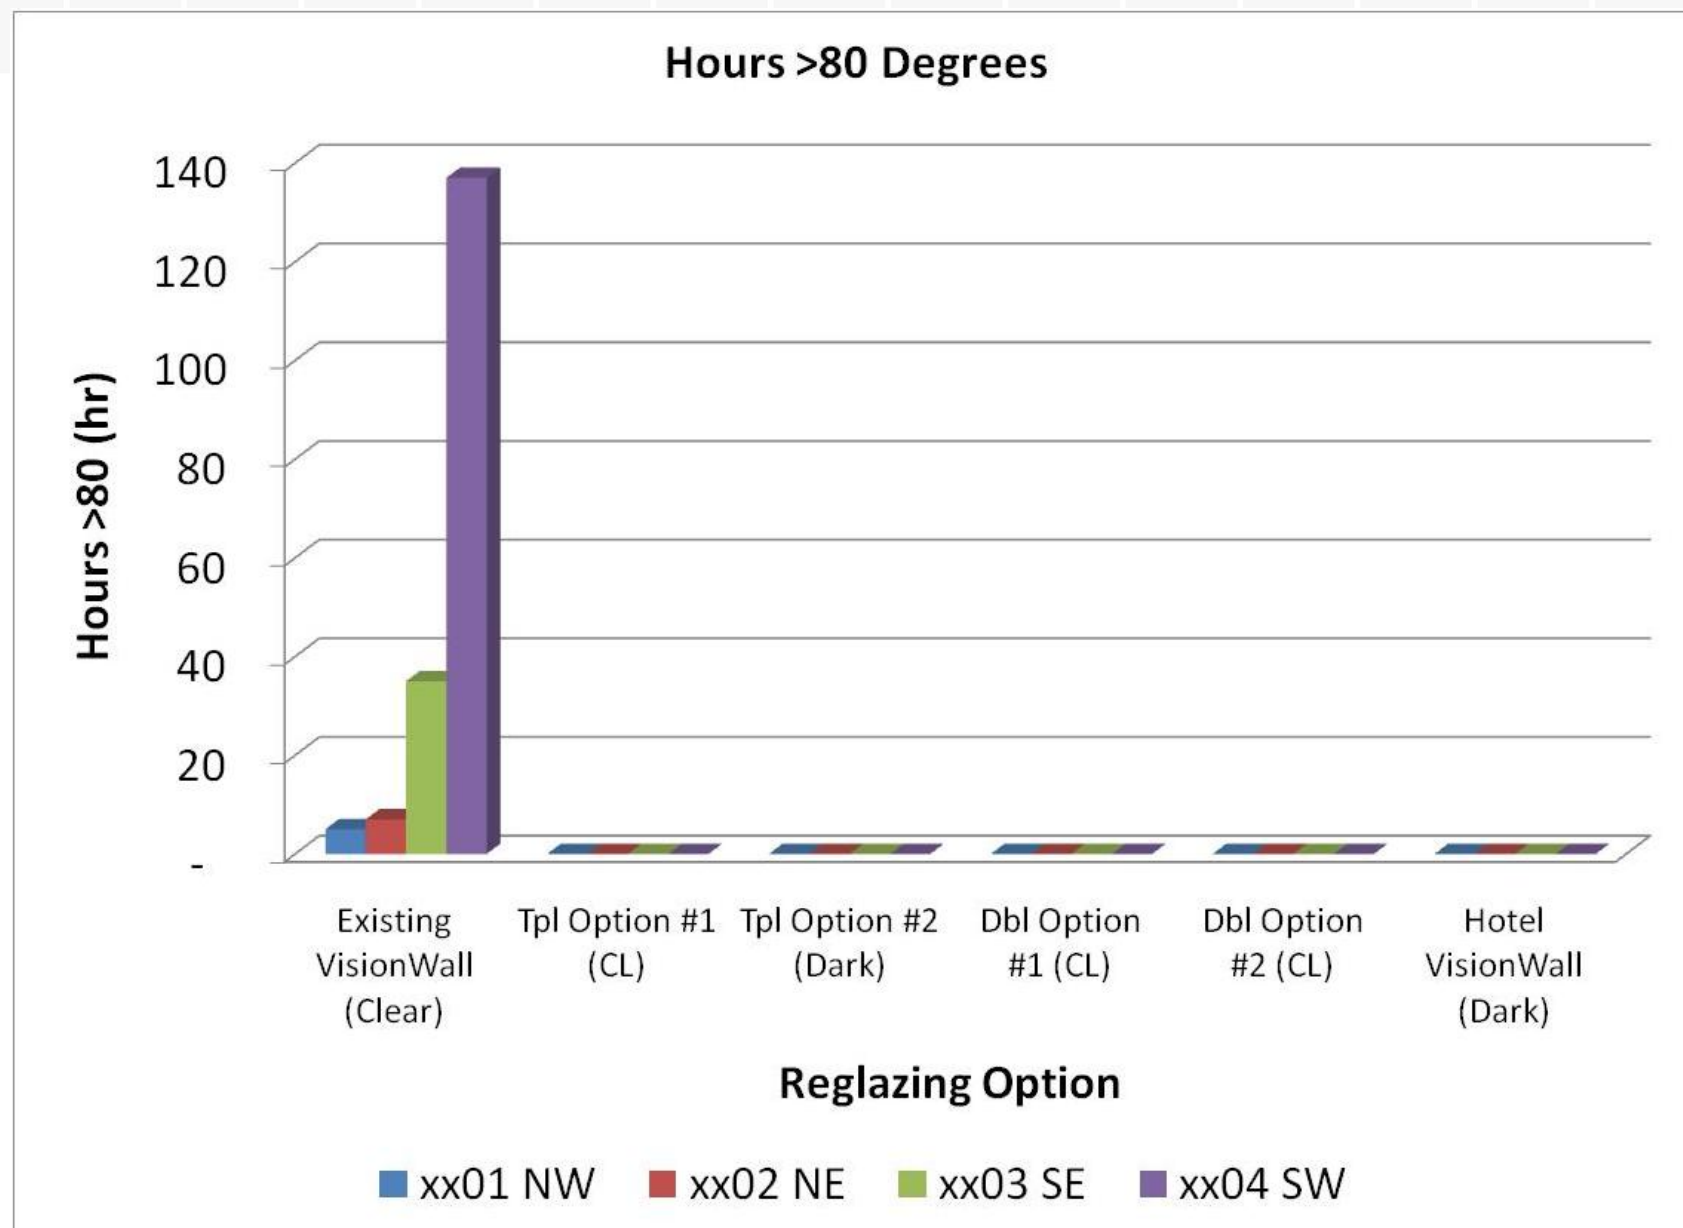
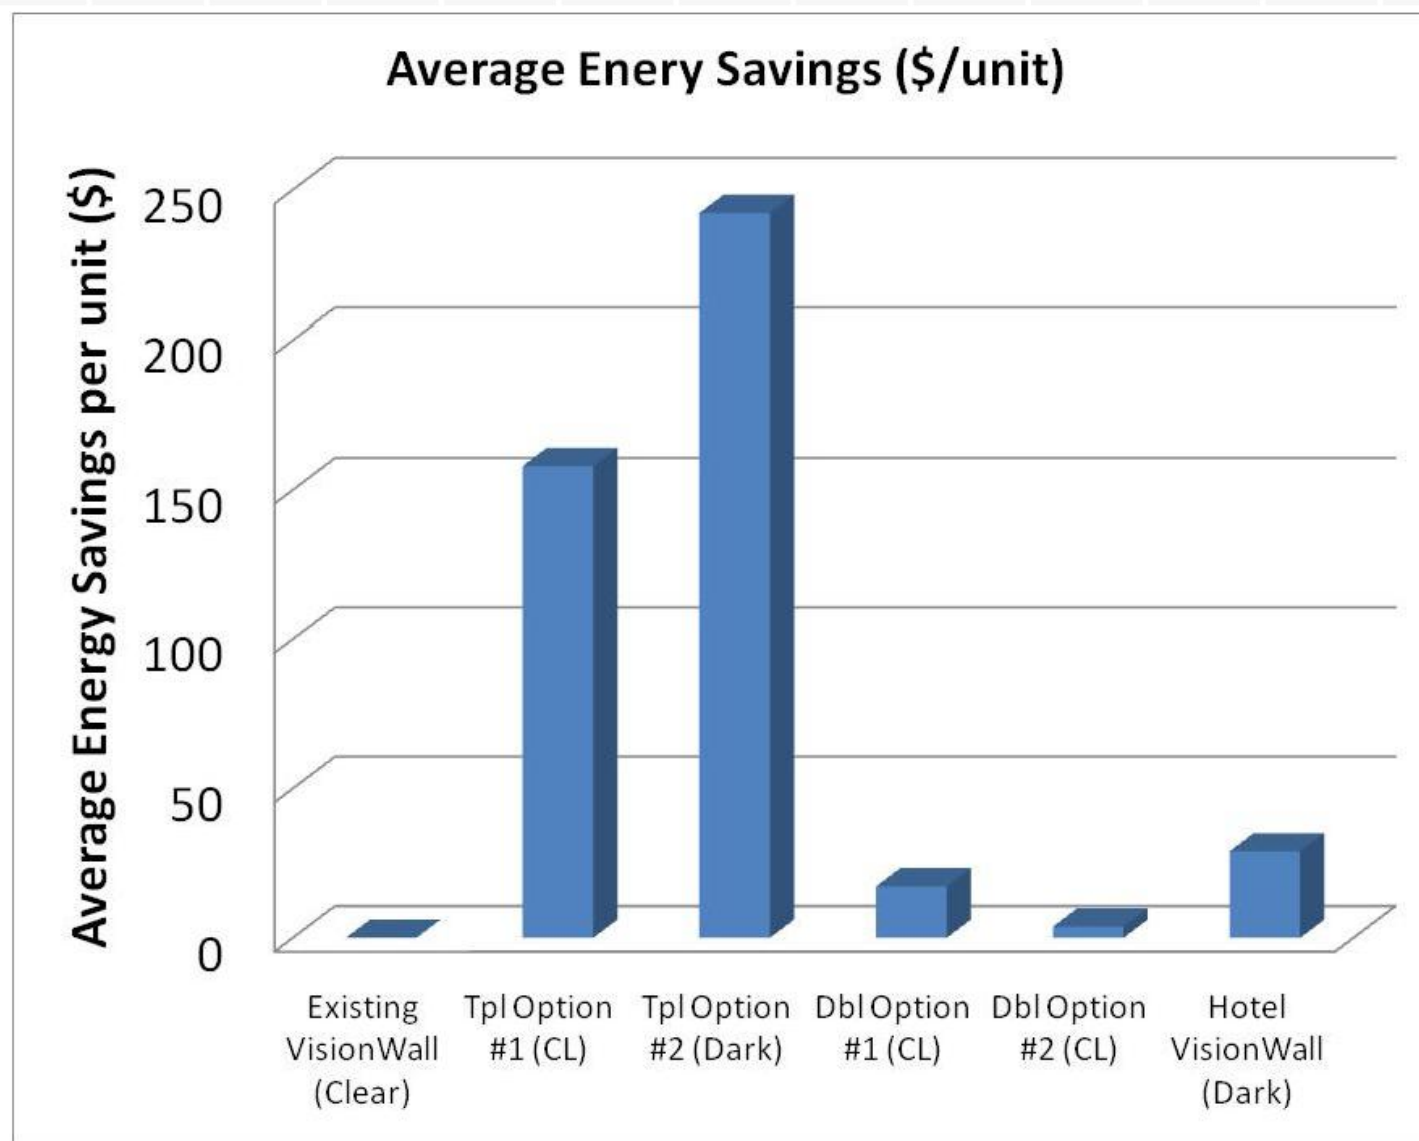
Mechanical - Results from 2010 Study

- Cooling units are generally undersized
- Ducting is significantly undersized (was not upgraded)
- New high performance clear glazing will provide similar performance to hotel dark glass.
- Mechanical under design can be resolved using high performance clear glazing in most suites
- Energy savings from glass replacement will be negligible

- Critical path
- Required to determine if dark glass is required to resolve overheating problem.
- No mechanical as-built drawings were ever produced. Information had to be field measured for all suites.
- Building energy model was completed for a typical floor using DOE analysis program by a forensic mechanical engineering company.

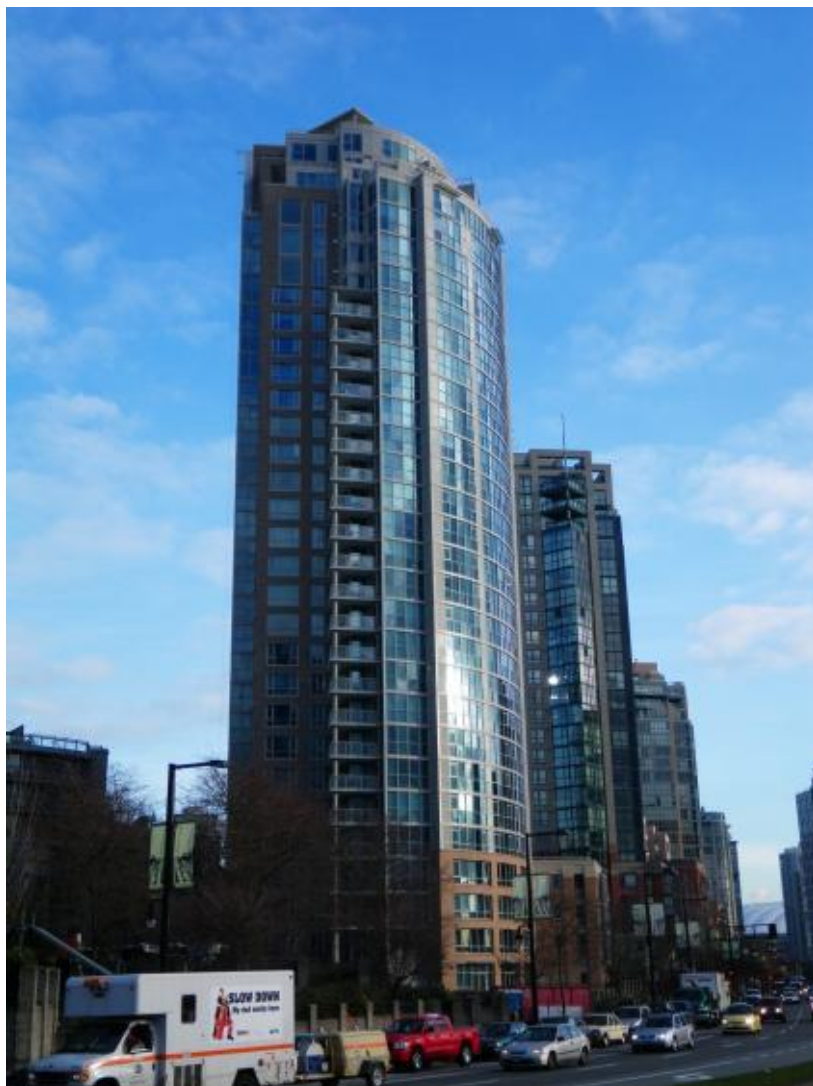
- Governor's Tower and Villas; one of the largest and most complex building envelope rehabilitations undertaken to date.
- While RDH works on projects of all types and sizes, if the issues are large, complicated, and challenging, RDH gets the call.
- Project costs initially budgeted at \$30 million by others.
- Final RDH rehabilitation costs less than \$26 million.

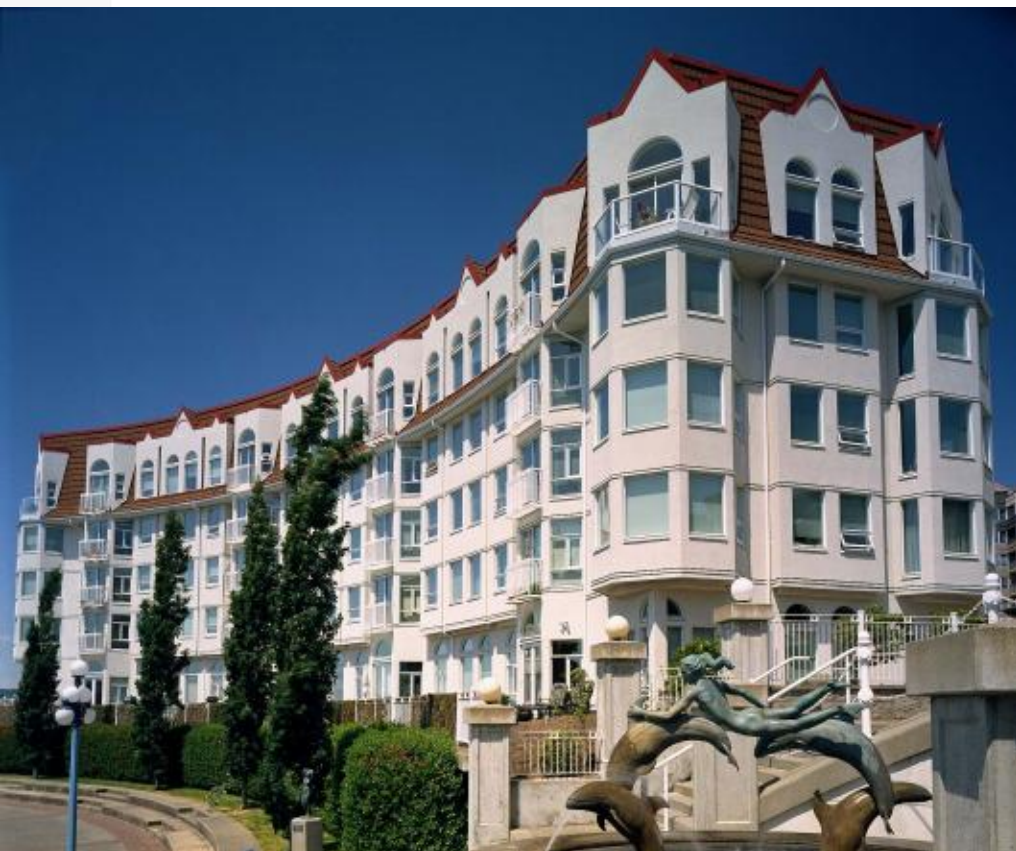
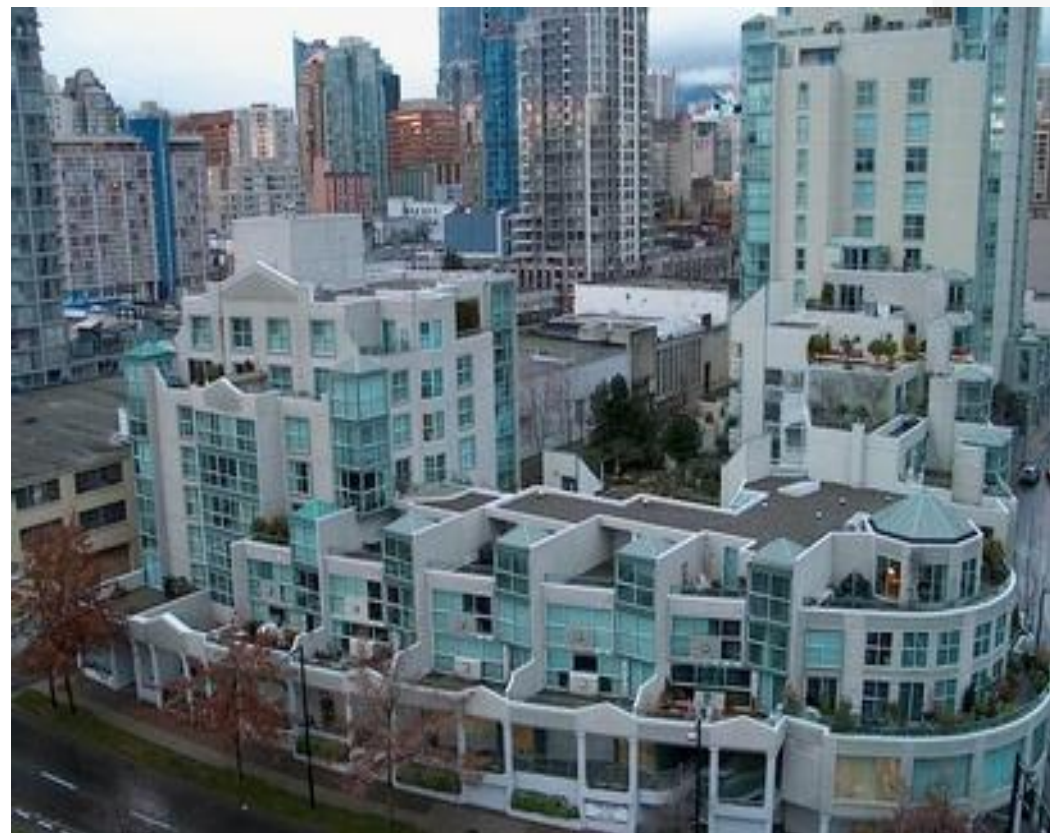
→ Royal Quays and Pacific Point. Complex and varied.

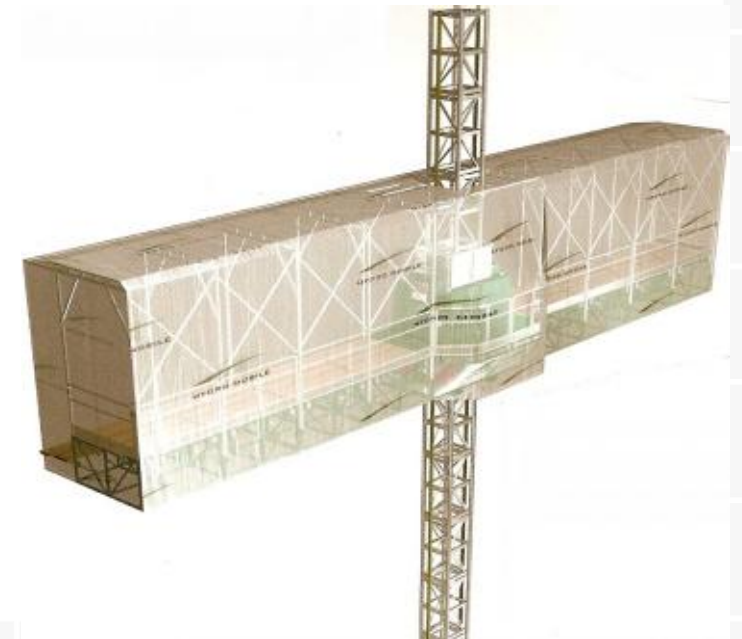
The Sheraton Guildford had some issues similar to One Wall

- RDH managed a cladding replacement program on the Sheraton Guildford Hotel while it carried on business as normal.
- RDH developed a rehabilitation strategy based on utilizing mast-climbers during the off-season to minimize disruption to hotel activities.

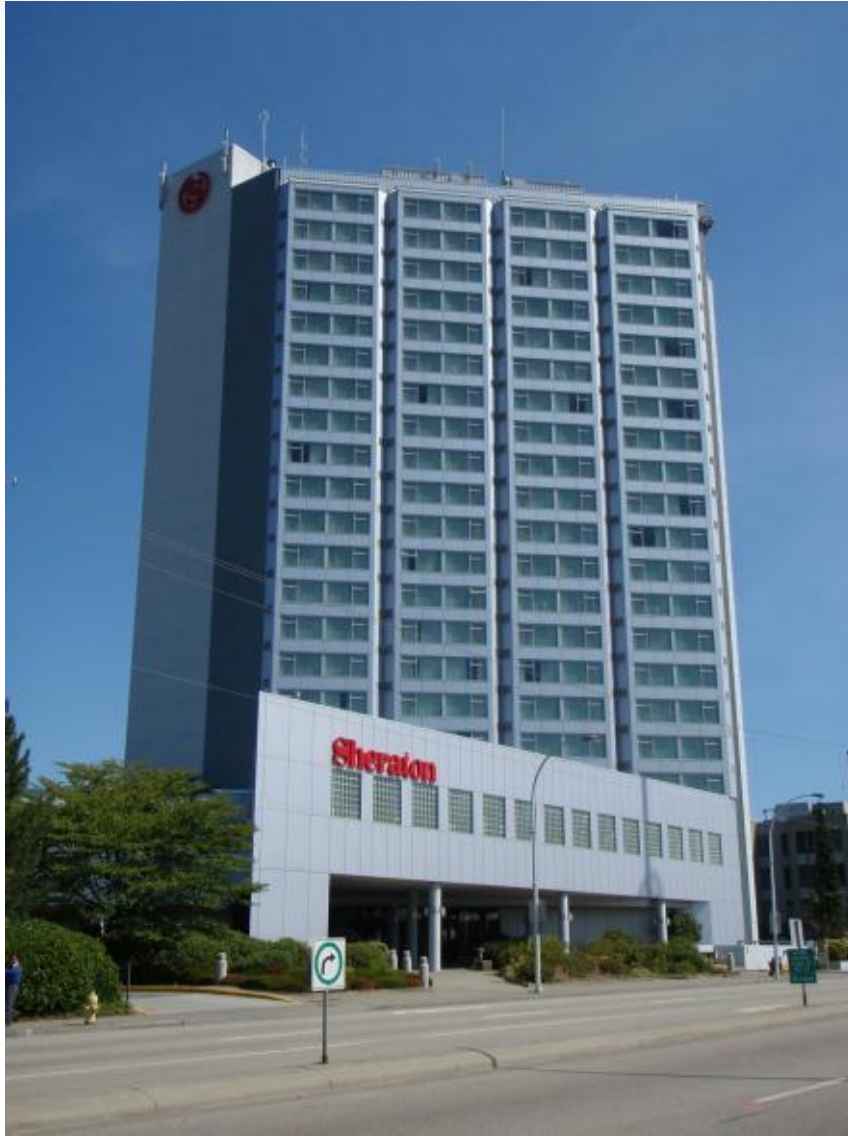
- Project complete.
- The owners of the property indicated no year/year loss of volume and minimal disruption to commercial activity throughout the process.

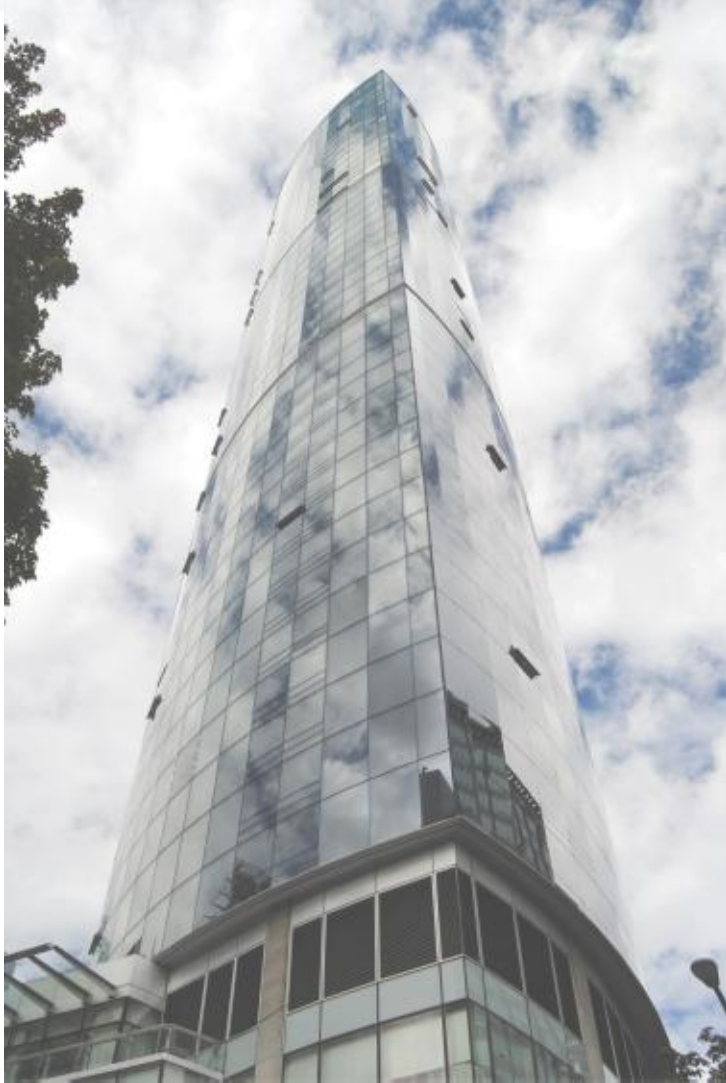
Logistical Considerations - Access

Accessing the work area is not straight forward

The height, exposure, and tight location makes this project especially challenging

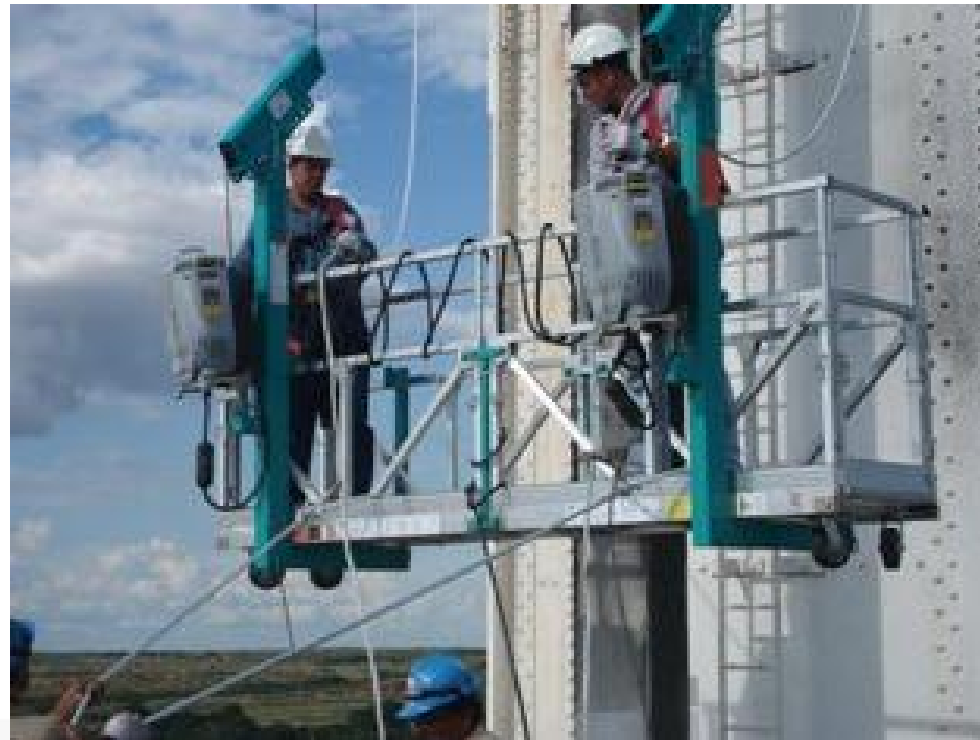
Swing stages are the conventional method for maintenance work however they aren't suitable for an extended construction project of this nature.

Swing stages have significant limitations with respect to efficiency, weight capacity, inclement weather, and wind.

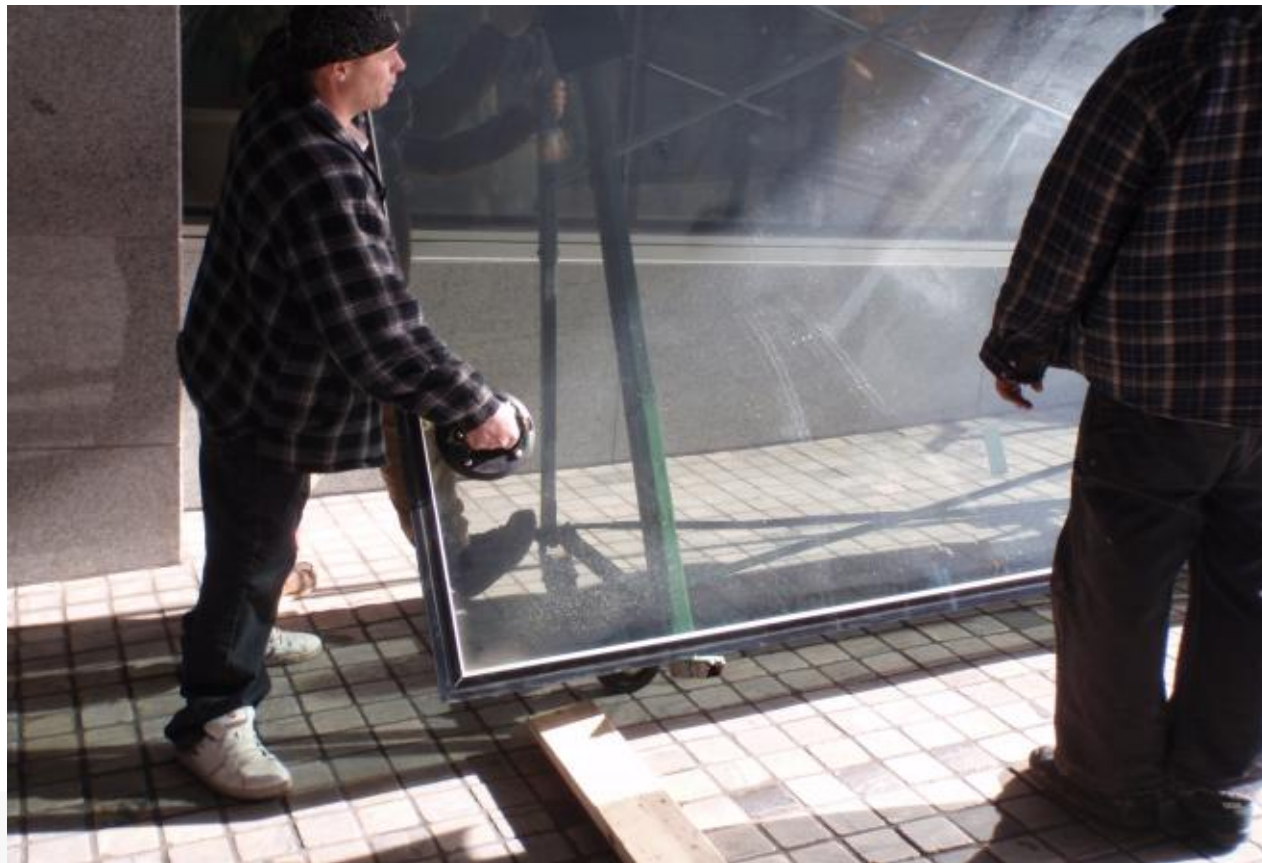
Logistical considerations – Material Movement

The sealed glazing units are very large, heavy, and difficult to handle.

Special methods will be required to remove, install, and transport these components.
