# Glazing Investigation Report

One Wall Centre, 938 Nelson Street, Vancouver, BC

PROJECT # 2324.10

DATE October 2, 2009

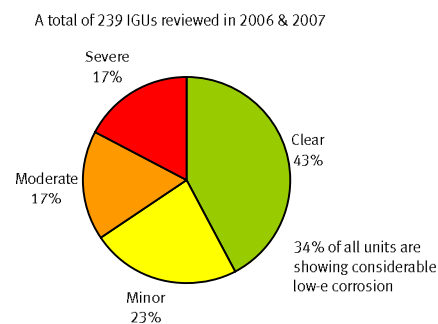
Fig. 3.1.1 2006-2007 Visual Review Summary

In 2006 and 2007 RDH visually reviewed a total of 239 Visionwall IGUs in 17 different suites. Suites were located on various floors and elevations making up a representative sample of the residential portion of the building. Of the IGUs reviewed, 17% had a visual rating of severe, 17% a rating of moderate, 23% a rating of minor, and 43% were clear. In 2008 RDH completed a review of 163 IGUs in 8 suites and found that 25% had a visual rating of severe, 31% a rating of moderate, 30% a rating of minor, and 13% clear (Fig. 3.1.2). During the mockup and broken IGU replacement program completed in 2009, RDH completed a visual review of 53 IGUs in 3 suites. Of the suites reviewed in 2009, 59% had a visual rating of severe, 26% a rating of moderate, 15% a rating of minor, and 0% were clear (Fig. 3.1.3).

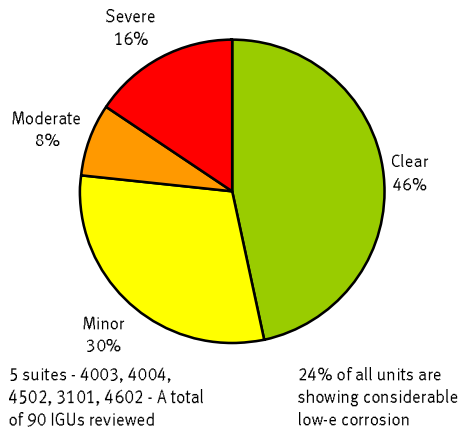
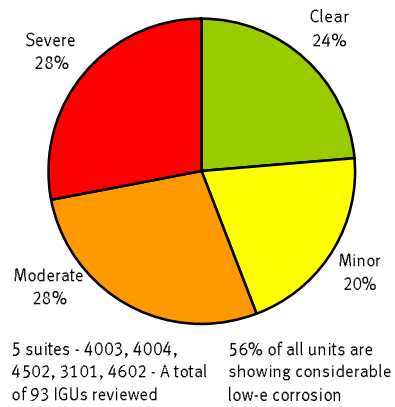
Based on all of the visual observations recorded by RDH between 2006 and 2009, the visual condition of the IGUs appears to be rapidly worsening over time. Fig. 3.1.4 and Fig. 3.1.5 compares the visual results from five suites that were reviewed both during the 2006-2007 investigation and again in 2008. When these results are compared, it is clear that rapid progressive failure of the Visionwall units is occurring. In less than two years the number of clear units has halved and the percentage of units showing either moderate or severe damage to the low-e coating doubled. Considering that the visual condition of the IGUs continues to worsen rapidly over time, it is not possible to use all of the visual review data taken between 2006 and 2009 to predict a current overall categorization for the entire residential portion of the building. Instead it would be more accurate to use the results from 2009 or the combined 2009 and 2008 sample to extrapolate the overall building condition at the time this report was written.

Fig. 3.1.4 2006-2007 Visual Review Summary (Suites 4003,4004,4502,3101,4602 only)

Fig. 3.1.5 2008 Visual Review Summary (Suites 4003,4004,4502,3101,4602 only)

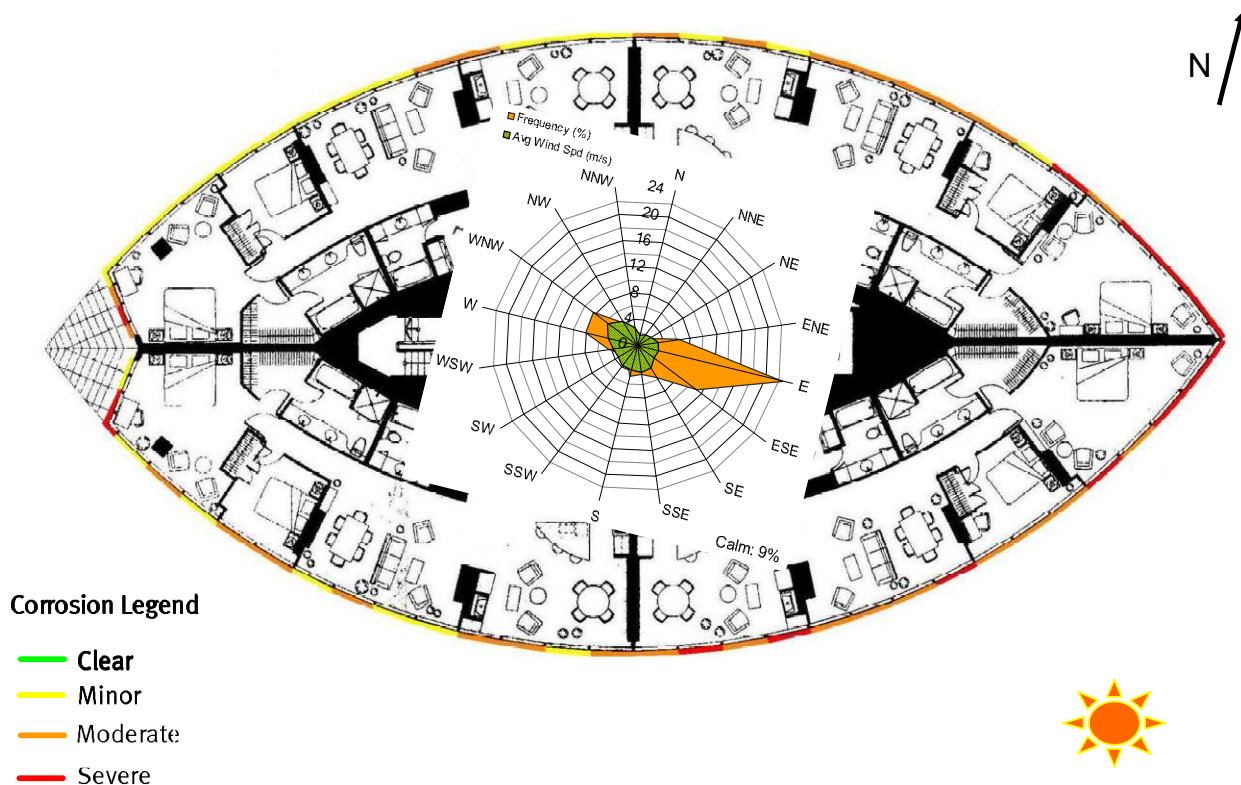
Corrosion of the low-e coating was observed on all elevations and residential floor levels. In Fig. 3.1.6 the visual results from the 2008 review are presented graphically on the 40<sup>th</sup> floor plan. None of the IGUs were identified as clear, indicating that condensation has occurred within all the IGUs on this floor. The severity of the corrosion is worse on the east and south side of the building where positive and negative wind loads from the prevailing south east winds are higher and more frequent. To a lesser extent the level of deterioration also appears to be affected by the orientation towards the sun and its resultant solar radiation loads. This relationship suggests that the primary cause of the condensation within the IGUs is wind driven air leakage into the IGU through discontinuities in the perimeter edge seal which is exacerbated by the higher thermal cycling on the southern elevations.

Fig. 3.1.6 2008 Visual Review – 40<sup>th</sup> Floor Results with local wind speed and direction overlay from YVR wind data

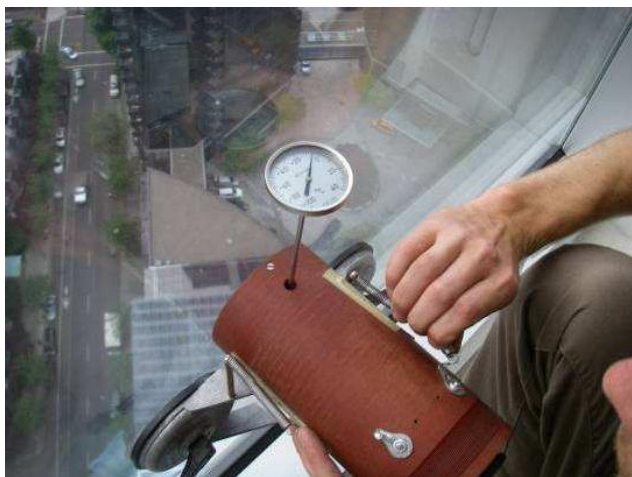
The dewpoint test is performed by cooling down a small area of the interior glass to a known temperature. As the temperature of the glass is slowly reduced the cooled area is periodically checked for condensation on surface 5 (the exterior surface of the inside glass lite). The dewpoint temperature is measured when condensation first starts to form. Fig. 3.2.2 and Fig. 3.2.3 show the dewpoint testing apparatus, and interstitial condensation formed on surface #5 during a test of an IGU at One-Wall Centre.

Fig. 3.2.2 Dewpoint Test Apparatus and Condensation Indicating Dewpoint Temperature

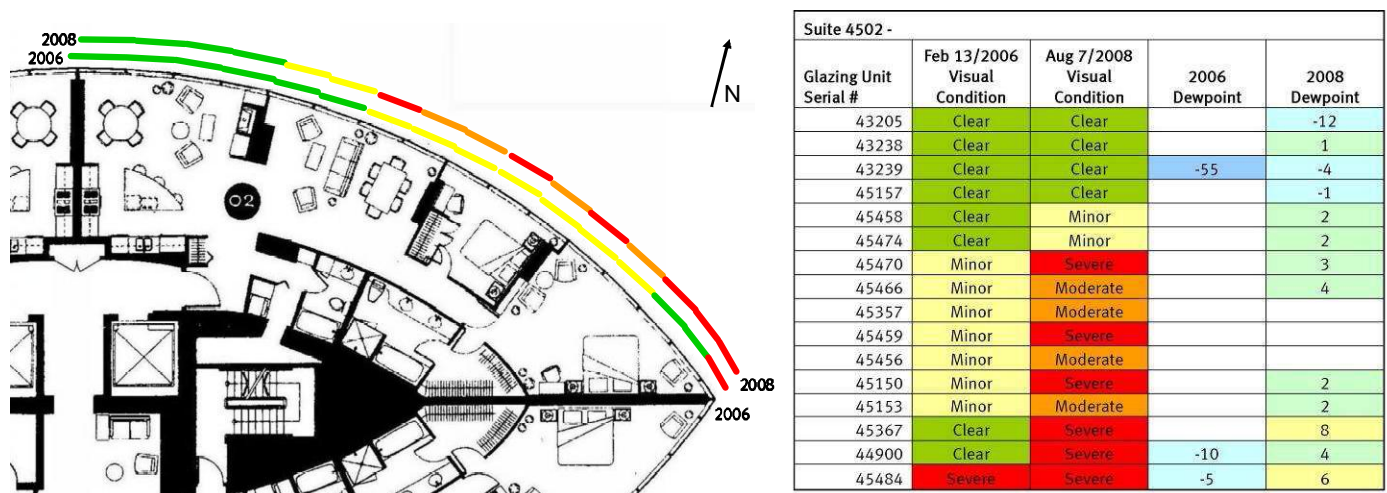
The results of the dewpoint testing indicate that the desiccant inside the IGU is at or near saturation on the majority of the IGUs regardless of their visual classification. In addition, the desiccant is continuing to absorb moisture increasing the level of visual corrosion rapidly over time. The results from the review of suite 4502 are shown graphically in Fig. 3.2.4 to show the level of degradation in both the dewpoint and the visual condition over a two year period.

Fig. 3.2.4 Results from the 2006 and 2008 visual review and dewpoint testing shown graphically on the floor plan for Suite 4502

In addition to the increase in level of deterioration, Fig. 3.2.4 also shows a similar failure pattern to the 40<sup>th</sup> floor wherein IGUs more directly affected by wind induced pressures from the south eastern prevailing winds are generally in a more advanced stage of deterioration than those near the centre of the north elevation.

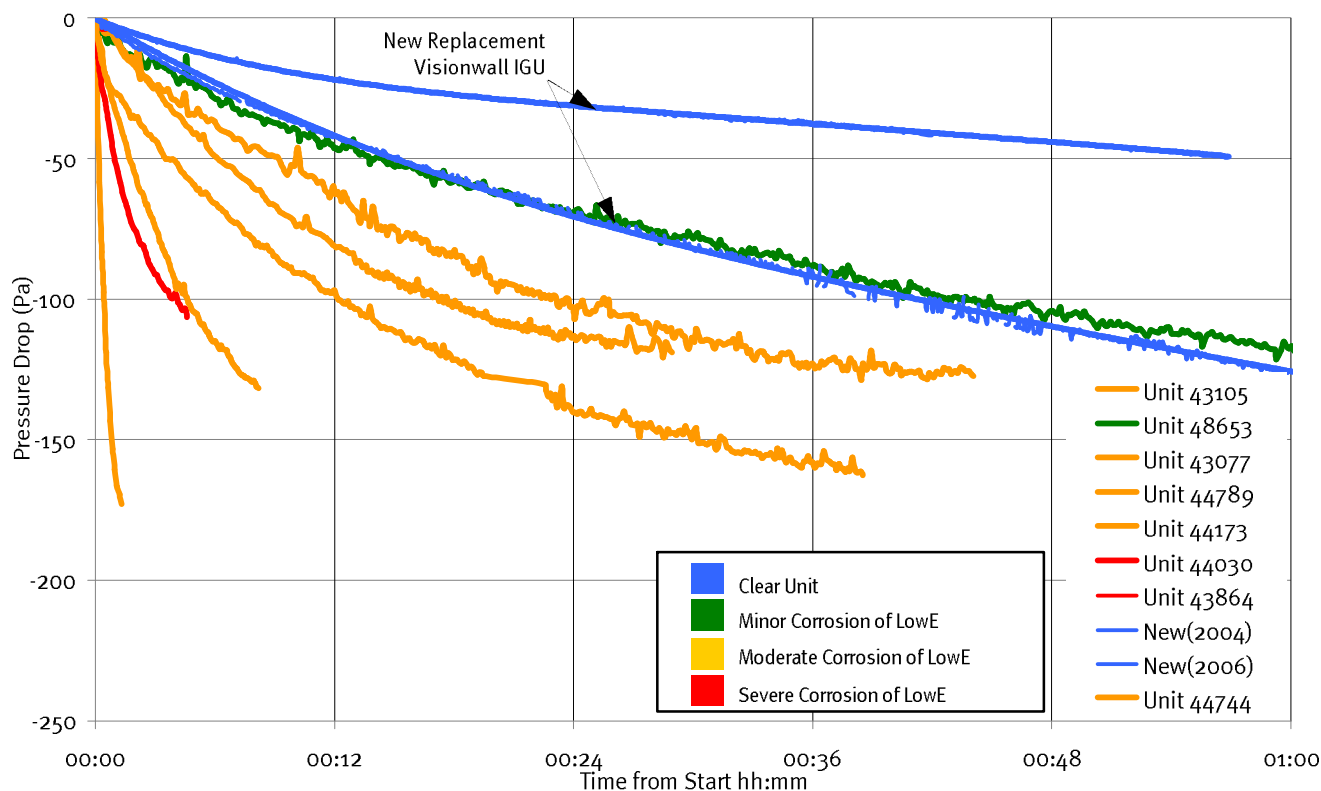
The pressure testing protocol and results are shown in Appendix B. The pressure test results from suite 3903 along with the two new clear IGUs that were located in the storage area are shown in Figure 3.4.1. In Suite 3903 and 4502, the results of the pressure testing correlate well with the visual condition of the IGUs. In these suites the IGUs with high air leakage rates (faster decay time), generally had a higher level of low-e corrosion damage than those with a slow decay time. The apparatus was calibrated with a perfectly sealed container and no pressure loss or decay was observed, therefore, any decay within the IGU is indicative of a small defect in the perimeter edge seal or desiccant tube penetration.

Fig. 3.4.1 Pressure Test Results, Suite 3903 by Visual Classification

A significant observation made during the pressure testing was that the two new replacement IGUs provided by Visionwall in 2004 and 2006 both showed significant pressure decay over the one hour period. This pressure decay suggests that these new IGUs already contain small perimeter seal defects prior to installation. In the case of the new IGU manufactured in 2006, the decay curve was similar to IGU 48653 which was exhibiting minor condensation of the low-e coating. This similar decay curve suggests that if the replacement IGU is installed in the same location, the new IGU will have a similarly unacceptable service life.

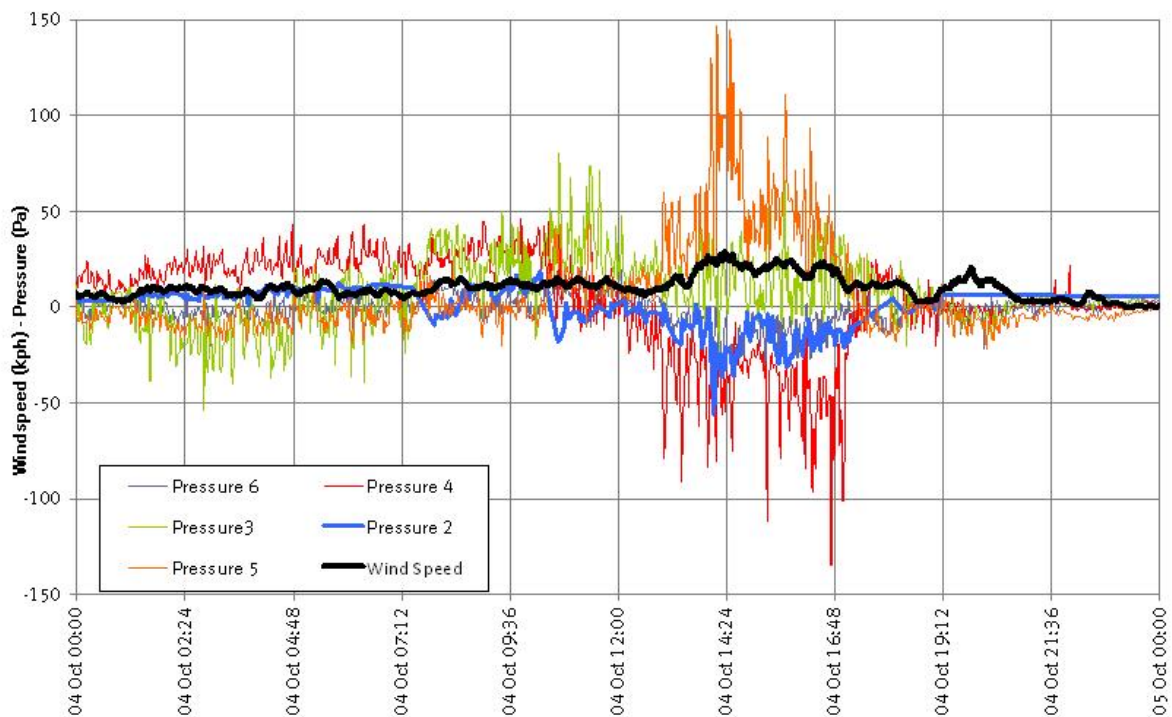
Fig. 3.5.2 shows the pressure within five monitored IGUs at the 40<sup>th</sup> floor and Fig. 3.5.2 shows the resulting airflow through the desiccant tube from the IGU into the suite. As shown, the IGU airspace pressure and airflow measured through the desiccant tube is directly influenced by the wind speed and direction.

Fig. 3.5.1 Pressure within IGUs at 40<sup>th</sup> floor over a 24-hour period caused by varying wind-speed and direction.

During light winds, IGU pressures of up to 50 Pa were common, with pressures greater than 100 Pa during larger wind events (up to 30 kph). No storms were recorded during the monitoring period, however much higher pressures of up to 500 Pa within the IGU would typically be experienced during wind-storms with winds greater than 80 kph. These pressures directly have an impact on the flow rate through the desiccant tube, but also flow through other IGU edge seal discontinuities.

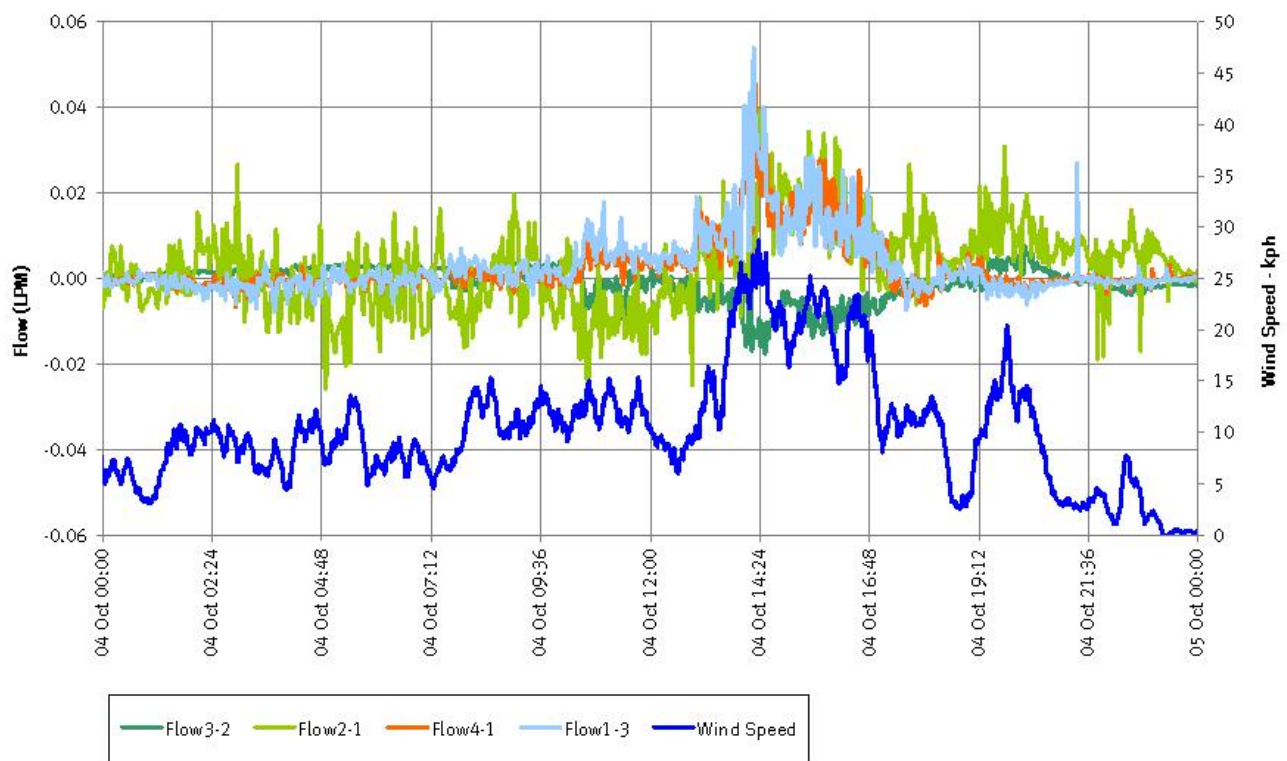
Fig. 3.5.2 Airflow Through Desiccant Tube of IGUs at 40<sup>th</sup> floor caused by Wind (Wind Direction Variable from East to South)

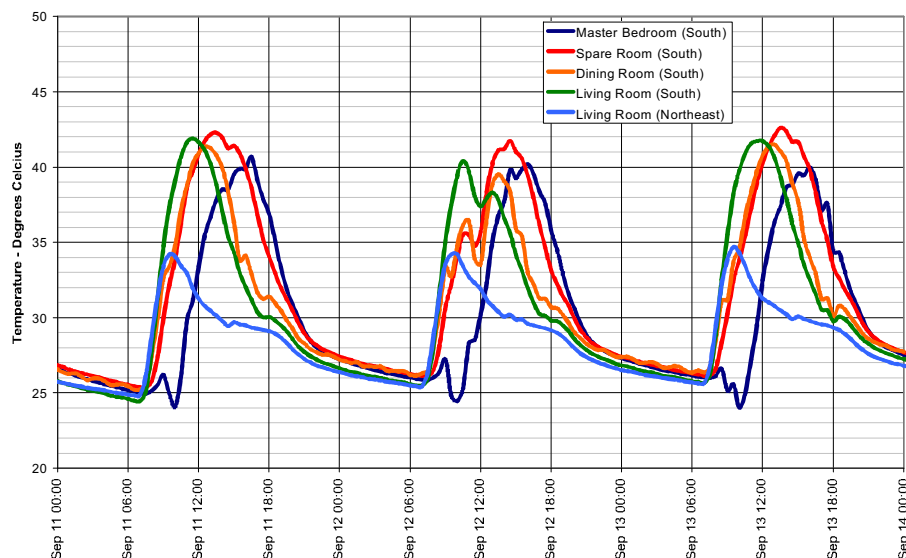
Fig. 3.6.1 Suite 3903 Perimeter air Temperatures, September 11 through 14, 2008

The results of the temperature monitoring are contained in Appendix D. Temperature measurements were taken in Suite 3903, 4001, 4002, 4003 and 4004. In Suite 3903 temperature measurements were taken in 5 locations between July 3 and October 2, 2008 to measure the air temperature near the exterior perimeter. During this period the heating, ventilation and air conditioning (HVAC) system was turned on and set to 21 °C. The perimeter indoor air temperature during three typical sunny days is shown for suite 3903 in Fig. 3.6.1. The temperatures near the windows

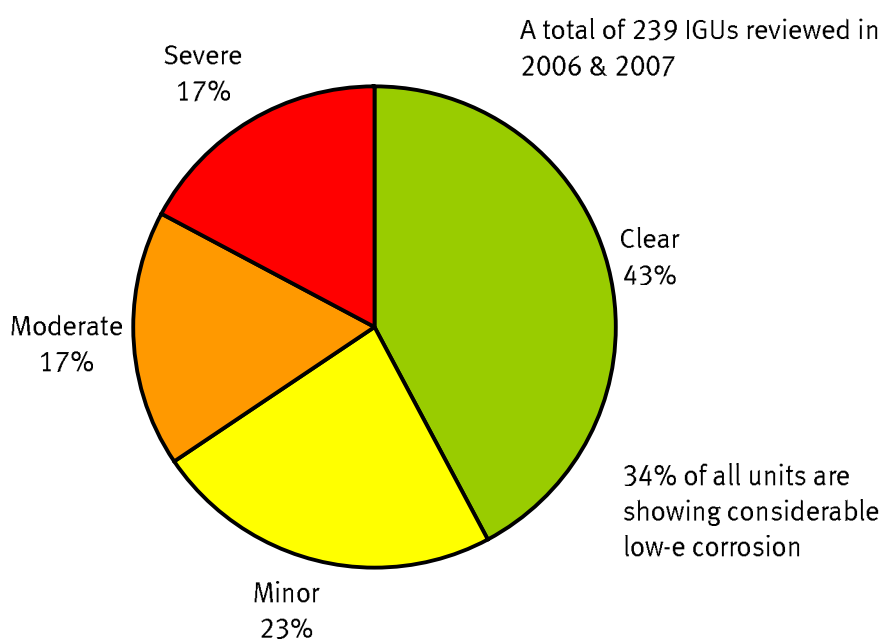
Figure A4: 2006-2007 Visual Review Summary, 239 IGUs

2006 and 2007 – All Suites Reviewed		
	# Units with visual Classification	% of Units
Clear	101	42%
Minor	56	23%
Moderate	41	17%
Severe	41	17%
<b>Total</b>	<b>239</b>

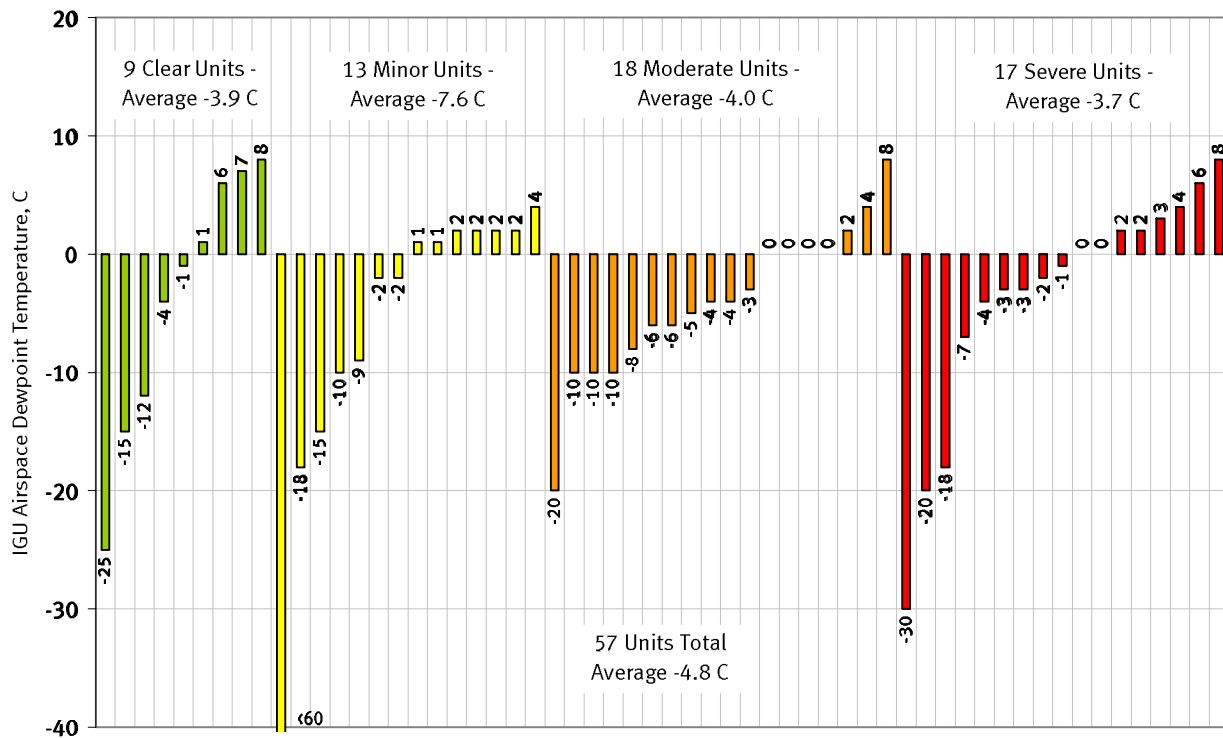
Figure A7: 2008 IGU Dewpoint Testing Summary

Average Dewpoint	# Units	% of Units above -18C
Clear	-3.9	9	89%
Minor	-7.6	13	85%
Moderate	-4.0	18	94%
Severe	-3.7	17	82%
Total	-4.8	57	88%

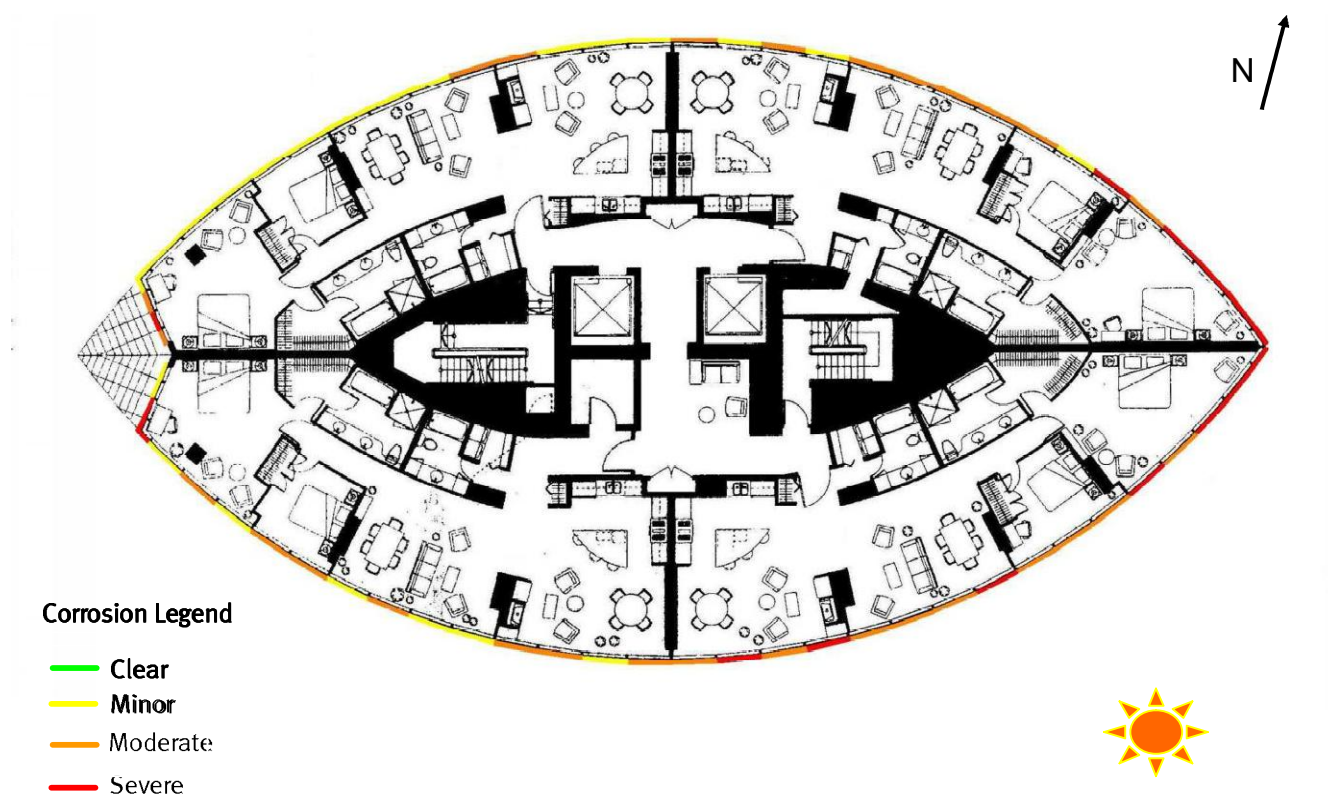
Figure A8: 40<sup>th</sup> Floor Suites, Visual Observation

The visual observations for the 40<sup>th</sup> floor suites are presented in Figure A8, showing the distribution of fogged/corroded IGUs around the building. The highest concentration of fogged/corroded IGUs is near the east corner, and south elevation.

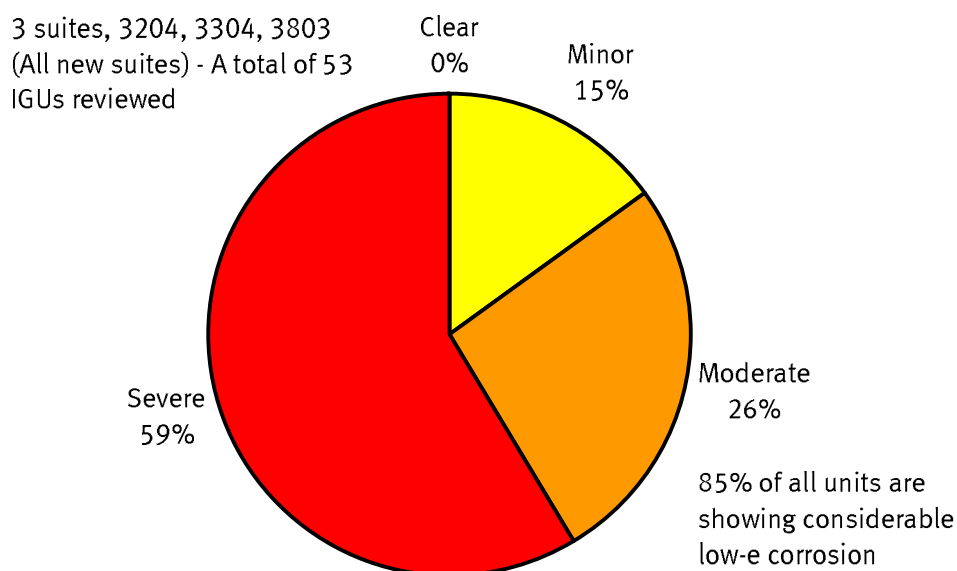
Figure A9: 2009 Visual Observation Summary

<b>2009 – Suites 3204, 3304, 3803</b>		
	# Units with visual Classification	% of Units
Clear	0	0%
Minor	8	15%
Moderate	14	26%
Severe	31	58%
<b>Total</b>	<b>53</b>

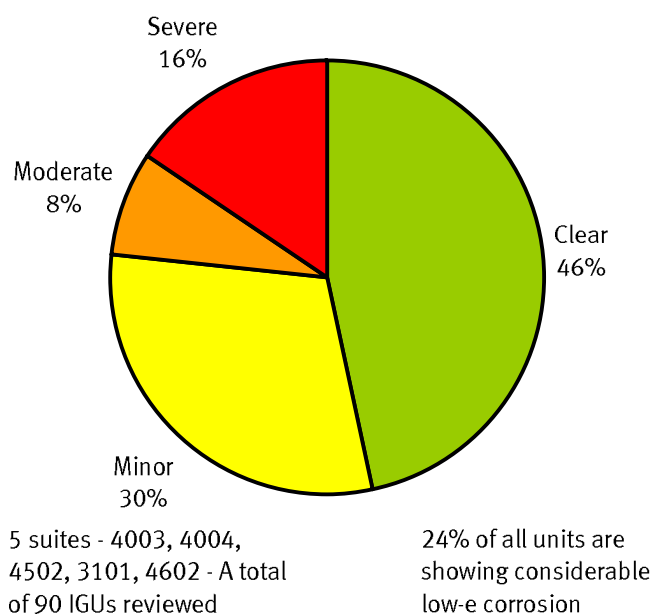
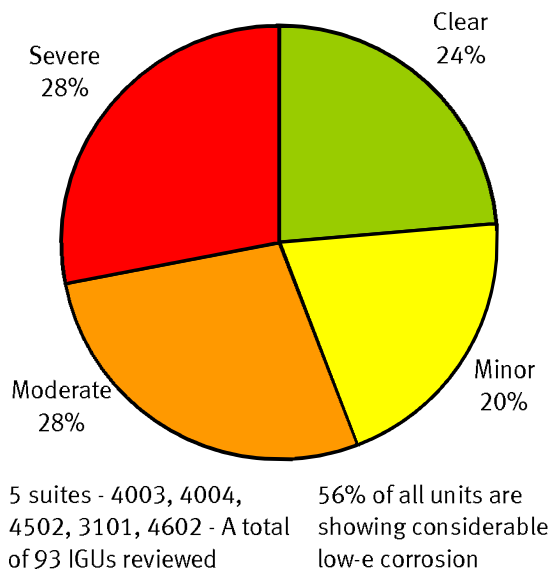
Figure A10: Comparison of IGU Visual Classification between 2006/2007 and 2008

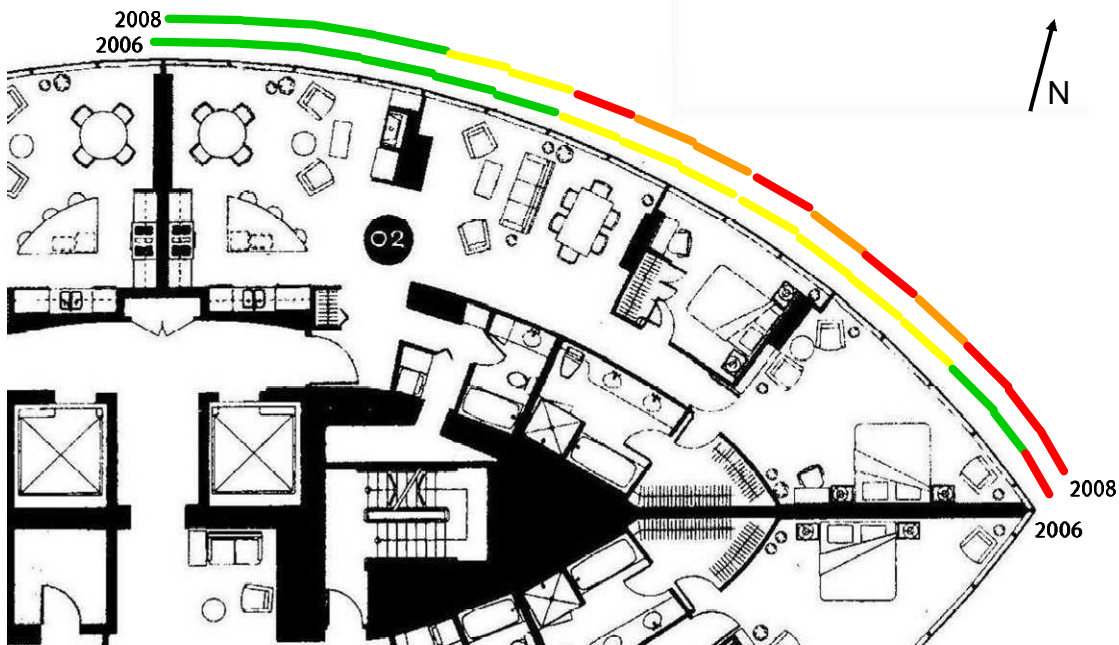
The IGUs specifically within suite 4502 are graphically compared in Figure A11 and summarized in Table A12.

Figure A11: Suite 4502, Degradation of IGU Condition between February 2006 and August 2008 (18 months).

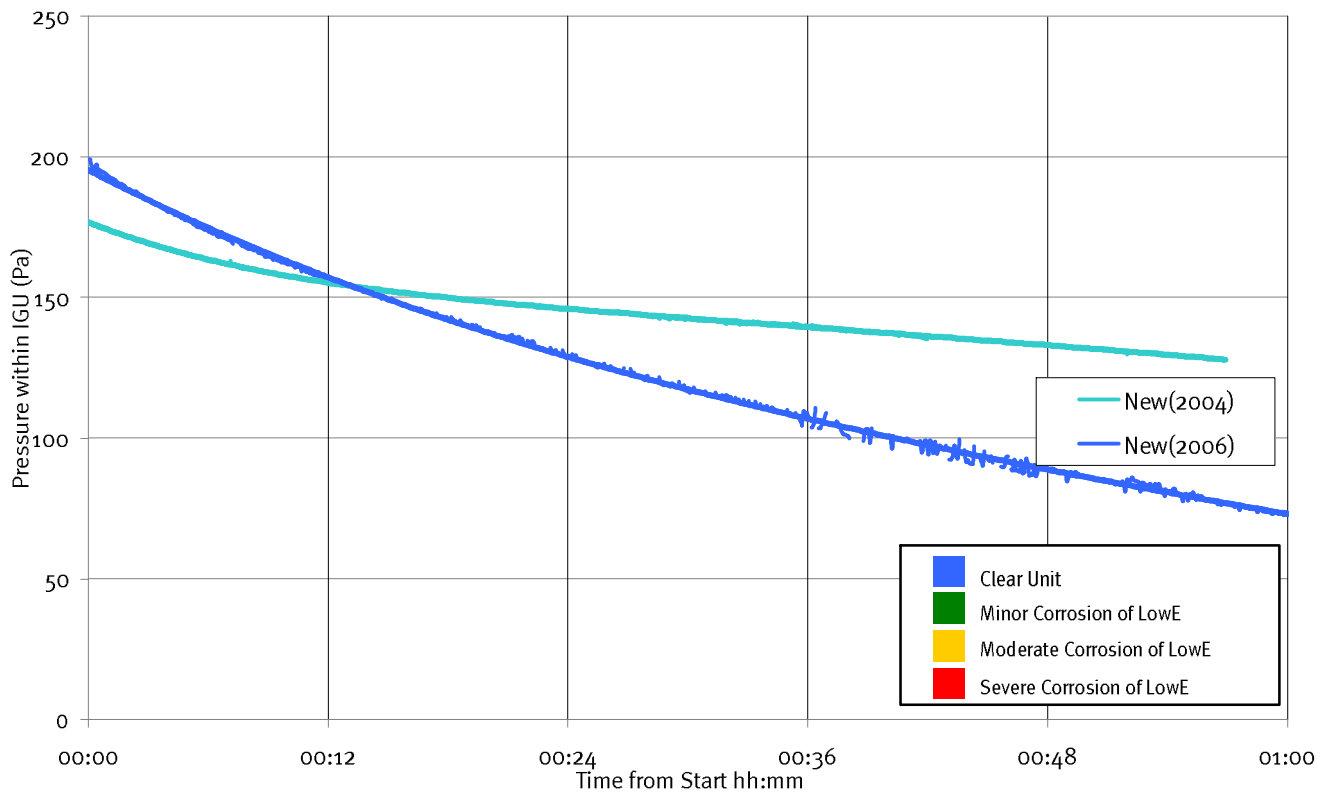
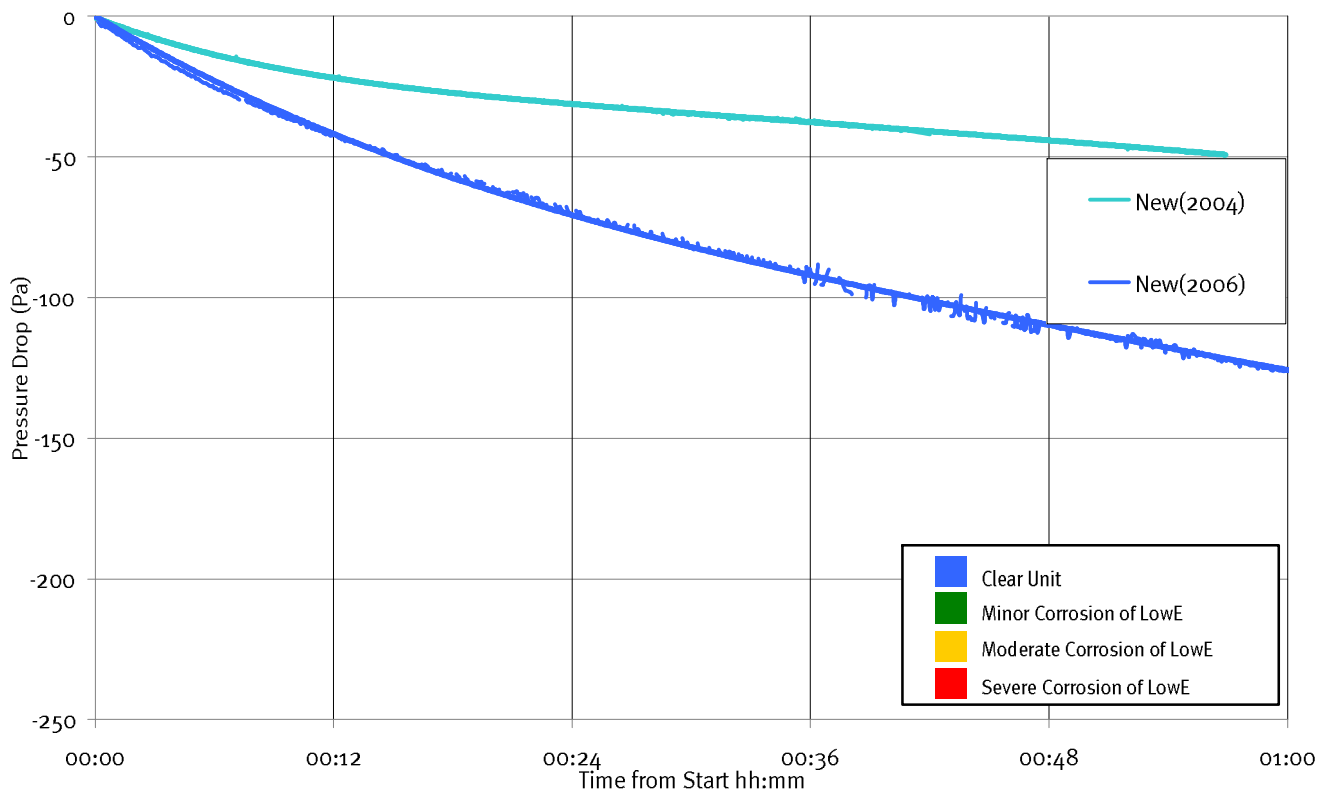
Each of the new units were pressurized to between 180 and 200 Pa and the pressure decay monitored using the previously mentioned equipment. Pressure decay curves indicated relatively air-tight units; however a slow pressure decay was observed, indicating a small amount of air leakage through the edge seal as shown in Figure 6. The results are presented in Figure B14 and B15.

Figure B14: Pressure Decay Curves for Two New Replacement Vision Wall Units.

Figure B15: Pressure Decay Drop for Two New Replacement Vision Wall Units.

Testing revealed that the new units are not perfectly air-tight, and the 2006 unit was leakier than the 2004 unit. It should be noted that both of these units were sealed using the original edge seal methodology. No new Visionwall units (post 2006) with the improved edge seal technology were available for testing.

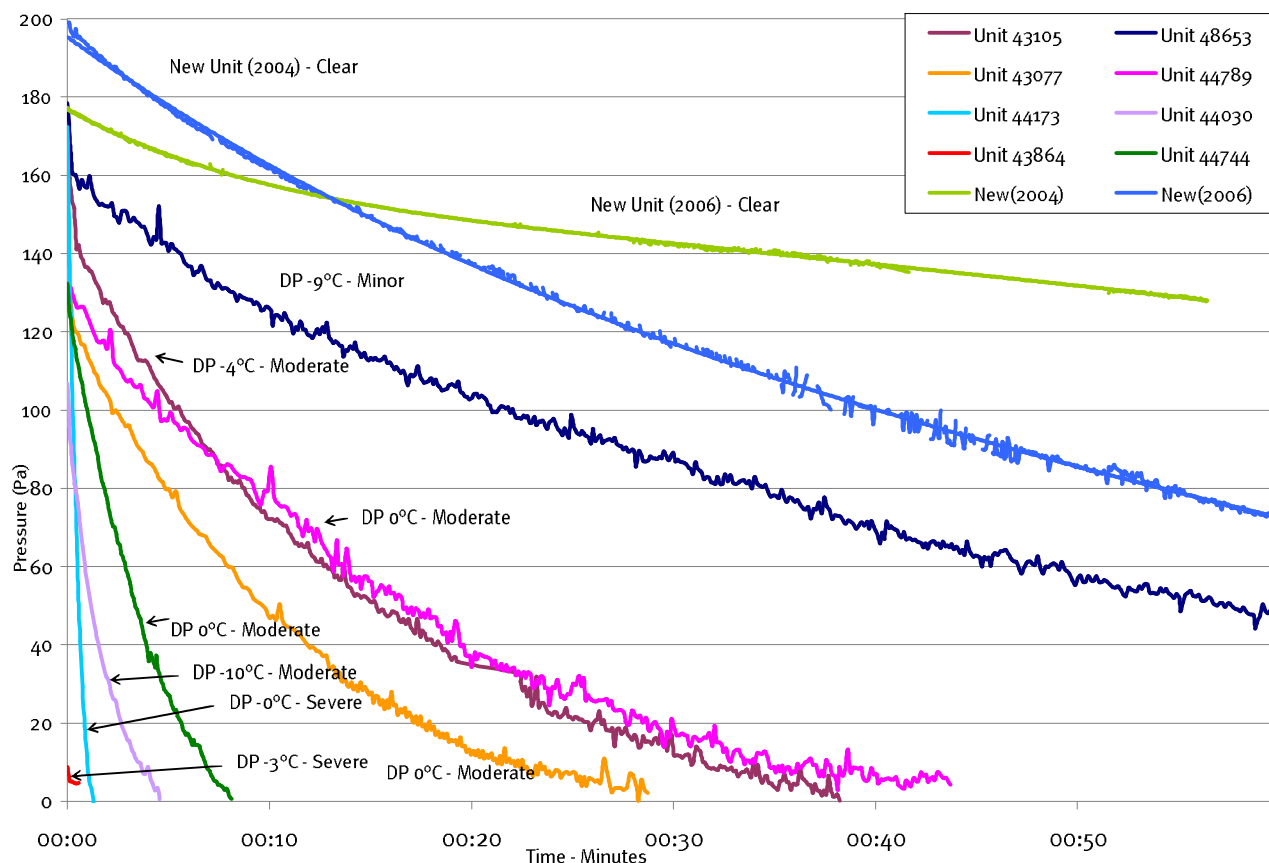
Figure B16: Pressure Test Results for Vision Wall IGUs within suite 3903.

Small variations in the pressure are caused by wind pressures on the IGUs and building pressure fluctuations as the result of wind or HVAC equipment. These did not adversely affect the pressure decay of the sealed IGUs – and pressure decay curves for each of the tests was relatively uniform. Statistical analyses of the curves indicate a repeatable and calculable logarithmic decay.

Unit 43864 (lower left, red line) was the most severely corroded unit within suite 3903 and recorded a very rapid pressure decay. When testing this unit, we found it extremely difficult to pressurize the unit beyond 50 Pa (even after 5-10 minutes) as the size of the edge seal defect is larger in area than the tube inlet used to pressurize the unit. All other units tested, we were able to pressurize to at least 150 Pa and record a pressure decay over minutes. On the opposite end of the spectrum, unit 48653 (navy blue line, 3rd from top) was the clearest unit tested with only very minor corrosion spotting. This unit had a relatively slow decay similar to the new units.

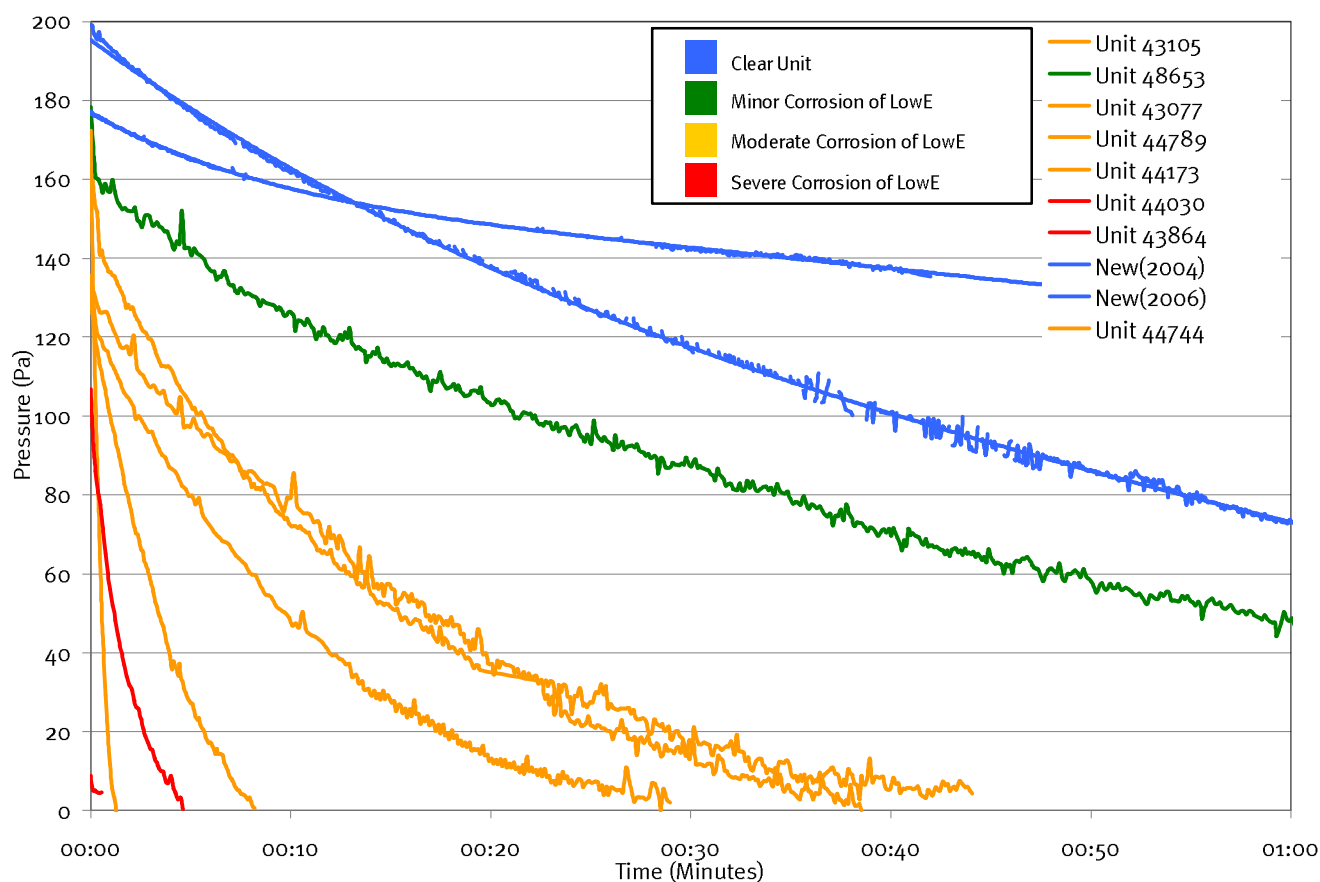
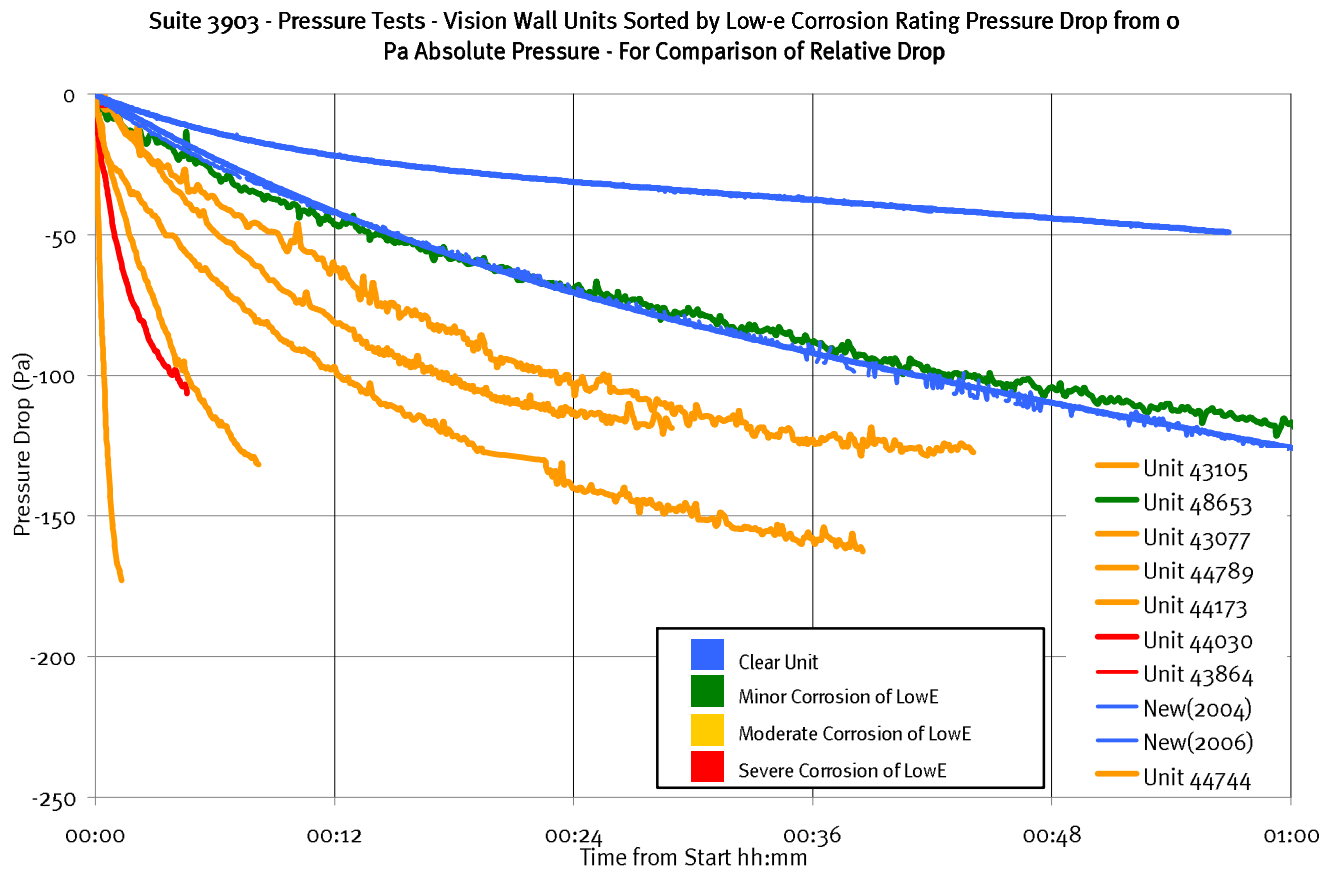
The pressure decay curves correlate well with low-e corrosion damage and partially with the airspace dewpoint temperature. This is due to the fact that the desiccant tubes were replaced in 2004-2005 and have saturated at varying rates (thus impacting the airspace dewpoint temperature), or that the corrosion damage observed may have occurred prior to desiccant tube replacement. What is clearly shown is that the more severely corroded units are quite leaky. This is further shown in Figures B17 and B18 where the ten tested units are colour-coded according to low-e corrosion classification.

Figure B17: Pressure Test Results, Suite 3903 – Correlated with Low-e Corrosion condition

Figure B18: Pressure Test Results, Suite 3903 – Correlated with Low-e Corrosion condition

As shown in the figures, the units with high air leakage rates (faster decay time) had a higher level of low-e corrosion damage, indicative of past or present moisture within the glazing unit.

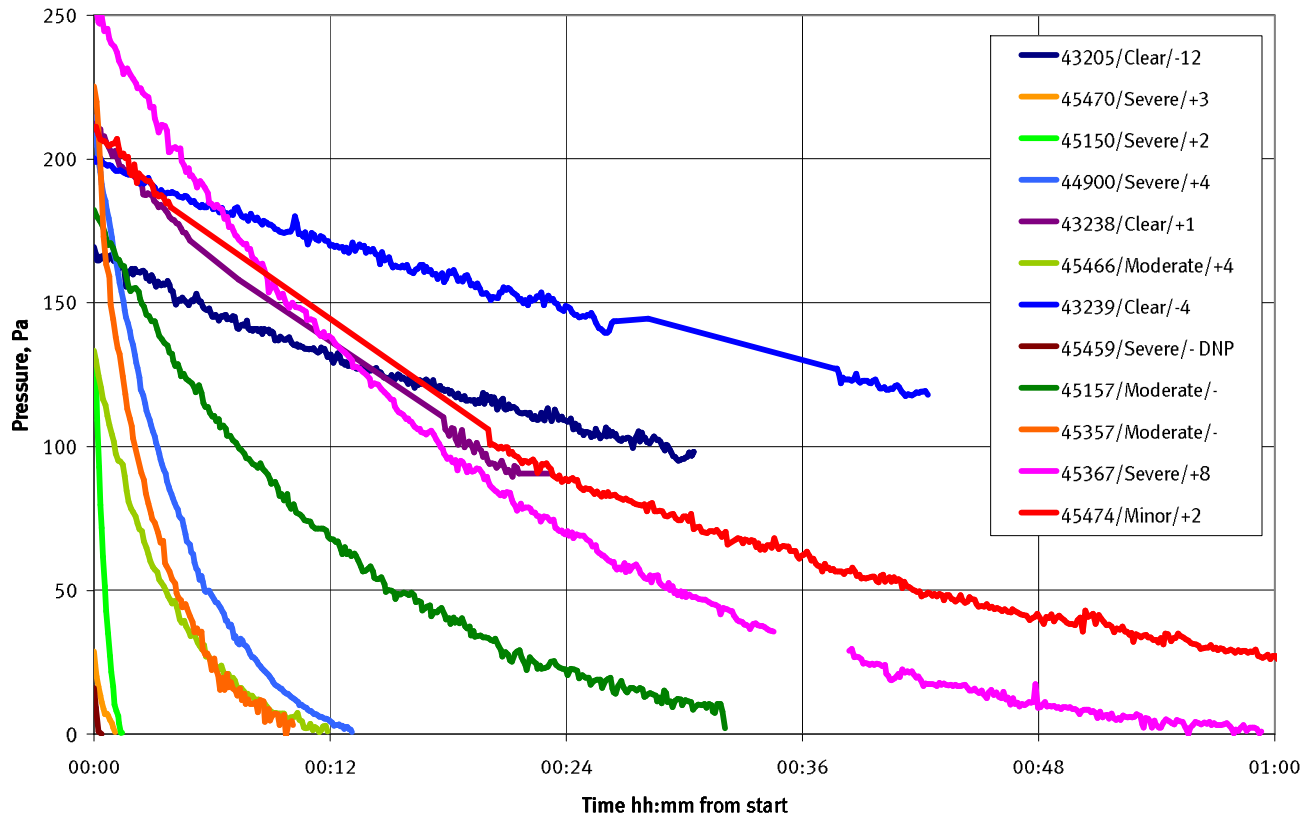
Figure B19: Pressure Test Results for 13 Visionwall IGUs within suite 4502.

Similar to pressure testing at suite 3903, more severe low-e corrosion is correlated with a faster decay curve.

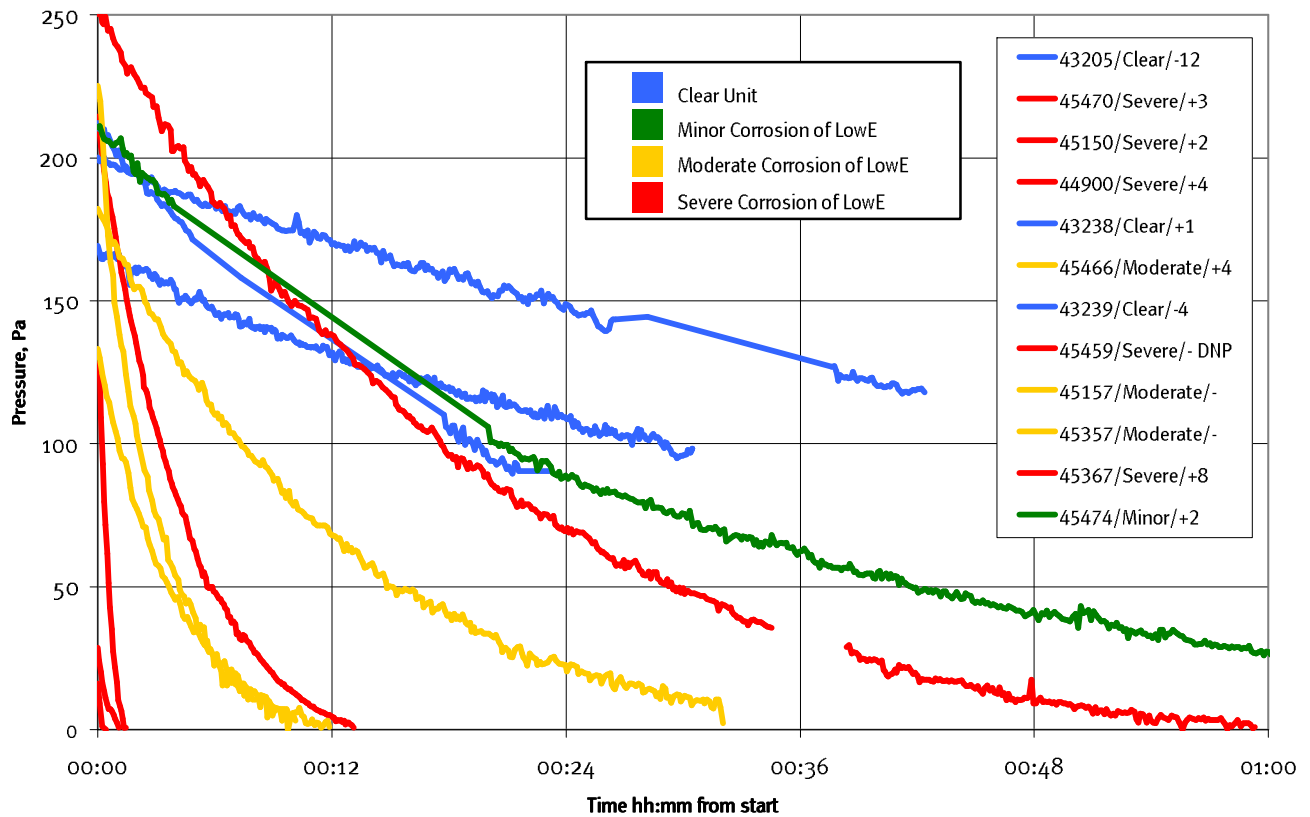
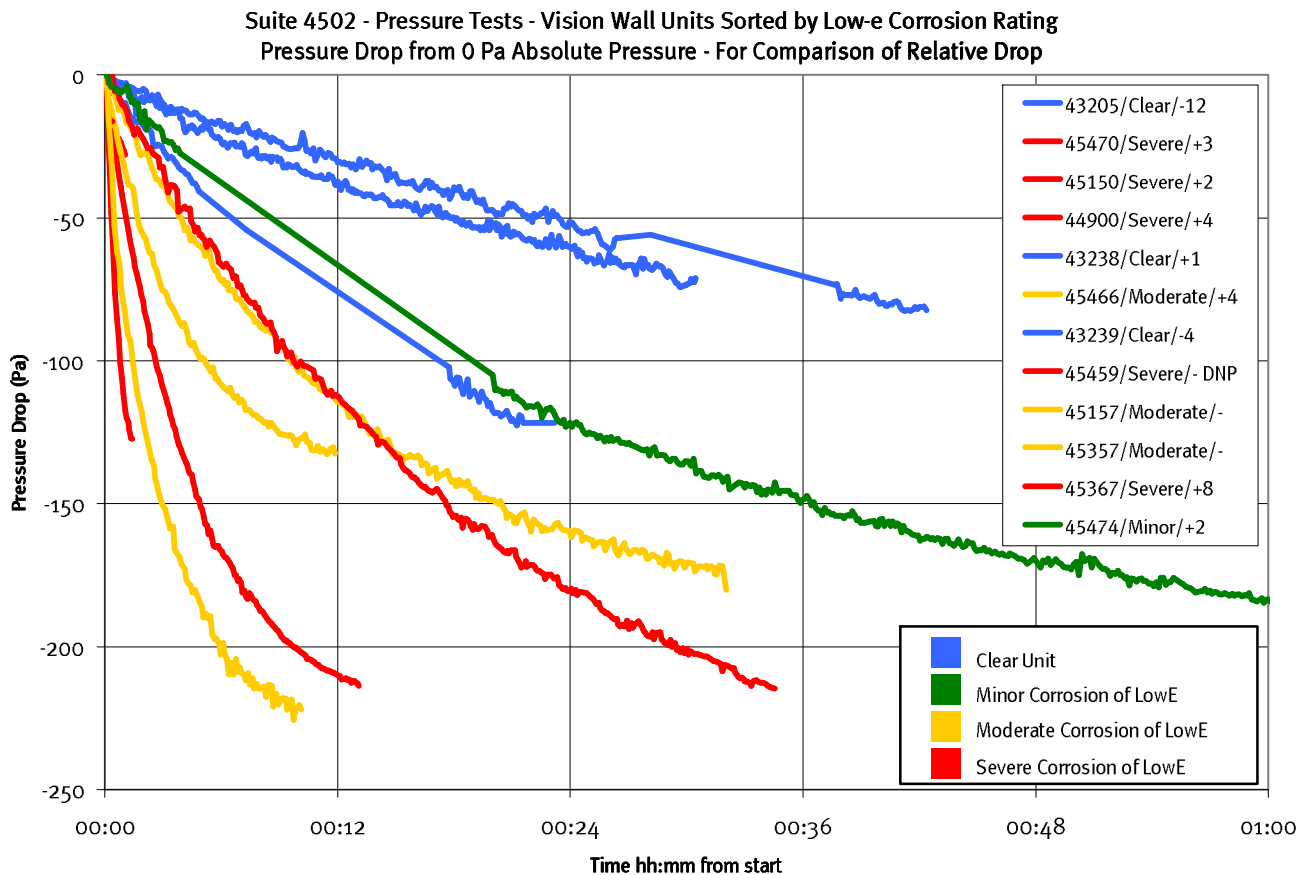
The severity of IGU low-e corrosion is correlated with the pressure decay curves in Figure B20 and B21.

Figure B20: Pressure Test Results, Suite 4502 – Correlated with Low-e Corrosion Condition

Figure B21: Pressure Test Results, Suite 4502 – Correlated with Low-e Corrosion condition
