# Glazing Investigation Report

One Wall Centre, 938 Nelson Street, Vancouver, BC

PROJECT # 2324.10

DATE October 2, 2009

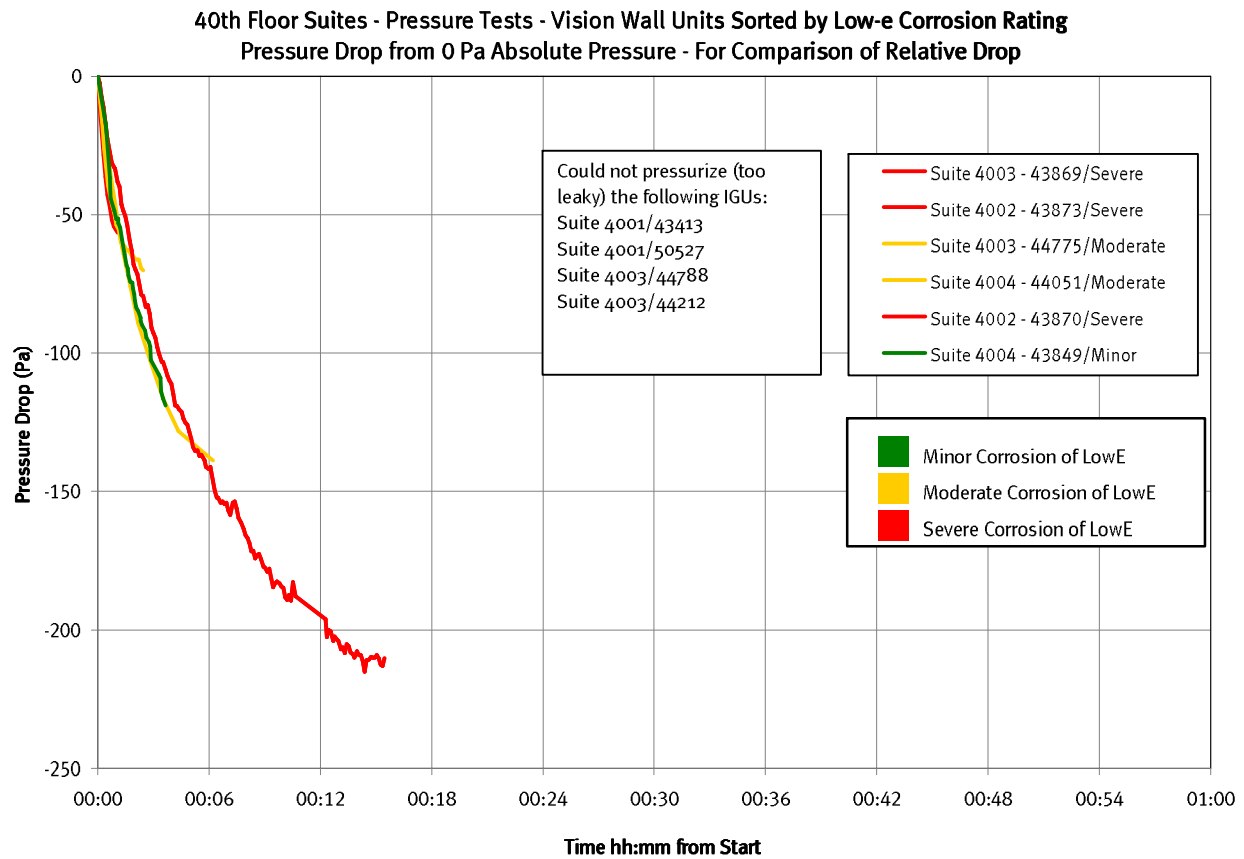
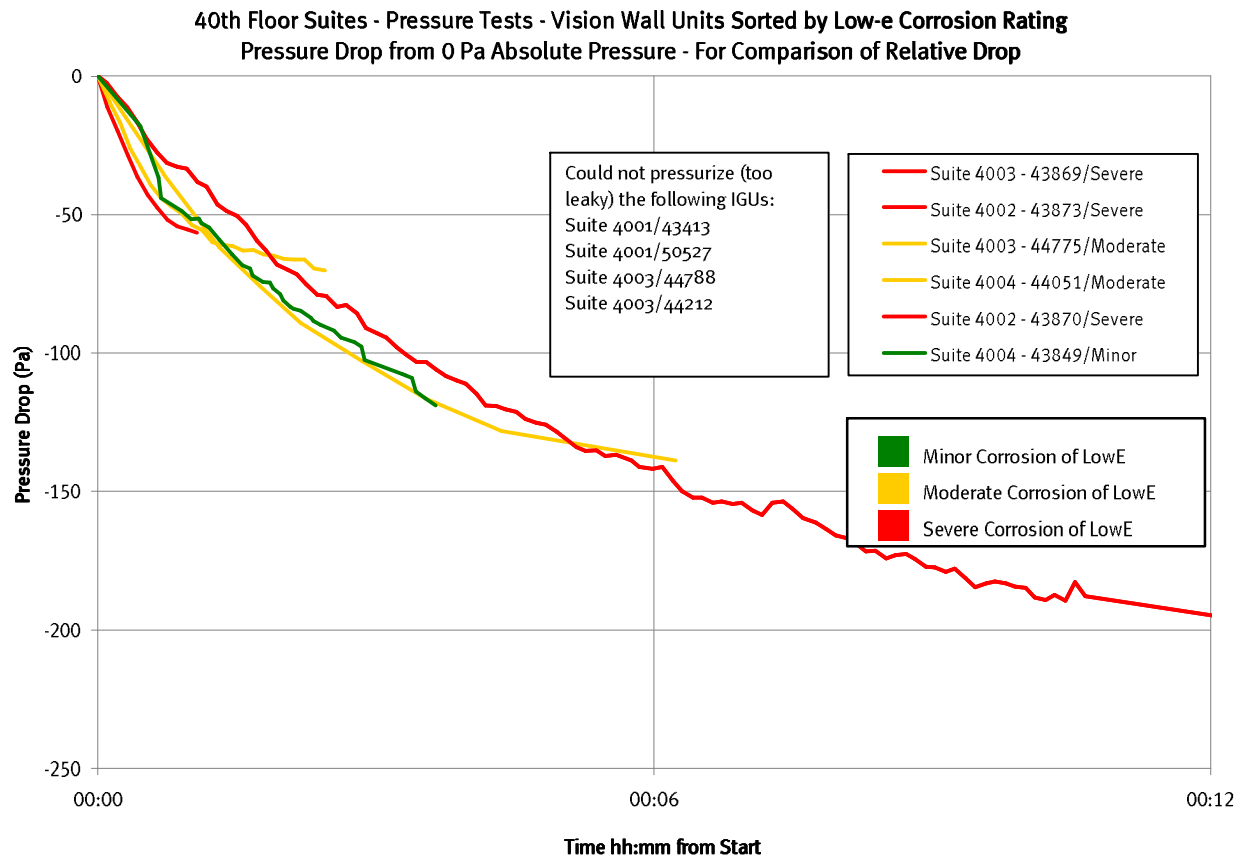
The results of the pressure tests are plotted in Figure D23 and D24, with the dewpoint temperature and low-e condition noted for each pressure decay. Four of the tested IGUs were too leaky to pressurize through the existing desiccant breather tube. Note the difference in the time-scale between Figures B23 and B24.

Figure B23: Pressure Test Results, 40<sup>th</sup> floor suites – Correlated with Low-e Corrosion condition, 0 – 60 minutes

Figure B24: Pressure Test Results, 40<sup>th</sup> floor suites – Correlated with Low-e Corrosion condition, 0 – 12 minutes

All six of the pressure tested IGUs showed a very rapid decay, regardless of the severity of the low-e corrosion damage.

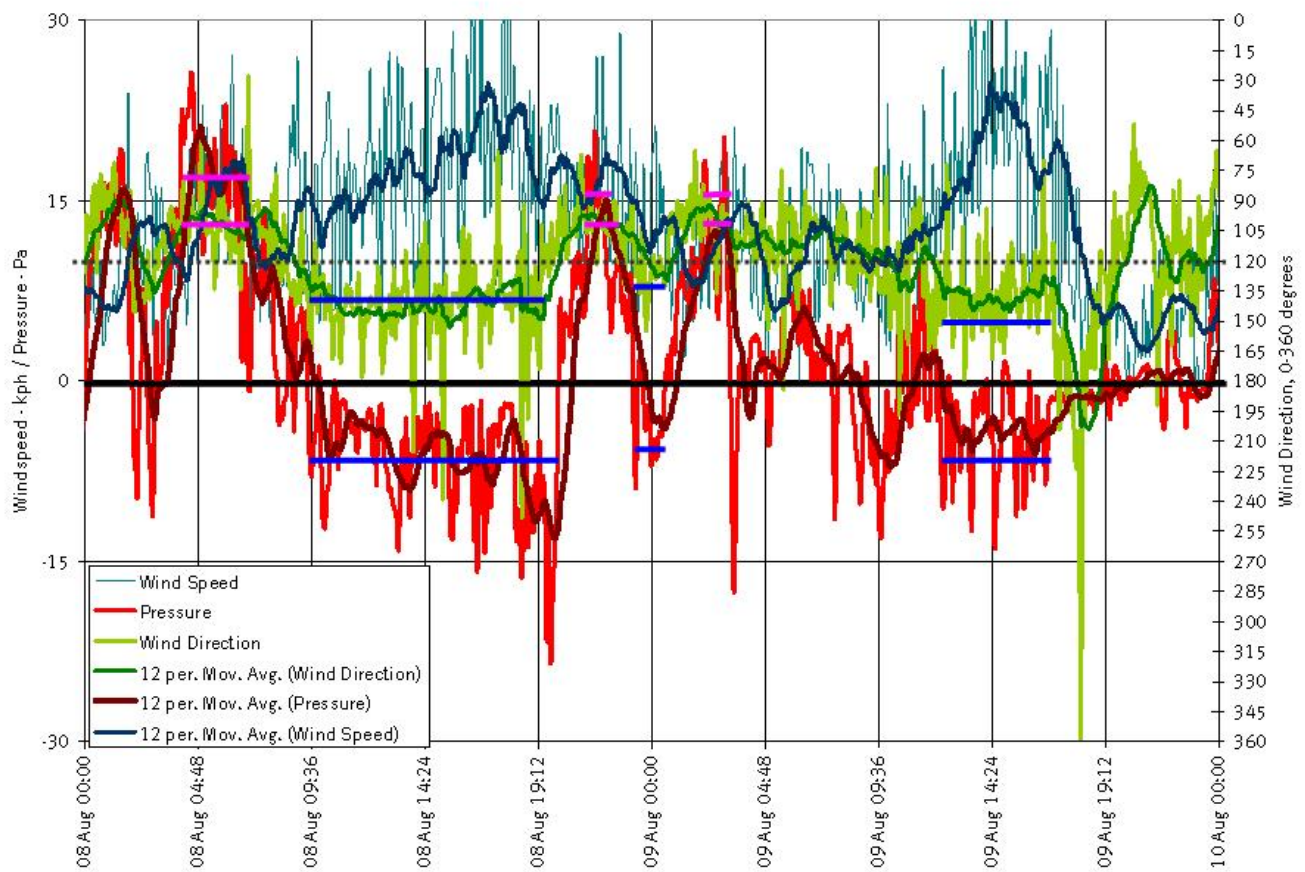
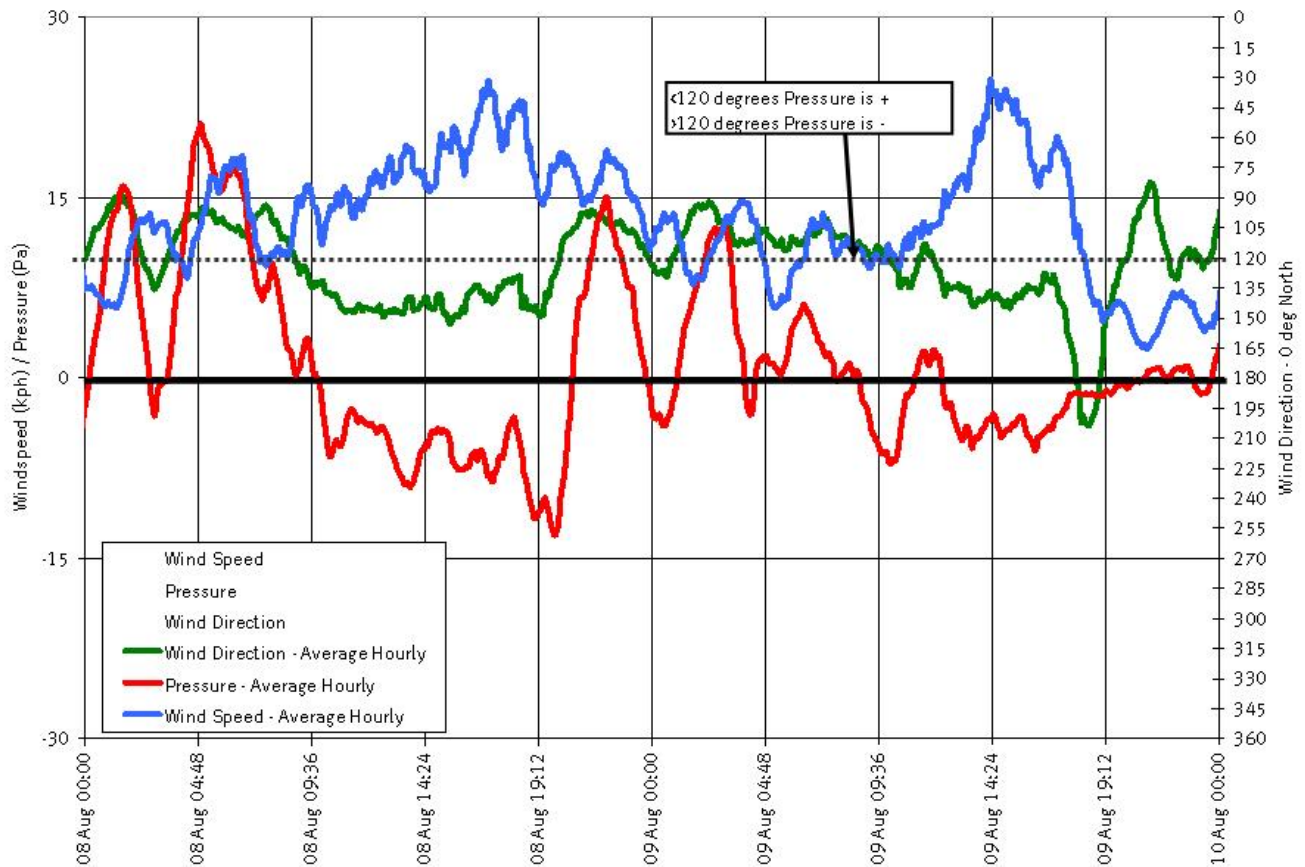
Figure B27: Influence of Wind-speed and Direction on Pressure within IGU 45367.

Figure B28: Influence of Wind-speed and Direction on Pressure within IGU – Average Values

Depending on the wind direction – the pressure within the IGU will be positive or negative. A positive pressure will result in airflow out of the IGU and negative pressure will result in airflow into the IGU, should the IGU not be perfectly sealed. As shown, at a wind direction of approximately 120° from north, the pressure within the IGU shifts from positive to negative.

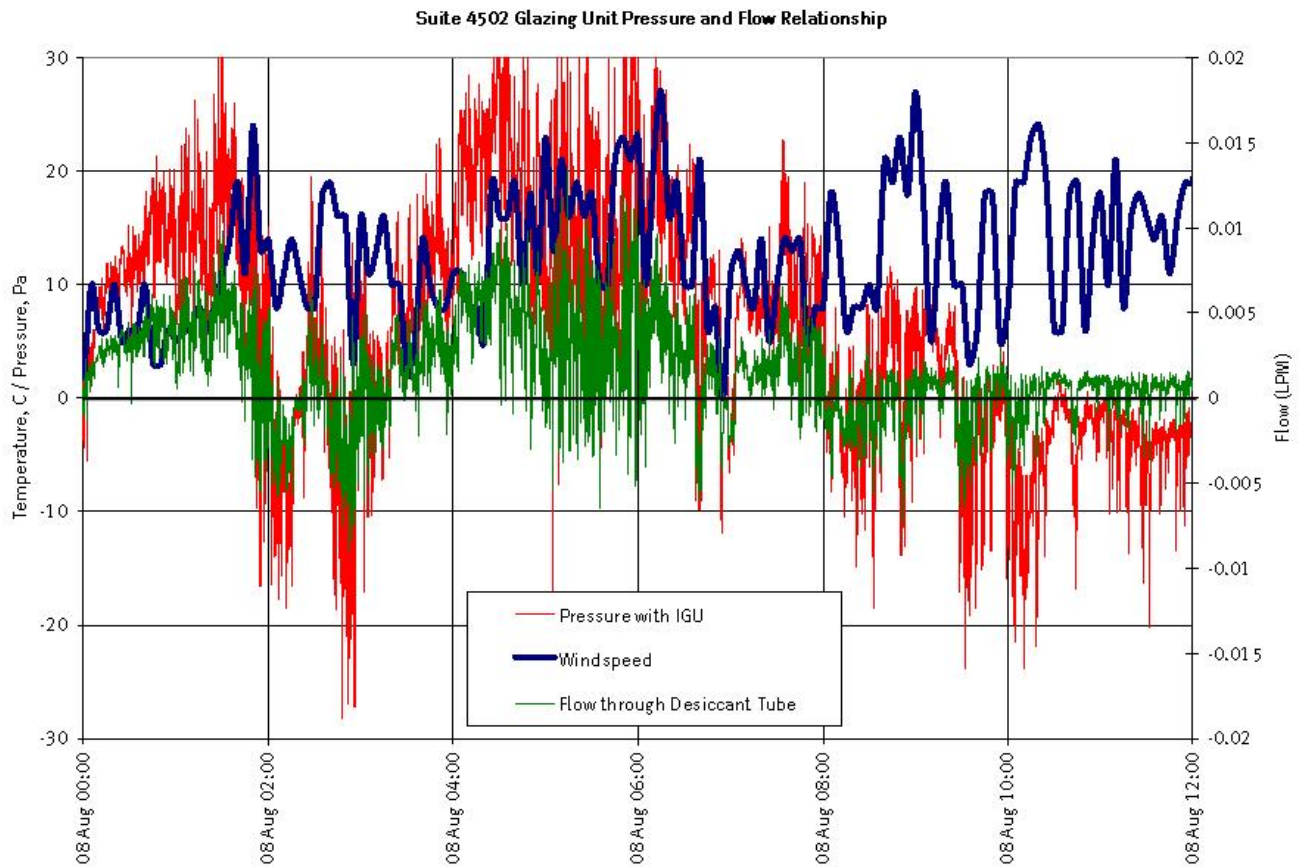
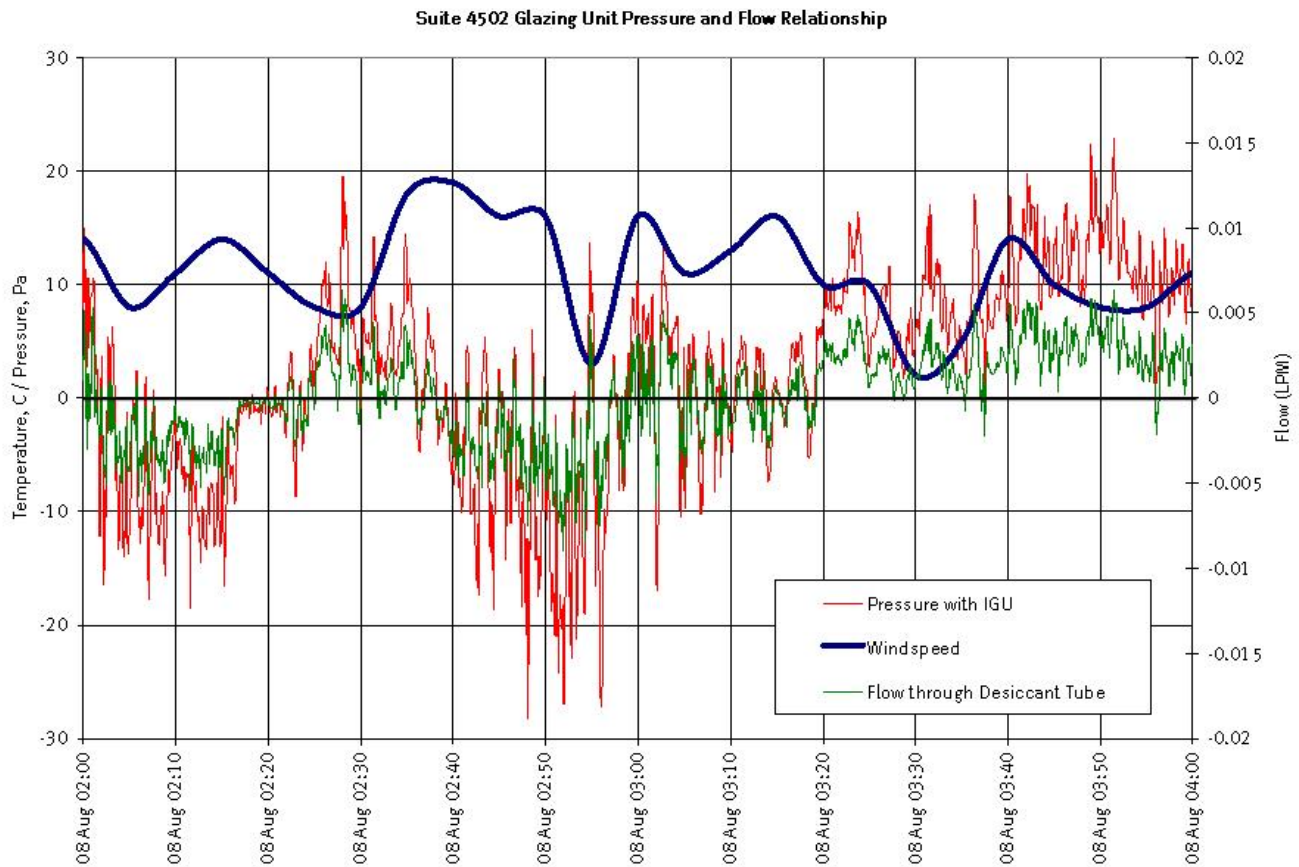
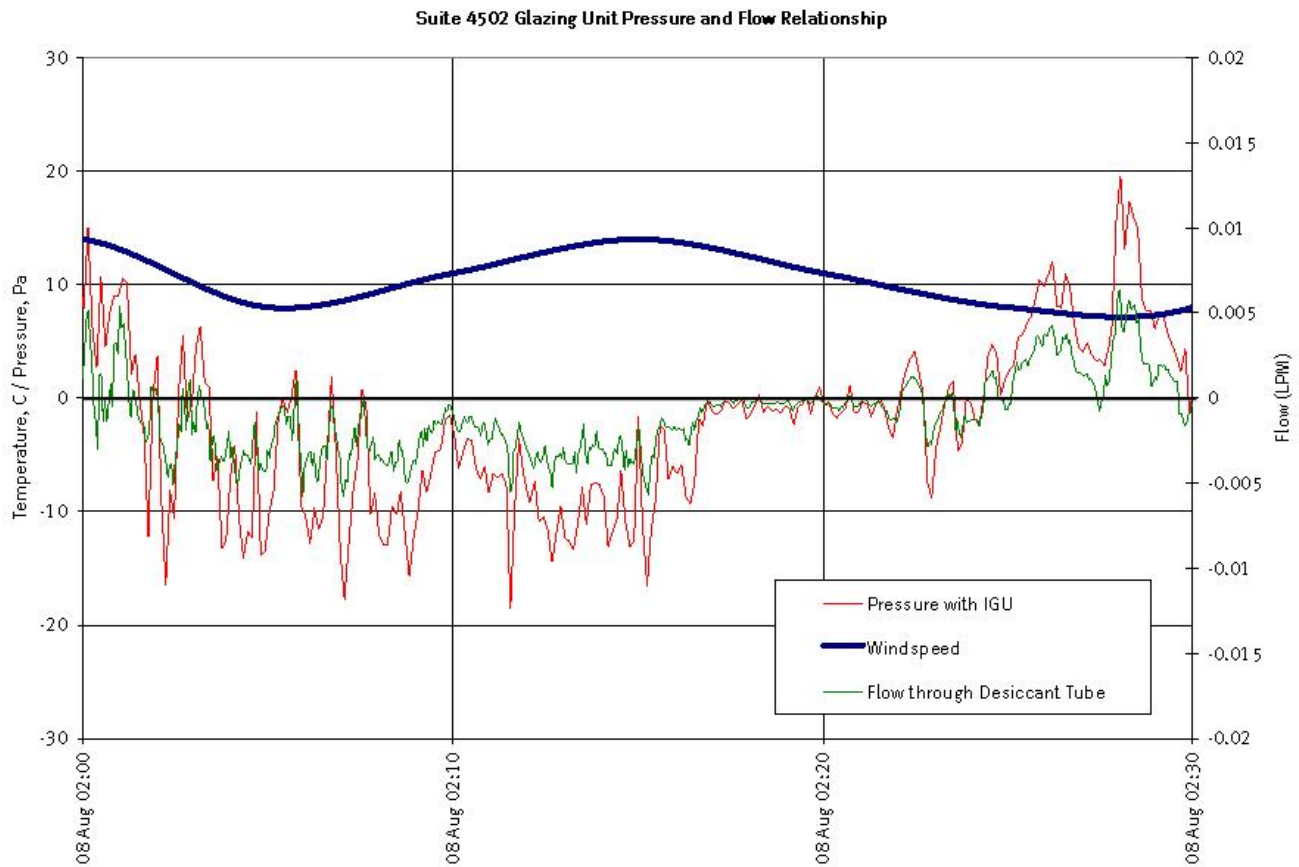
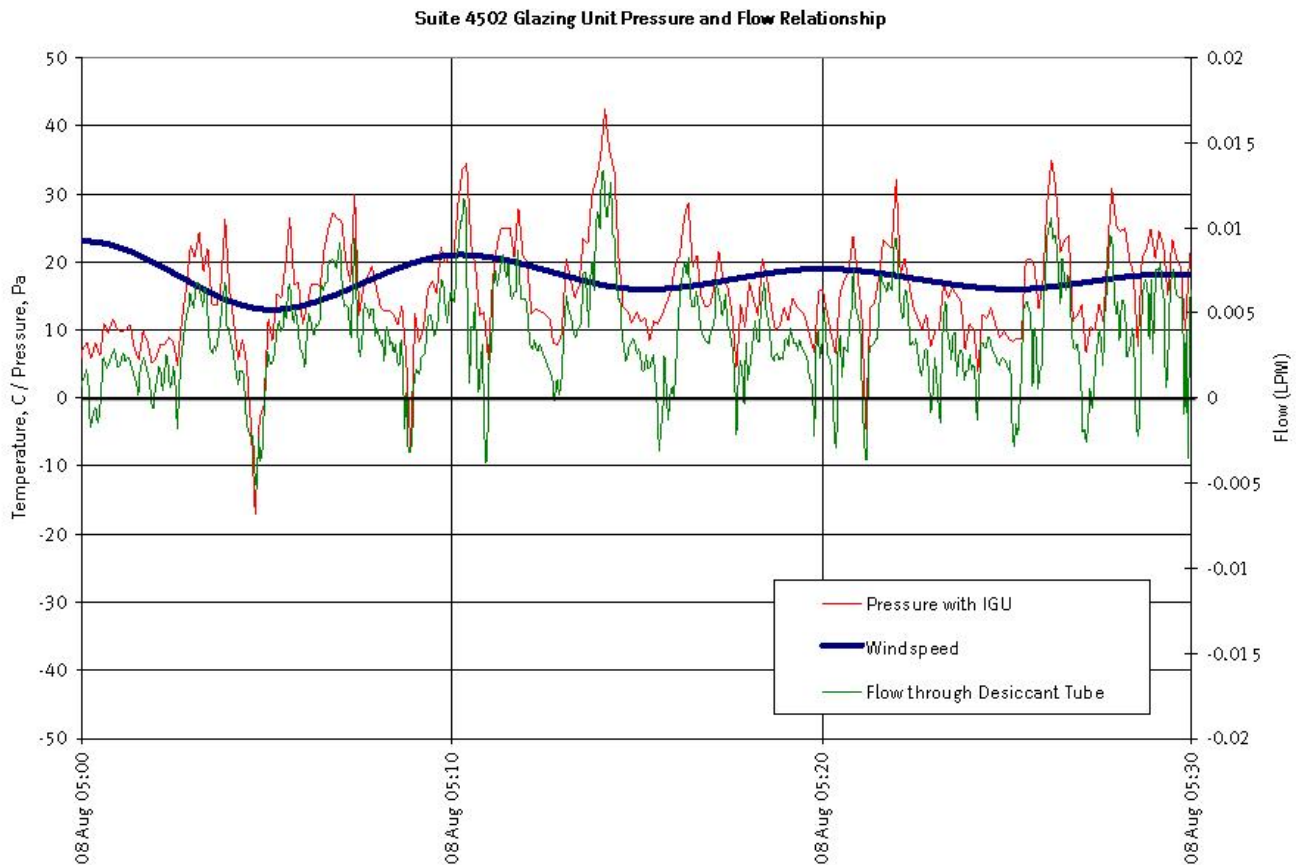
The relationship between this IGU pressure and flow into and out of the IGU is presented in Figures B29 through B31. As shown, the pressure, caused by wind, also results in a flow of air out of or into the IGU through the Desiccant tube. As the desiccant tube makes up only a portion of the IGU leakage, it is assumed that the pressure also causes leakage of the IGUs out of other edge seal deficiencies.

Figure B29: Pressure with IGU 45367 and Flow out of Desiccant Tube at adjacent IGU 44900, 12 hour period. Wind-speed in kph

Figure B30: Pressure with IGU 45367 and Flow out of Desiccant Tube at adjacent IGU 44900, 2 hour period. Wind-speed in kph.

Figure B31: Pressure with IGU 45367 and Flow out of Desiccant Tube at adjacent IGU 44900, 0.5 hour period. Wind-speed in kph

Figure B32: Pressure with IGU 45367 and Flow out of Desiccant Tube at adjacent IGU 44900, 0.5 hour period

During the monitored period between August 7<sup>th</sup> and 11<sup>th</sup> 2008 the maximum negative pressure measured was -59 Pa, and the maximum positive pressure was +42 Pa.

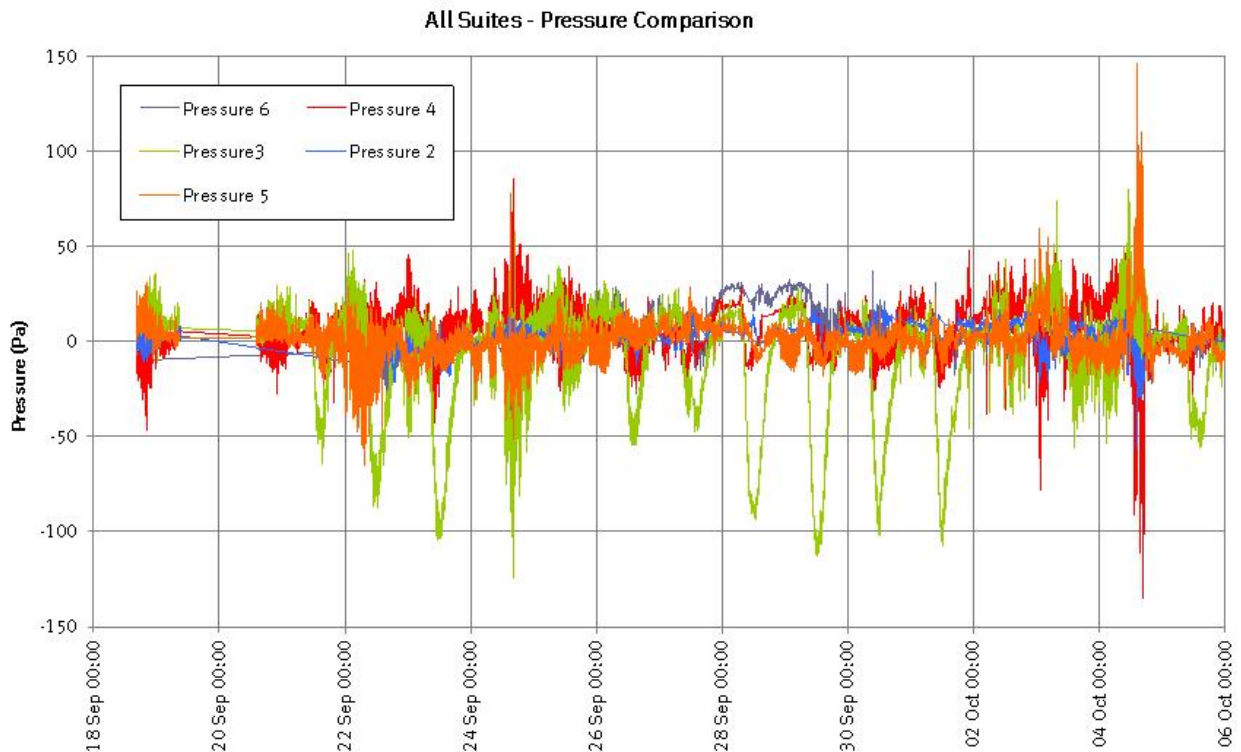
Figure B34: Pressure data for 5 monitored IGUs, September 8<sup>th</sup> through October 6<sup>th</sup>.

In general the IGU pressure is influenced by wind pressures on the building. It is suspected the setup for Pressure Gauge #3 was adversely affected by solar heating and hence produced some potentially erroneous results (green line

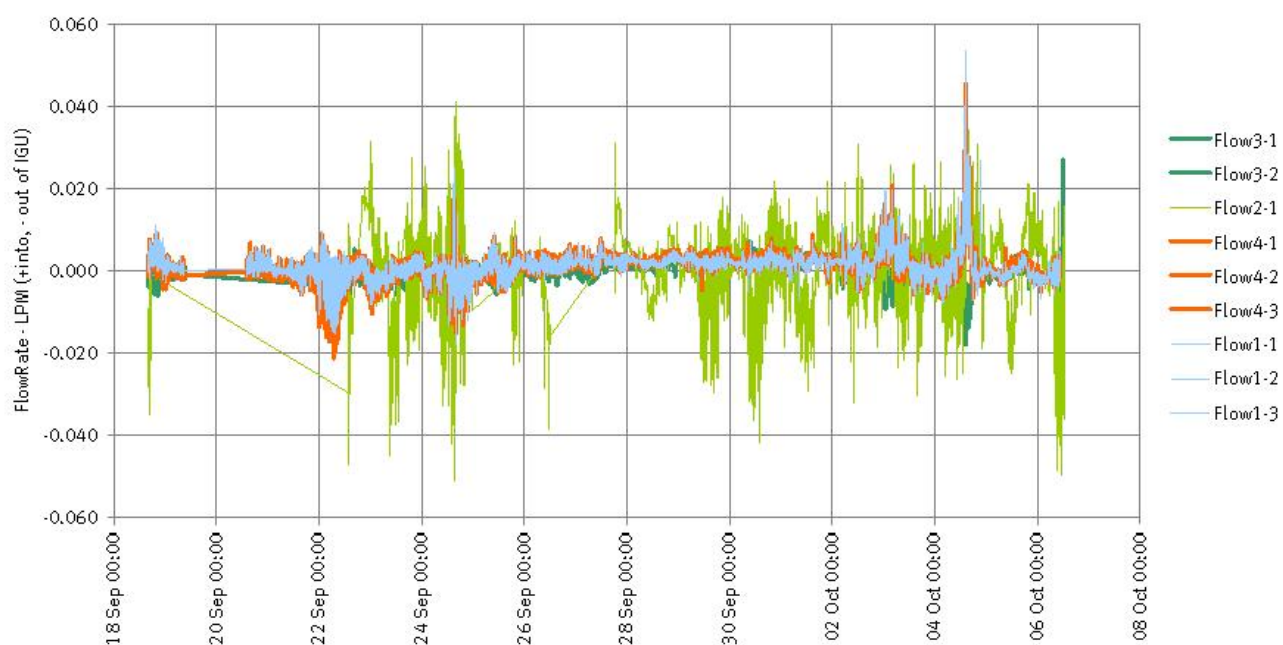
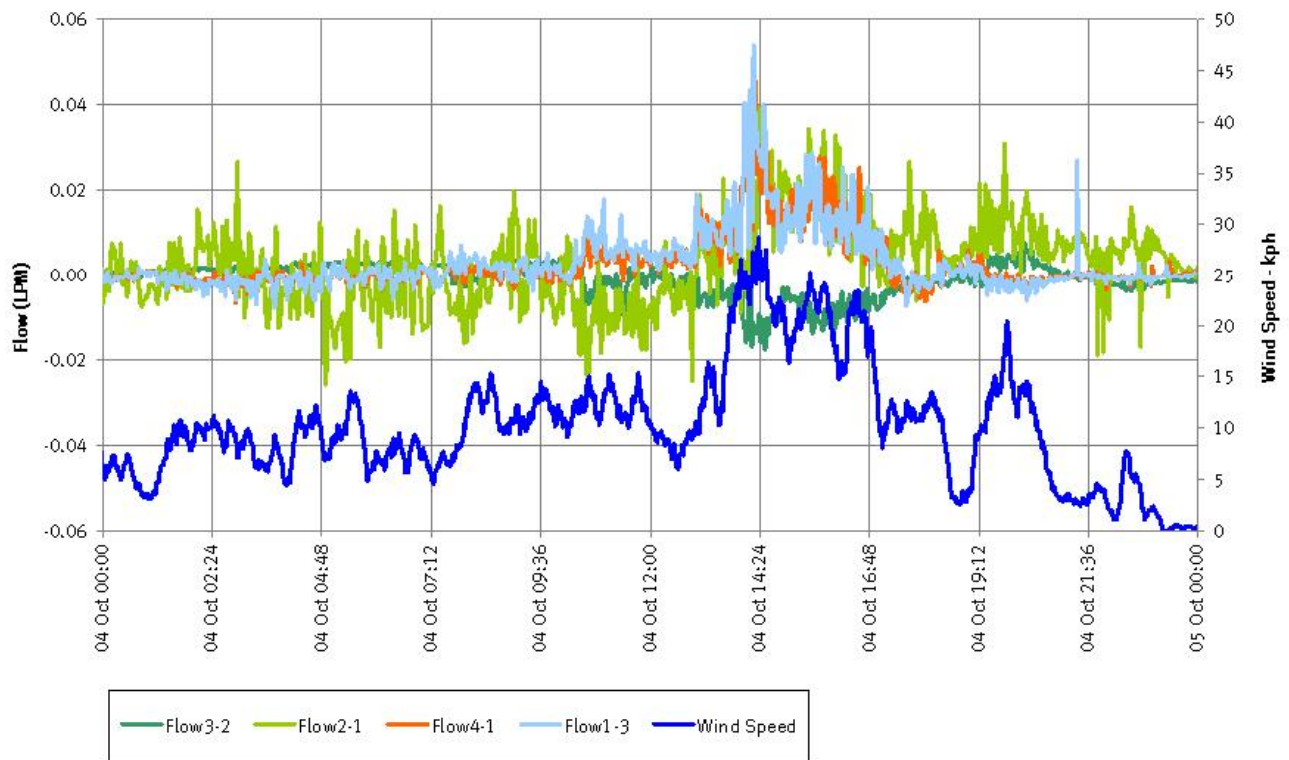
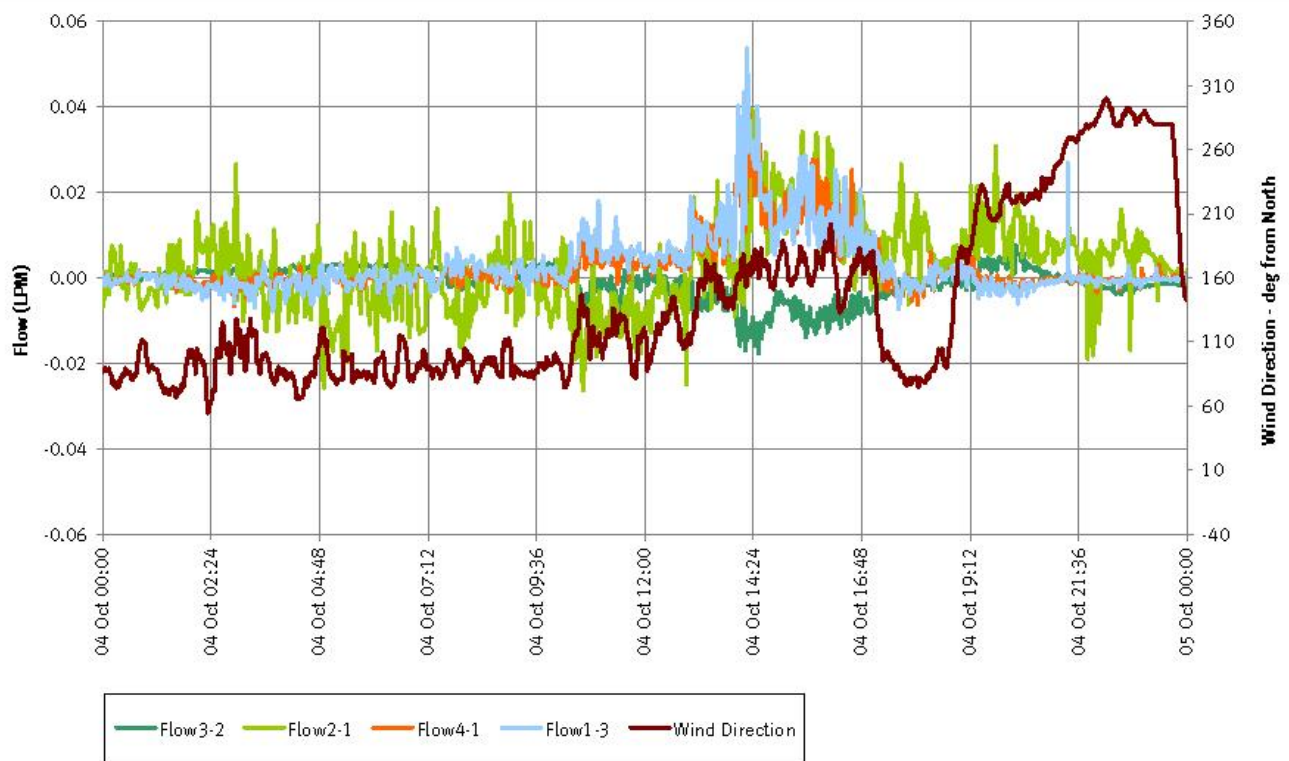
Flow data for IGUs is presented in Figure B36 for the entire period and in Figure B37 for October 4th. Flow Sensor 5 at suite 4002 malfunctioned during the testing and did not record and is excluded from the plot.

Figure B36: Flow through IGU Tube, September 18 through October 8, 2008.

Figure B37: Flow into and out of Desiccant Tubes - October 4, 2008.

Flow units #1 and #4 are located within the same suite (4003) on the same orientation exposed to the prominent wind direction and have very similar behaviour. Flow unit #2 is at suite 4002 and subject to varying wind pressures on the prominently leeward side of the building. Flow unit #3 is at suite 4004 and subject to varying wind pressures on the shear wind side of the building.

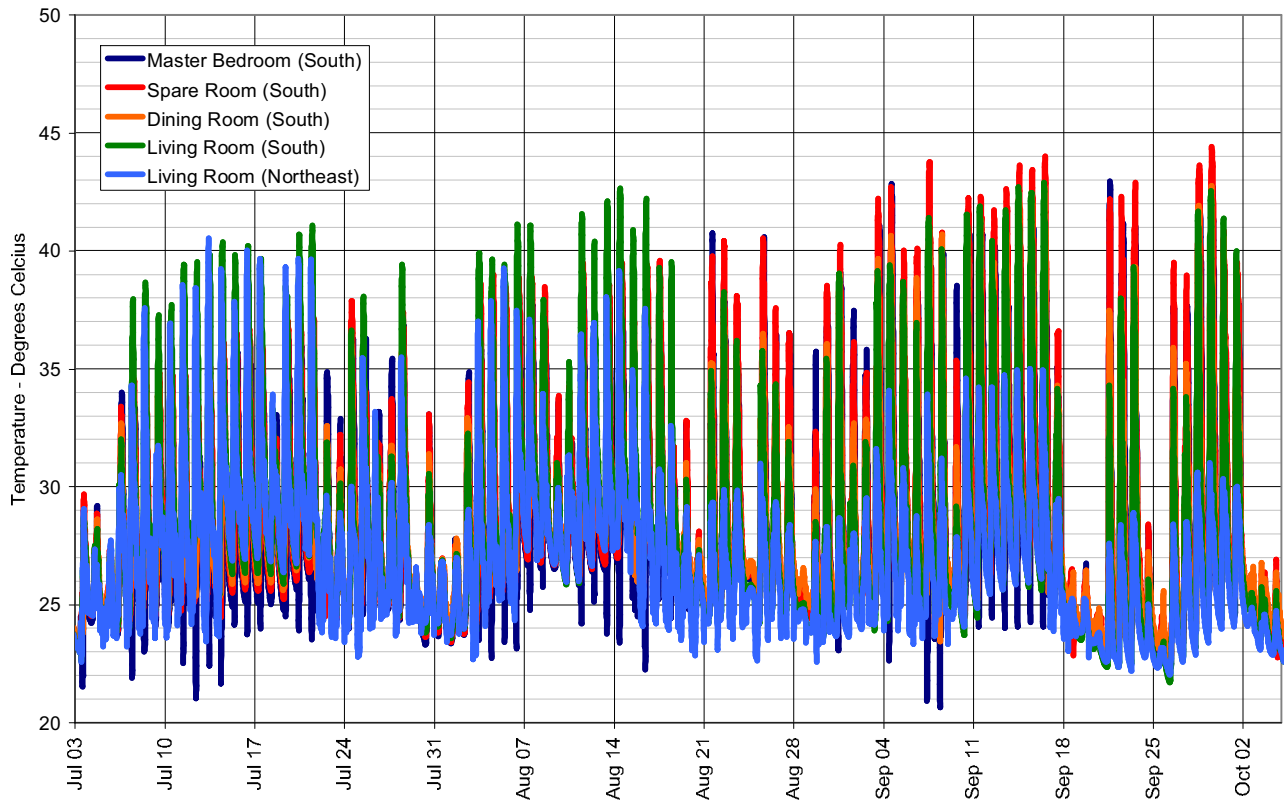
Figure D3: Suite 3903 - Near Window Indoor Air Temperature, July 3 through October 5, 2008

Temperatures near the windows are uncomfortably hot over the entire monitored period (up to above 40°C), and this is consistent with the occupant complaints. The warm window temperatures affect the thermal comfort within the suite and required energy to air-condition the suite. Temperatures at the north side of the suite in the afternoon indicate temperatures within the suite are regularly around 30°C, even with the air-conditioning system running. Night-time temperatures are frequently above 25°C, which may be uncomfortable to some people.

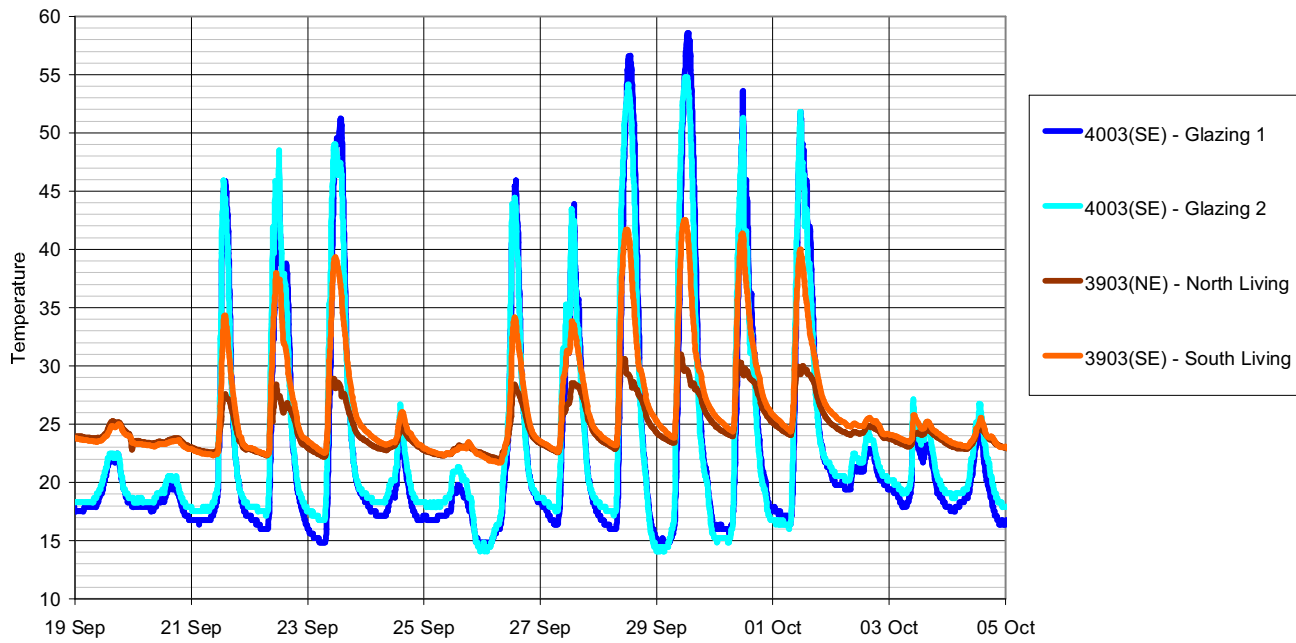
Figure D10: Comparison of Suite 3903 near window temperature and 4003 glazing surface temperature

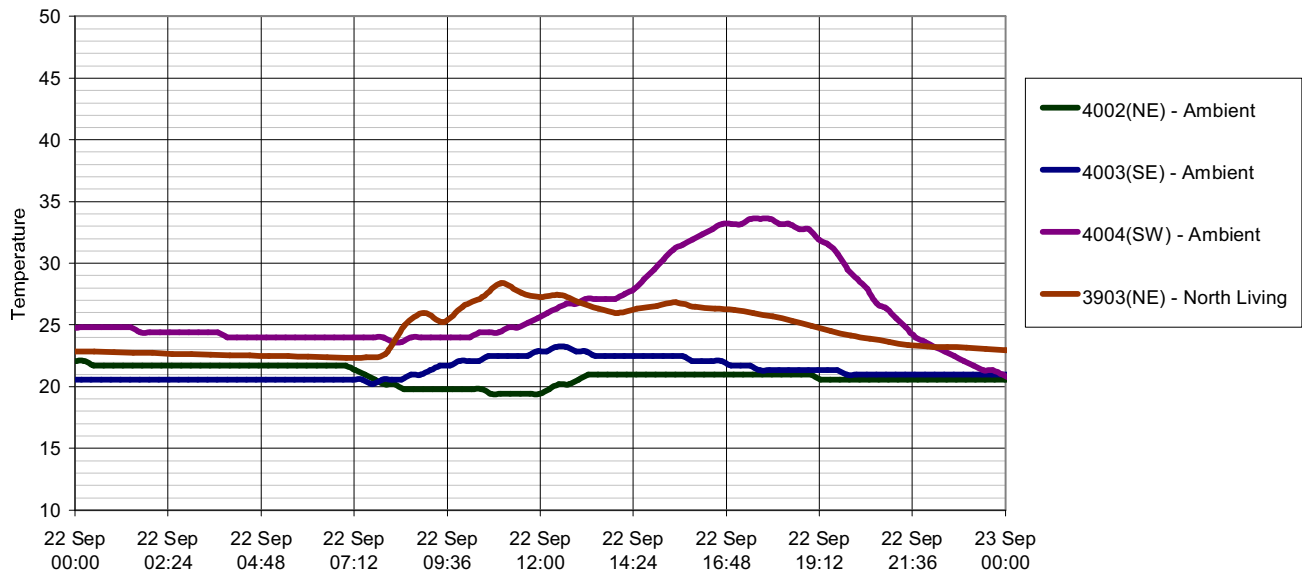
Figure D12: Overheating of Suite 4004 on September 22, 2008, when air-conditioning unit not working, compared to adjacent suites

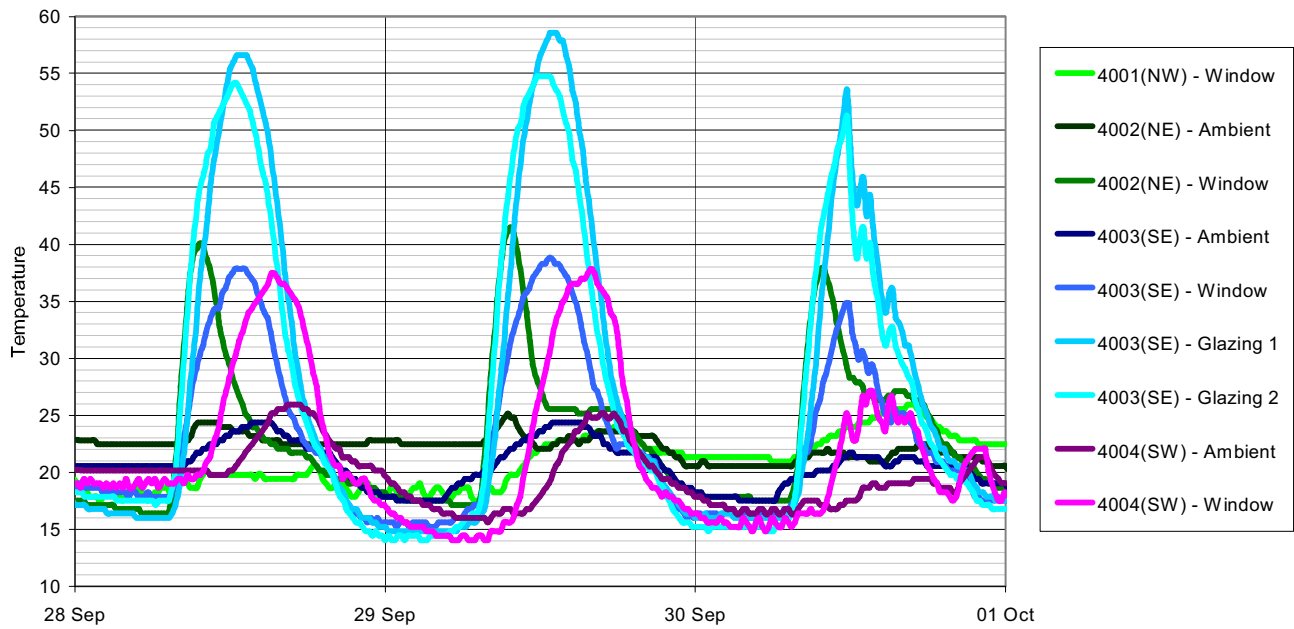
Figure D13: 40<sup>th</sup> Floor, Peak Solar Heating Events from September 28 through October 1, 2008

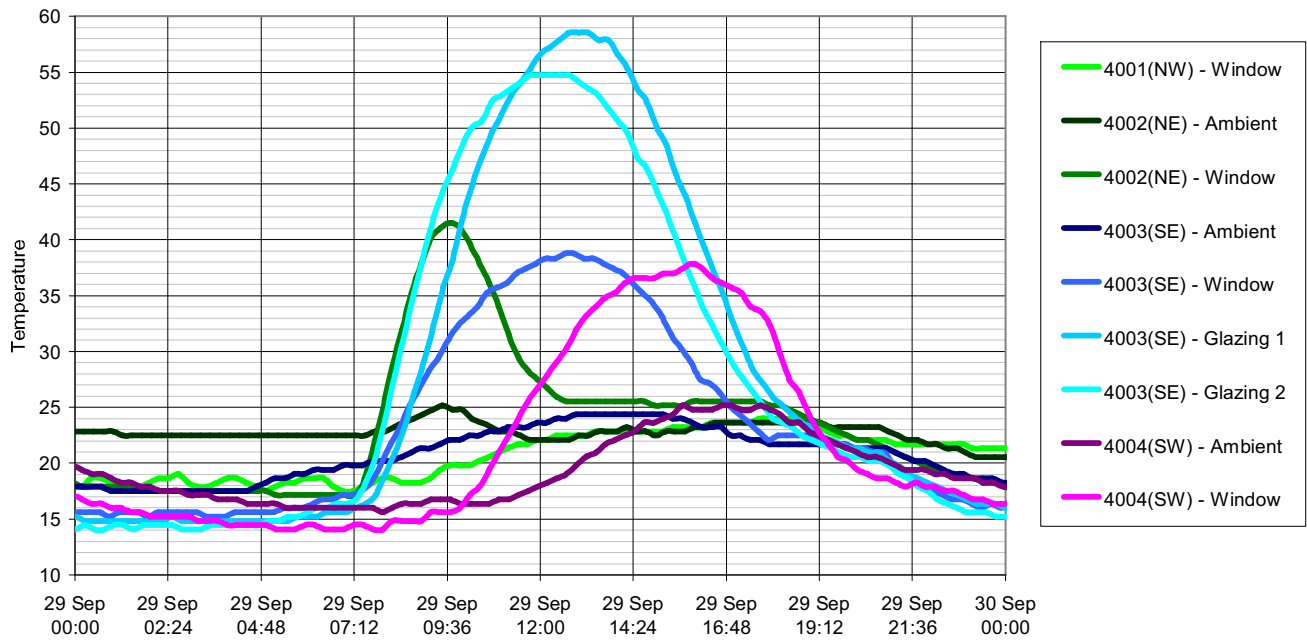
Figure D14: 40<sup>th</sup> Floor, Peak Solar Heating Event on September 29, 2008.
